## Appendix

<b>Name</b>	<b>Appendix No.</b>
Ready to Dig Searches and Responses	A
Arboricultural	B
Topographical Survey	C
Decontamination Survey	D
Habitat & Bat Survey	E
Asbestos	F

REFERENCE: 34638/PS  
ROUTE: Cotswold Road, Sutton  
OSGR: 525954,162355  
POSTCODE: SM2 5NF

**Ready to Dig – Utility Search Service**

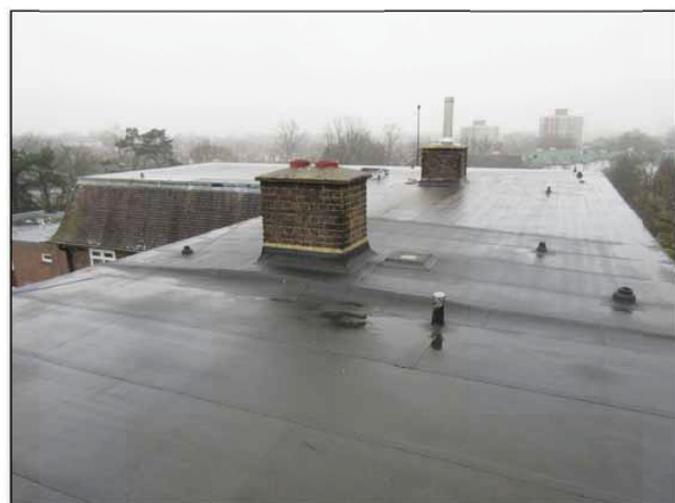
FINDING DETAILS					
Finding Code 04122014AGPA001		Item Bitumen	Recommendations Remove Prior to Demolition		
LOCATION					
Internal/External	Floor Level	Location Description	Extent	Identification	
External	Roof	Flat Roof, Poured Bitumen Coating onto Timber Boards	200sq. m	Identified	
MATERIAL ASSESSMENT					
Material	Asbestos Type	Condition	Accessibility	Encapsulation	Material Assessment
Bitumen	Chrysotile (white)	Good Condition: No Visible Damage	Accessible, but in restricted access areas	Composite materials: reinforced plastics, vinyl tiles.	2
SURVEYORS COMMENTS					
REMEDIAL ACTION TAKEN					
Action			Date Works Completed

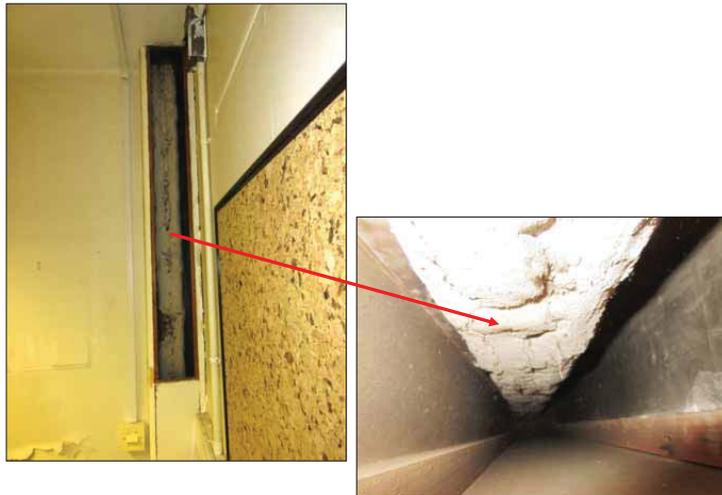
FINDING DETAILS					
Finding Code 04122014AGPA018		Item	Thermal Insulation on Pipework		
		Recommendations	Remove Prior to Demolition		
LOCATION					
Internal/External	Floor Level	Location Description	Extent	Identification	
Internal Unoccupied	First Floor	Room 007011025, Vertical Riser, Vertical Heating Pipe	3m	Identified	
MATERIAL ASSESSMENT					
Material	Asbestos Type	Condition	Accessibility	Encapsulation	Material Assessment
Thermal Insulation	Crocidolite, Amosite & Chrysotile	Low Damage: a few scratches or surface marks	Accessible, but in restricted access areas	Unsealed	9
SURVEYORS COMMENTS					
REMEDIAL ACTION TAKEN					
Action		Date Works Completed

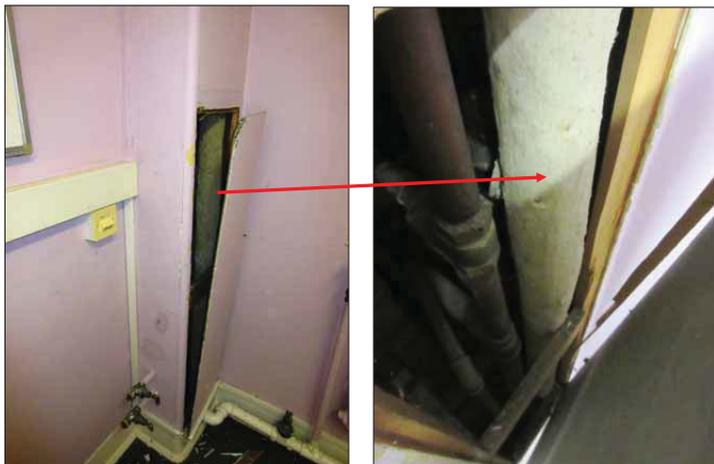
FINDING DETAILS					
Finding Code 04122014AGPA019		Item	Thermal Insulation on Pipework		
		Recommendations	Remove Prior to Demolition		
LOCATION					
Internal/External	Floor Level	Location Description		Extent	Identification
Internal Unoccupied	First Floor	Room 007011010, Vertical Riser to LHS of Window, Vertical Heating Pipe		3m	Identified
MATERIAL ASSESSMENT					
Material	Asbestos Type	Condition	Accessibility	Encapsulation	Material Assessment
Thermal Insulation	Crocidolite, Amosite & Chrysotile	Low Damage: a few scratches or surface marks	Accessible, but in restricted access areas	Unsealed	9
SURVEYORS COMMENTS					
REMEDIAL ACTION TAKEN					
Action			Date Works Completed

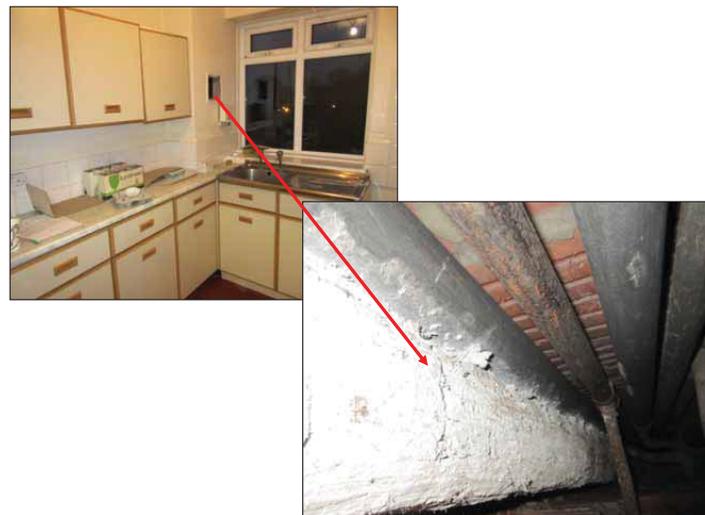
FINDING DETAILS					
Finding Code 04122014AGPA020		Item	Thermal Insulation on Pipework		
		Recommendations	Remove Prior to Demolition		
LOCATION					
Internal/External	Floor Level	Location Description		Extent	Identification
Internal Unoccupied	First Floor	Room 007011024, Vertical Riser to LHS of Window, Vertical Heating Pipe		3m	Identified
MATERIAL ASSESSMENT					
Material	Asbestos Type	Condition	Accessibility	Encapsulation	Material Assessment
Thermal Insulation	Crocidolite, Amosite & Chrysotile	Low Damage: a few scratches or surface marks	Accessible, but in restricted access areas	Unsealed	9
SURVEYORS COMMENTS					
REMEDIAL ACTION TAKEN					
Action			Date Works Completed

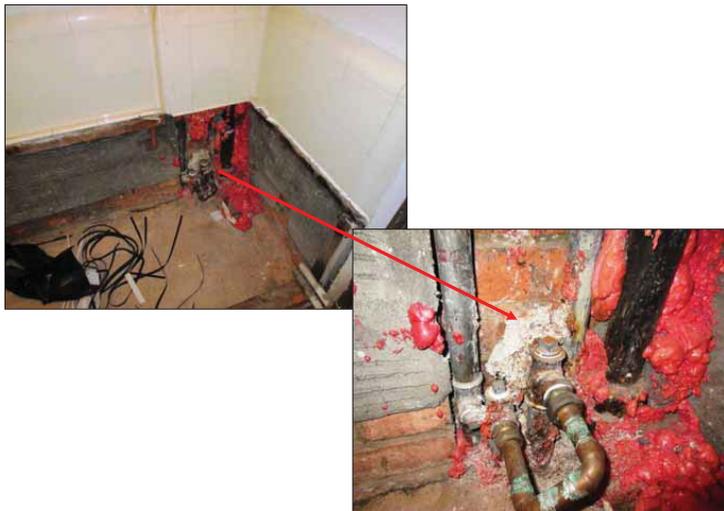
FINDING DETAILS					
Finding Code 04122014AGPA023		Item Thermal Insulation			
		Recommendations Remove Prior to Demolition			
LOCATION					
Internal/External	Floor Level	Location Description		Extent	Identification
Internal Unoccupied	First Floor	Room 007011021, Vertical Riser to LHS of Window, Debris		3m	Identified
MATERIAL ASSESSMENT					
Material	Asbestos Type	Condition	Accessibility	Encapsulation	Material Assessment
Thermal Insulation	Crocidolite, Amosite & Chrysotile	Low Damage: a few scratches or surface marks	Accessible, but in restricted access areas	Unsealed	9
SURVEYORS COMMENTS					
REMEDIAL ACTION TAKEN					
Action			Date Works Completed

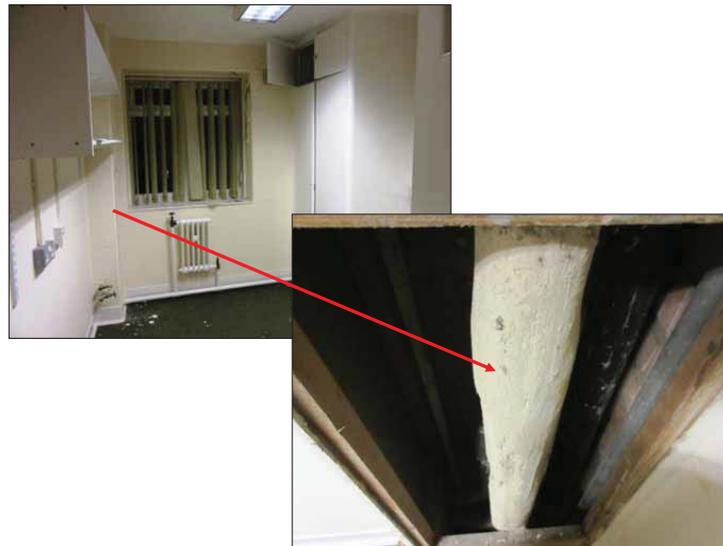
FINDING DETAILS					
Finding Code 04122014AGPA024		Item Thermal Insulation on Pipework			
		Recommendations Remove Prior to Demolition			
LOCATION					
Internal/External	Floor Level	Location Description		Extent	Identification
Internal Unoccupied	First Floor	Room 007011012, Vertical Riser, Vertical Heating Pipe		3m	Identified
MATERIAL ASSESSMENT					
Material	Asbestos Type	Condition	Accessibility	Encapsulation	Material Assessment
Thermal Insulation	Crocidolite, Amosite & Chrysotile	Low Damage: a few scratches or surface marks	Accessible, but in restricted access areas	Unsealed	9
SURVEYORS COMMENTS					
REMEDIAL ACTION TAKEN					
Action			Date Works Completed

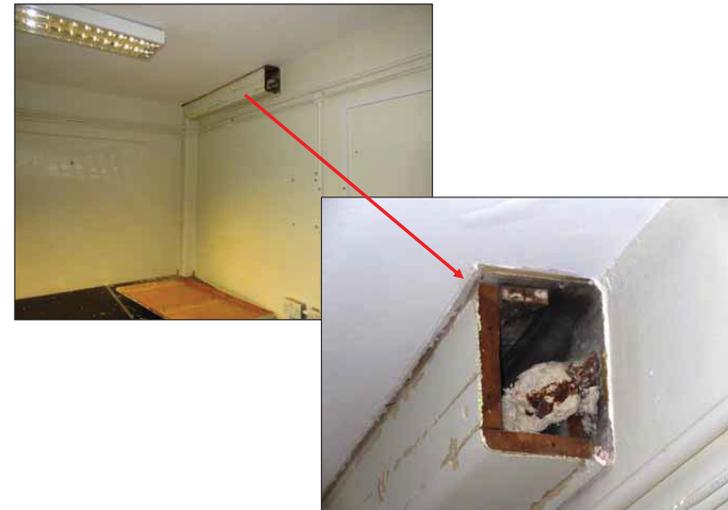
FINDING DETAILS					
Finding Code 04122014AGPA028		Item Thermal Insulation			
		Recommendations Remove Prior to Demolition			
LOCATION					
Internal/External	Floor Level	Location Description	Extent	Identification	
Internal Unoccupied	First Floor	Room 007011016, High Level Horizontal and Vertical Timber Boxing, Heating Pipe	5m	Identified	
MATERIAL ASSESSMENT					
Material	Asbestos Type	Condition	Accessibility	Encapsulation	Material Assessment
Thermal Insulation	Crocidolite, Amosite & Chrysotile	Low Damage: a few scratches or surface marks	Accessible, but in restricted access areas	Unsealed	9
SURVEYORS COMMENTS					
REMEDIAL ACTION TAKEN					
Action			Date Works Completed

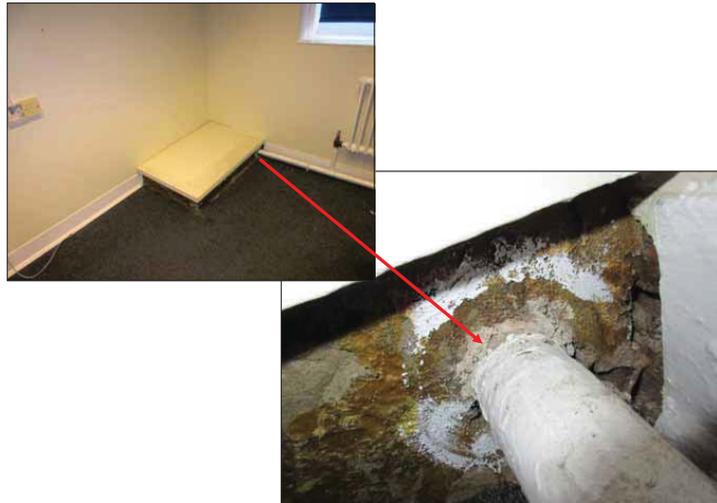
FINDING DETAILS					
Finding Code 04122014AGPA029		Item	Thermal Insulation on Pipework		
		Recommendations	Remove Prior to Demolition		
LOCATION					
Internal/External	Floor Level	Location Description		Extent	Identification
Internal Unoccupied	First Floor	Room 007011016, RHS of Window, Perimeter Heating Pipes Below Timber Cupboard, Embedded in Poured Concrete		1m	Identified
MATERIAL ASSESSMENT					
Material	Asbestos Type	Condition	Accessibility	Encapsulation	Material Assessment
Thermal Insulation	Crocidolite, Amosite & Chrysotile	Low Damage: a few scratches or surface marks	Accessible, but in restricted access areas	Enclosed	8
SURVEYORS COMMENTS					
REMEDIAL ACTION TAKEN					
Action			Date Works Completed

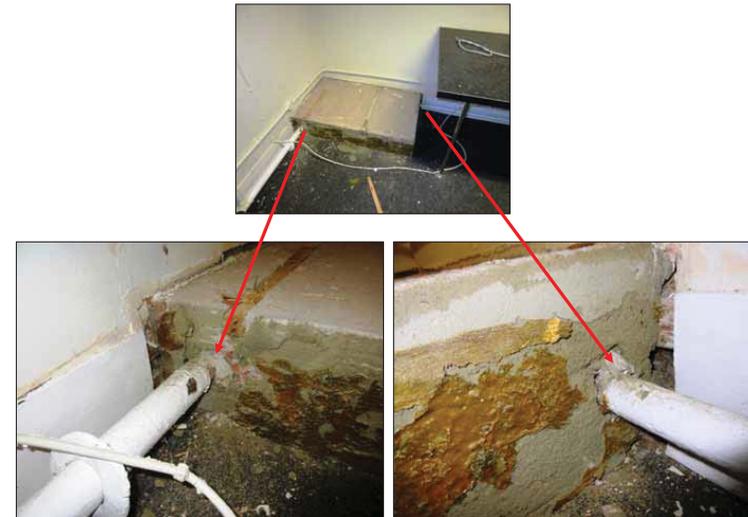
FINDING DETAILS					
Finding Code 04122014AGPA030		Item	Thermal Insulation on Pipework		
		Recommendations	Remove Prior to Demolition		
LOCATION					
Internal/External	Floor Level	Location Description		Extent	Identification
Internal Unoccupied	First Floor	Room 007011016, LHS of Window, Perimeter Heating Pipes Below Timber Cupboard, Embedded in Poured Concrete		1m	Identified
MATERIAL ASSESSMENT					
Material	Asbestos Type	Condition	Accessibility	Encapsulation	Material Assessment
Thermal Insulation	Crocidolite, Amosite & Chrysotile	Low Damage: a few scratches or surface marks	Accessible, but in restricted access areas	Enclosed	8
SURVEYORS COMMENTS					
REMEDIAL ACTION TAKEN					
Action			Date Works Completed

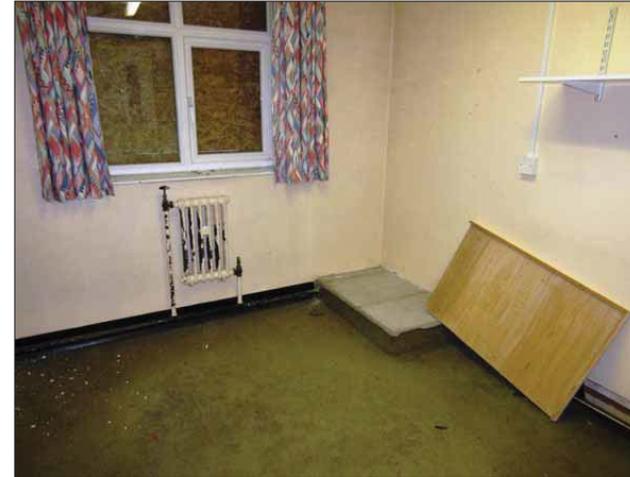
FINDING DETAILS					
Finding Code 04122014AGPA034		Item Thermal Insulation on Pipework			
		Recommendations Remove Prior to Demolition			
LOCATION					
Internal/External	Floor Level	Location Description	Extent	Identification	
Internal Unoccupied	Ground Floor	Room 00701G014, RHS of Window, Perimeter Heating Pipes Embedded in Poured Concrete Plinth	1m	Identified	
MATERIAL ASSESSMENT					
Material	Asbestos Type	Condition	Accessibility	Encapsulation	Material Assessment
Thermal Insulation	Crocidolite, Amosite & Chrysotile	Low Damage: a few scratches or surface marks	Accessible, but in restricted access areas	Enclosed	8
SURVEYORS COMMENTS					
REMEDIAL ACTION TAKEN					
Action			Date Works Completed

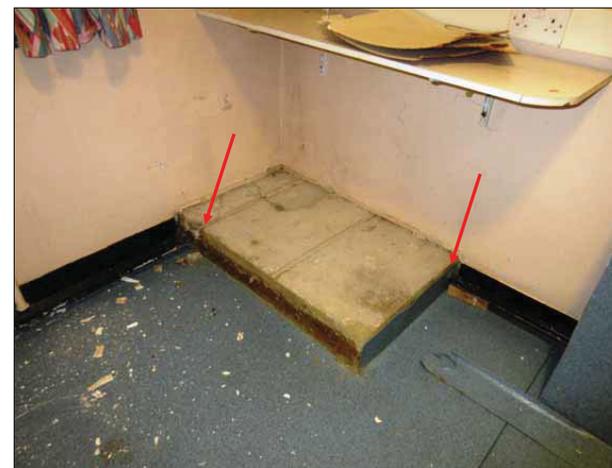
FINDING DETAILS					
Finding Code 04122014AGPA038		Item Thermal Insulation on Pipework			
		Recommendations Remove Prior to Demolition			
LOCATION					
Internal/External	Floor Level	Location Description		Extent	Identification
Internal Unoccupied	Ground Floor	Room 00701G011, RHS of Window, Perimeter Heating Pipes Embedded in Poured Concrete Plinth		2m	Identified
MATERIAL ASSESSMENT					
Material	Asbestos Type	Condition	Accessibility	Encapsulation	Material Assessment
Thermal Insulation	Crocidolite, Amosite & Chrysotile	Low Damage: a few scratches or surface marks	Accessible, but in restricted access areas	Enclosed	8
SURVEYORS COMMENTS					
REMEDIAL ACTION TAKEN					
Action			Date Works Completed

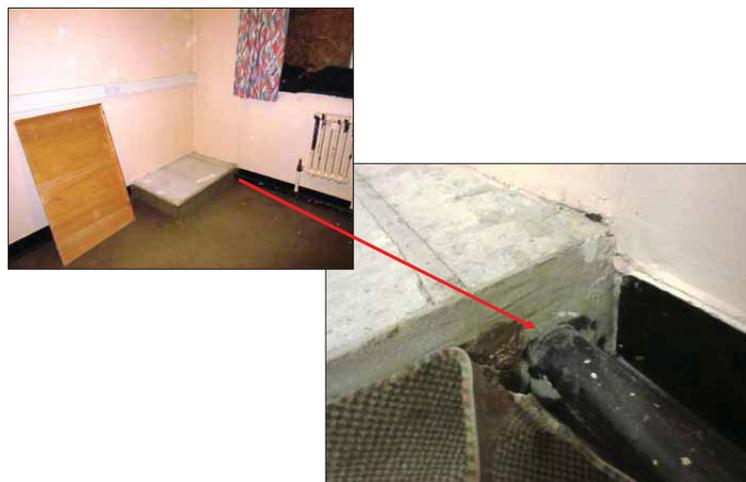
FINDING DETAILS					
Finding Code 04122014AGPA041		Item	Thermal Insulation on Pipework		
		Recommendations	Remove Prior to Demolition		
LOCATION					
Internal/External	Floor Level	Location Description		Extent	Identification
Internal Unoccupied	Ground Floor	Room 00701G010, LHS of Window, Perimeter Heating Pipes Embedded in Poured Concrete Plinth		1m	Identified
MATERIAL ASSESSMENT					
Material	Asbestos Type	Condition	Accessibility	Encapsulation	Material Assessment
Thermal Insulation	Crocidolite, Amosite & Chrysotile	Low Damage: a few scratches or surface marks	Accessible, but in restricted access areas	Enclosed	8
SURVEYORS COMMENTS					
REMEDIAL ACTION TAKEN					
Action			Date Works Completed

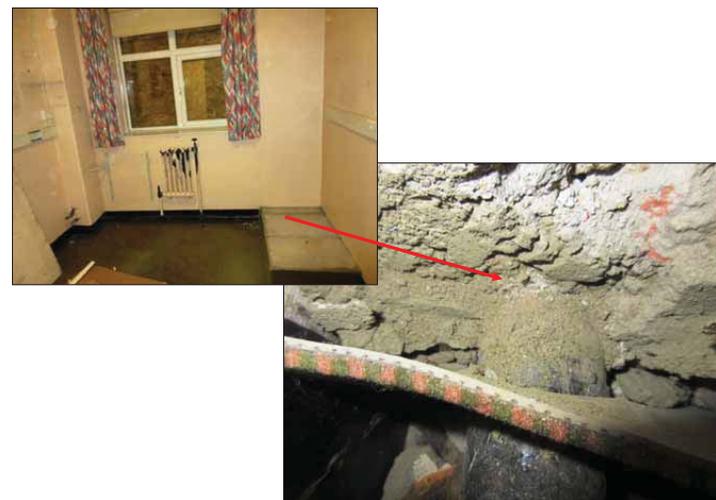
FINDING DETAILS					
Finding Code 04122014AGPA042		Item	Thermal Insulation on Pipework		
		Recommendations	Remove Prior to Demolition		
LOCATION					
Internal/External	Floor Level	Location Description		Extent	Identification
Internal Unoccupied	Ground Floor	Room 00701G009, RHS of Window, Perimeter Heating Pipes Embedded in Poured Concrete Plinth		1m	Identified
MATERIAL ASSESSMENT					
Material	Asbestos Type	Condition	Accessibility	Encapsulation	Material Assessment
Thermal Insulation	Crocidolite, Amosite & Chrysotile	Low Damage: a few scratches or surface marks	Accessible, but in restricted access areas	Enclosed	8
SURVEYORS COMMENTS					
REMEDIAL ACTION TAKEN					
Action			Date Works Completed

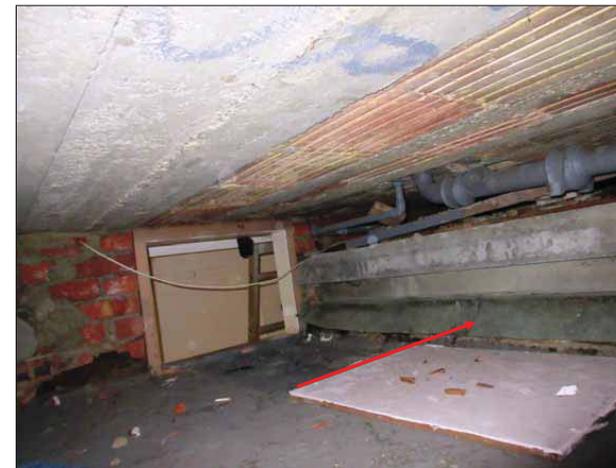
FINDING DETAILS					
Finding Code 04122014AGPA050		Item Bitumen Felt	Recommendations No action required		
LOCATION					
Internal/External Internal Unoccupied	Floor Level Ground Floor	Location Description Void above Room 00701G022, Felt to top of Concrete	Extent 40sq.m	Identification Identified	
MATERIAL ASSESSMENT					
Material Bitumen	Asbestos Type No Asbestos Detected	Condition Good Condition: No Visible Damage	Accessibility Accessible, but in restricted access areas	Encapsulation Composite materials: reinforced plastics, resins, vinyl tiles.	Material Assessment 0
SURVEYORS COMMENTS					
REMEDIAL ACTION TAKEN					
Action			Date Works Completed

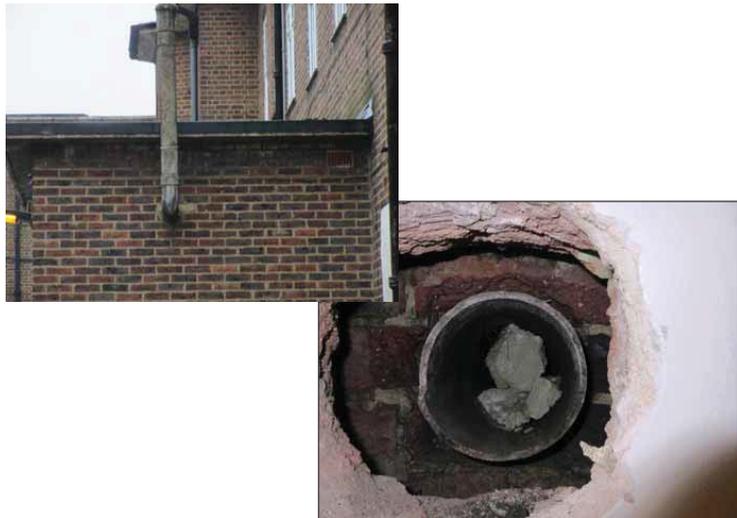
FINDING DETAILS					
Finding Code 04122014AGPA053		Item Asbestos Cement	Recommendations Remove Prior to Demolition		
LOCATION					
Internal/External	Floor Level	Location Description	Extent	Identification	
External	Ground Floor	Room 00701G022, Redundant Flue Pipe and Cowl	4m	Identified	
MATERIAL ASSESSMENT					
Material	Asbestos Type	Condition	Accessibility	Encapsulation	Material Assessment
Cement	Amosite & Chrysotile	Good Condition: No Visible Damage	Accessible, but above head height	Enclosed	4
SURVEYORS COMMENTS					
It has been cut off within the external brick wall					
REMEDIAL ACTION TAKEN					
Action			Date Works Completed

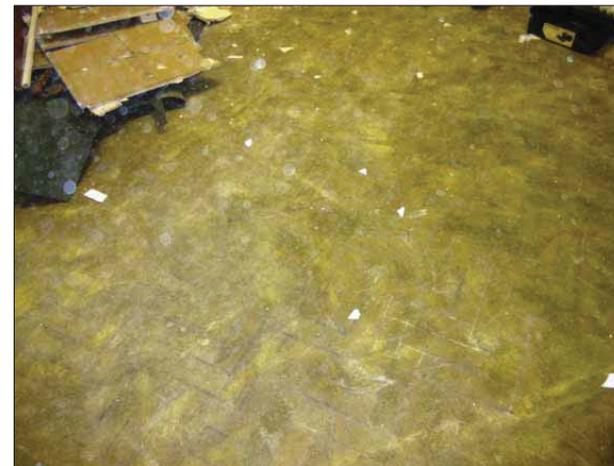
FINDING DETAILS					
Finding Code 04122014AGPA054		Item Bitumen Adhesive	Recommendations No action required		
LOCATION					
Internal/External	Floor Level	Location Description	Extent	Identification	
Internal Unoccupied	Ground Floor	Room 00701G005, Parquet Flooring, Adhesive	17sq.m	Identified	
MATERIAL ASSESSMENT					
Material	Asbestos Type	Condition	Accessibility	Encapsulation	Material Assessment
Bitumen	No Asbestos Detected	Good Condition: No Visible Damage	Accessible, but in restricted access areas	Composite materials: reinforced plastics, resins, vinyl tiles.	0
SURVEYORS COMMENTS					
REMEDIAL ACTION TAKEN					
Action			Date Works Completed

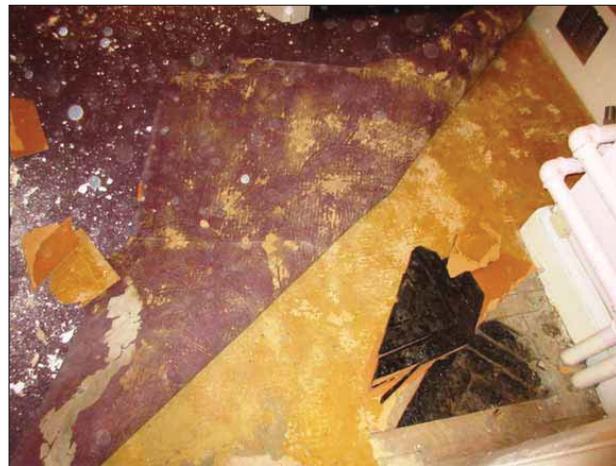
FINDING DETAILS					
Finding Code 04122014AGPA057		Item Bitumen Adhesive	Recommendations No action required		
LOCATION					
Internal/External Internal Unoccupied	Floor Level Ground Floor	Location Description Room 00701G025, Parquet Flooring, Adhesive	Extent 10sq.m	Identification Identified	
MATERIAL ASSESSMENT					
Material Bitumen	Asbestos Type No Asbestos Detected	Condition Good Condition: No Visible Damage	Accessibility Accessible, but in restricted access areas	Encapsulation Composite materials: reinforced plastics, resins, vinyl tiles.	Material Assessment 0
SURVEYORS COMMENTS					
REMEDIAL ACTION TAKEN					
Action			Date Works Completed

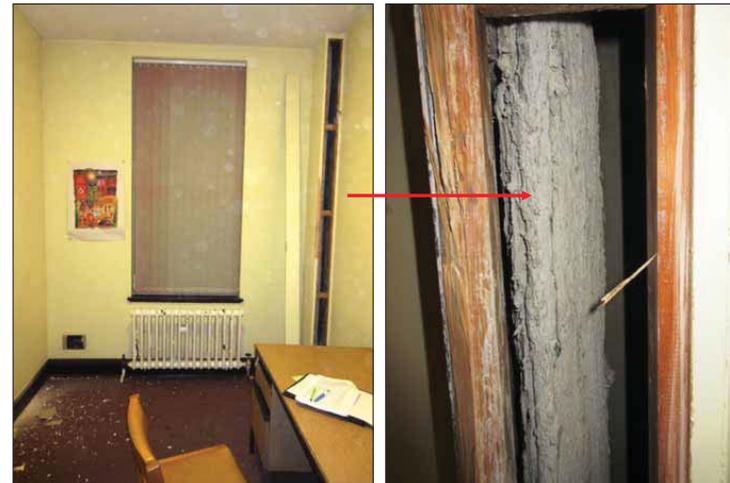
FINDING DETAILS					
Finding Code 04122014AGPA058		Item Thermal Insulation on Pipework	Recommendations Remove Prior to Demolition		
LOCATION					
Internal/External Internal Unoccupied	Floor Level Ground Floor	Location Description Room 00701G003 (sub-division), Vertical Riser to RHS of Window, Vertical Pipe	Extent 4m	Identification Identified	
MATERIAL ASSESSMENT					
Material Thermal Insulation	Asbestos Type Crocidolite, Amosite & Chrysotile	Condition Low Damage: a few scratches or surface marks	Accessibility Accessible, but in restricted access areas	Encapsulation Unsealed	Material Assessment 9
SURVEYORS COMMENTS					
REMEDIAL ACTION TAKEN					
Action			Date Works Completed

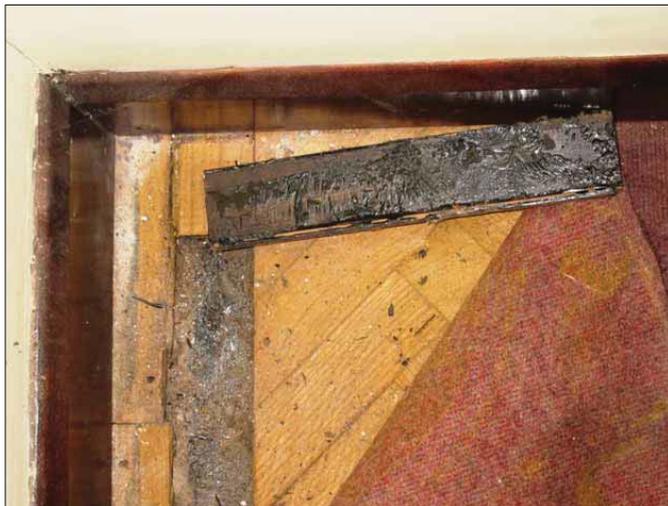
FINDING DETAILS					
Finding Code 04122014AGPA059		Item	Bitumen Adhesive		
		Recommendations	No action required		
LOCATION					
Internal/External	Floor Level	Location Description		Extent	Identification
Internal Unoccupied	Ground Floor	Room 00701G003, Parquet Flooring, Adhesive		30sq.m	Identified
MATERIAL ASSESSMENT					
Material	Asbestos Type	Condition	Accessibility	Encapsulation	Material Assessment
Bitumen	No Asbestos Detected	Good Condition: No Visible Damage	Accessible, but in restricted access areas	Composite materials: reinforced plastics, resins, vinyl tiles.	0
SURVEYORS COMMENTS					
REMEDIAL ACTION TAKEN					
Action			Date Works Completed

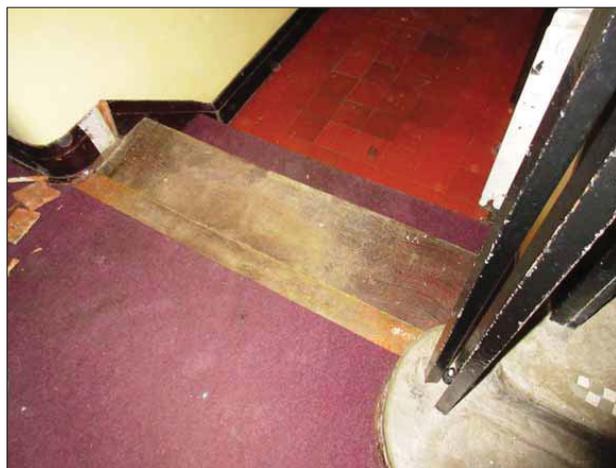
FINDING DETAILS					
Finding Code 04122014AGPA061		Item	Bitumen Adhesive		
		Recommendations	No action required		
LOCATION					
Internal/External	Floor Level	Location Description		Extent	Identification
Internal Unoccupied	Ground Floor	Corridor 00701GC01, Parquet Flooring, Adhesive		6sq.m	Identified
MATERIAL ASSESSMENT					
Material	Asbestos Type	Condition	Accessibility	Encapsulation	Material Assessment
Bitumen	No Asbestos Detected	Good Condition: No Visible Damage	Accessible, but in restricted access areas	Composite materials: reinforced plastics, resins, vinyl tiles.	0
SURVEYORS COMMENTS					
REMEDIAL ACTION TAKEN					
Action			Date Works Completed

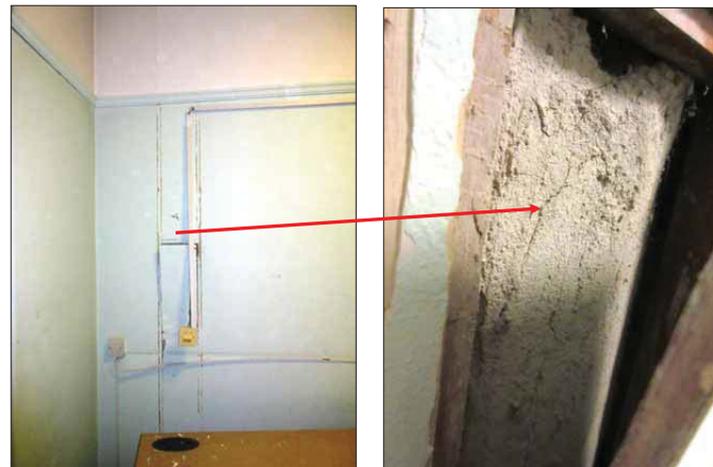
FINDING DETAILS					
Finding Code 04122014AGPA062		Item	Thermal Insulation on Pipework		
		Recommendations	Remove Prior to Demolition		
LOCATION					
Internal/External	Floor Level	Location Description		Extent	Identification
Internal Unoccupied	Ground Floor	Room 00701G001, Vertical Riser Embedded in Wall to RHS of Window, Vertical Pipe		4m	Identified
MATERIAL ASSESSMENT					
Material	Asbestos Type	Condition	Accessibility	Encapsulation	Material Assessment
Thermal Insulation	Crocidolite, Amosite & Chrysotile	Low Damage: a few scratches or surface marks	Accessible, but in restricted access areas	Unsealed	9
SURVEYORS COMMENTS					
REMEDIAL ACTION TAKEN					
Action			Date Works Completed

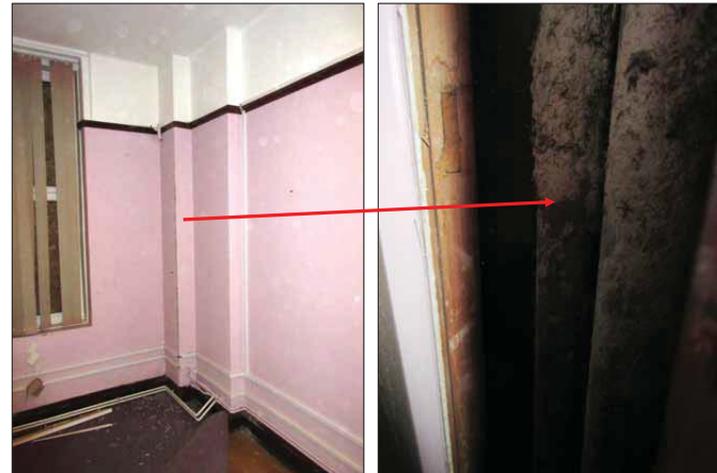
FINDING DETAILS					
Finding Code 04122014AGPA064		Item Thermal Insulation on Pipework			
		Recommendations Remove Prior to Demolition			
LOCATION					
Internal/External	Floor Level	Location Description	Extent	Identification	
Internal Unoccupied	Ground Floor	Room 00701G002, Vertical Riser to RHS of Window, Vertical Pipes [x2 pipes]	Each 4m	Identified	
MATERIAL ASSESSMENT					
Material	Asbestos Type	Condition	Accessibility	Encapsulation	Material Assessment
Thermal Insulation	Crocidolite, Amosite & Chrysotile	Low Damage: a few scratches or surface marks	Accessible, but in restricted access areas	Unsealed	9
SURVEYORS COMMENTS					
REMEDIAL ACTION TAKEN					
Action			Date Works Completed

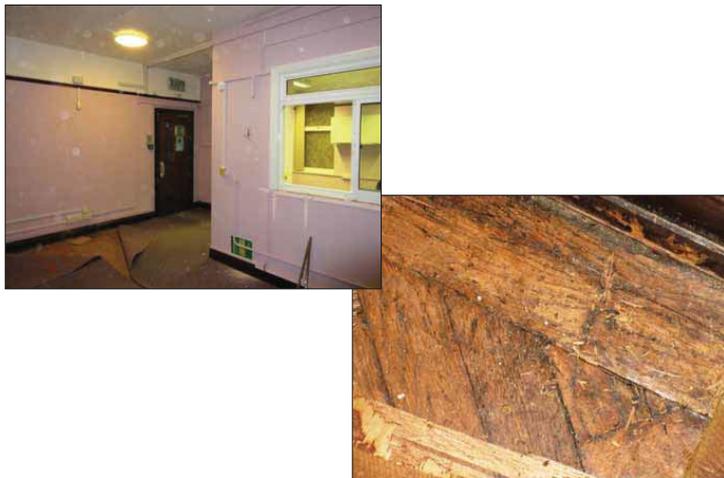
FINDING DETAILS					
Finding Code 04122014AGPA065		Item Bitumen Adhesive	Recommendations No action required		
LOCATION					
Internal/External Internal Unoccupied	Floor Level Ground Floor	Location Description Room 00701G002, Parquet Flooring, Adhesive	Extent 35sq.m	Identification Identified	
MATERIAL ASSESSMENT					
Material Bitumen	Asbestos Type No Asbestos Detected	Condition Good Condition: No Visible Damage	Accessibility Accessible, but in restricted access areas	Encapsulation Composite materials: reinforced plastics, resins, vinyl tiles.	Material Assessment 0
SURVEYORS COMMENTS					
REMEDIAL ACTION TAKEN					
Action			Date Works Completed

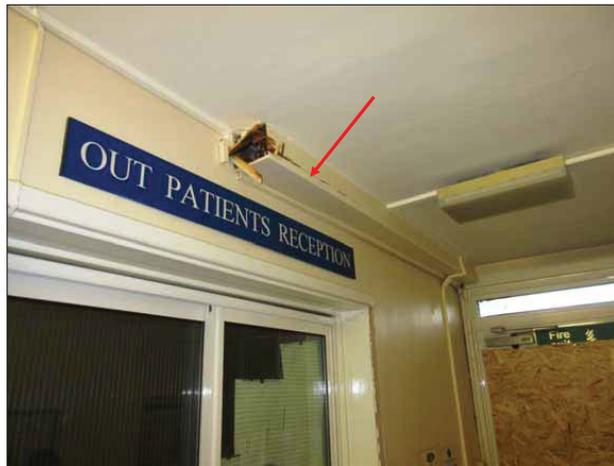
FINDING DETAILS					
Finding Code 04122014AGPA069		Item Thermal Insulation on Pipework			
		Recommendations Remove Prior to Demolition			
LOCATION					
Internal/External	Floor Level	Location Description	Extent	Identification	
Internal Unoccupied	Ground Floor	Corridor 00701GC04, Wall to Room 00701G016, High Level Boxing Heating Pipe	2m	Identified	
MATERIAL ASSESSMENT					
Material	Asbestos Type	Condition	Accessibility	Encapsulation	Material Assessment
Thermal Insulation	Crocidolite, Amosite & Chrysotile	Low Damage: a few scratches or surface marks	Accessible, but in restricted access areas	Unsealed	9
SURVEYORS COMMENTS					
REMEDIAL ACTION TAKEN					
Action			Date Works Completed

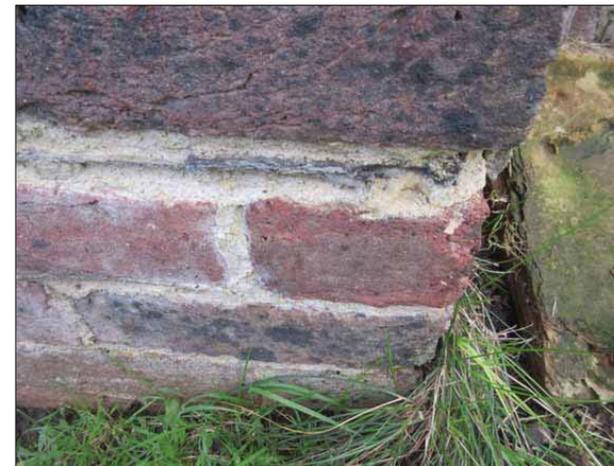
FINDING DETAILS					
Finding Code 04122014AGPA070		Item Damp Proof Course			
		Recommendations No action required			
LOCATION					
Internal/External	Floor Level	Location Description	Extent	Identification	
External	Ground Floor	Room 00701G021	22sq.m	Identified	
MATERIAL ASSESSMENT					
Material	Asbestos Type	Condition	Accessibility	Encapsulation	Material Assessment
Bitumen	No Asbestos Detected	Good Condition: No Visible Damage	Accessible, but in restricted access areas	Composite materials: reinforced plastics, resins, vinyl tiles.	0
SURVEYORS COMMENTS					
REMEDIAL ACTION TAKEN					
Action			Date Works Completed

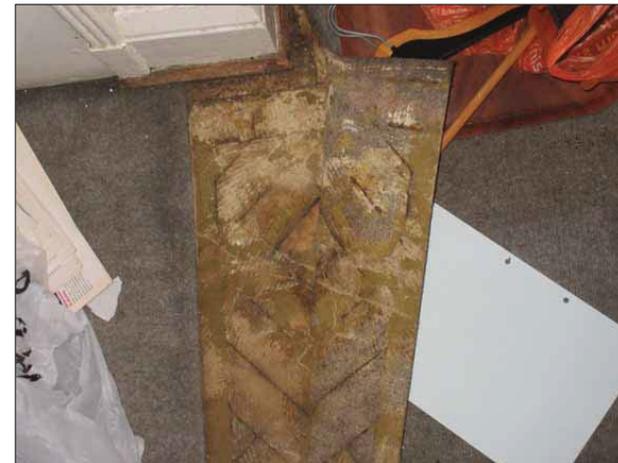
FINDING DETAILS					
Finding Code 07122014AGPA014		Item Bitumen Adhesive	Recommendations No action required		
LOCATION					
Internal/External Internal Unoccupied	Floor Level Ground Floor	Location Description Corridor 00702G121, Parquet Flooring	Extent 14.5sq. m	Identification Strongly Presumed	
MATERIAL ASSESSMENT					
Material Bitumen	Asbestos Type No Asbestos Detected	Condition Good Condition: No Visible Damage	Accessibility Accessible, but in restricted access areas	Encapsulation Enclosed	Material Assessment 0
SURVEYORS COMMENTS					
REMEDIAL ACTION TAKEN					
Action			Date Works Completed

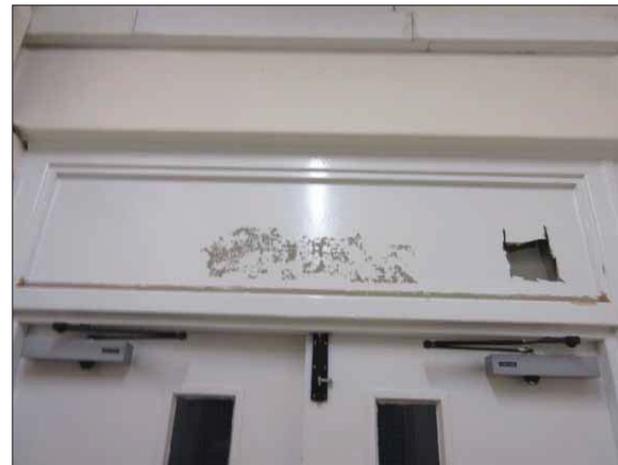
FINDING DETAILS					
Finding Code 07122014AGPA017		Item Fanlight Panel	Recommendations No action required		
LOCATION					
Internal/External Internal Unoccupied	Floor Level First Floor	Location Description Corridor 007021C06, Above Fire Door	Extent 2sq.m	Identification Identified	
MATERIAL ASSESSMENT					
Material Insulating Board	Asbestos Type No Asbestos Detected	Condition Low Damage: a few scratches or surface marks	Accessibility Accessible, but in restricted access areas	Encapsulation Unsealed	Material Assessment 0
SURVEYORS COMMENTS					
REMEDIAL ACTION TAKEN					
Action			Date Works Completed

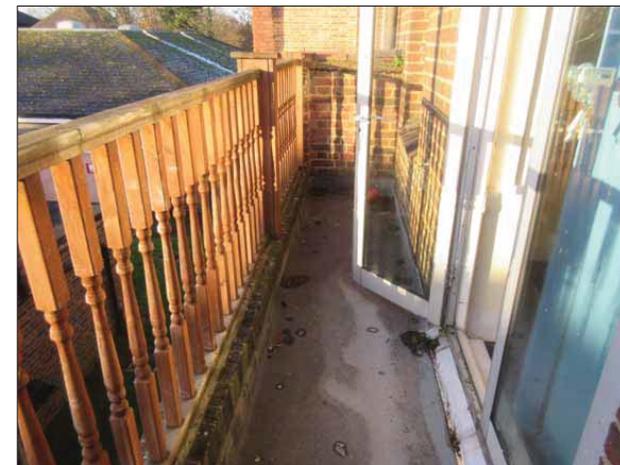
FINDING DETAILS					
Finding Code 07122014AGPA018		Item Bitumen Cover to Roof	Recommendations Remove Prior to Demolition		
LOCATION					
Internal/External External	Floor Level First Floor	Location Description Balcony Roof To Room 007021021 (above ground floor rooms 00702G043/44)	Extent 6sq.m	Identification Identified	
MATERIAL ASSESSMENT					
Material Bitumen	Asbestos Type Chrysotile (white)	Condition Good Condition: No Visible Damage	Accessibility Accessible, but in restricted access areas	Encapsulation Enclosed	Material Assessment 3
SURVEYORS COMMENTS					
REMEDIAL ACTION TAKEN					
Action			Date Works Completed

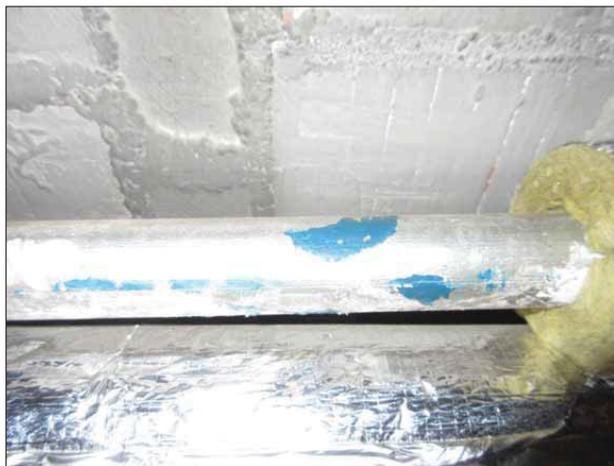
FINDING DETAILS					
Finding Code 07122014AGPA051		Item Thermal Insulation Debris			
		Recommendations Remove Prior to Demolition			
LOCATION					
Internal/External	Floor Level	Location Description	Extent	Identification	
Internal Unoccupied	Basement	Room 00702B001, Pipework Residue	60m	Identified	
MATERIAL ASSESSMENT					
Material	Asbestos Type	Condition	Accessibility	Encapsulation	Material Assessment
Thermal Insulation	Crocidolite, Amosite & Chrysotile	High Damage: Or delamination of material	Accessible, but in restricted access areas	Unsealed	11
SURVEYORS COMMENTS					
REMEDIAL ACTION TAKEN					
Action			Date Works Completed

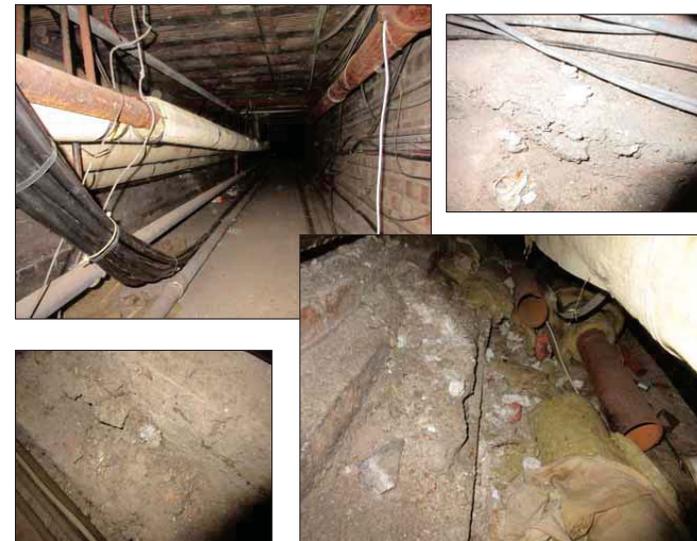
FINDING DETAILS					
Finding Code 07122014AGPA054		Item Debris on Floor	Recommendations Remove Prior to Demolition		
LOCATION					
Internal/External Internal Unoccupied	Floor Level Basement	Location Description Main Service Duct Running From Boiler Room towards Cheviot House	Extent 36sq.m	Identification Identified	
MATERIAL ASSESSMENT					
Material Paper	Asbestos Type Chrysotile (white)	Condition High Damage: Or delamination of material	Accessibility Accessible, but in restricted access areas	Encapsulation Unsealed	Material Assessment 8
SURVEYORS COMMENTS					
REMEDIAL ACTION TAKEN					
Action			Date Works Completed

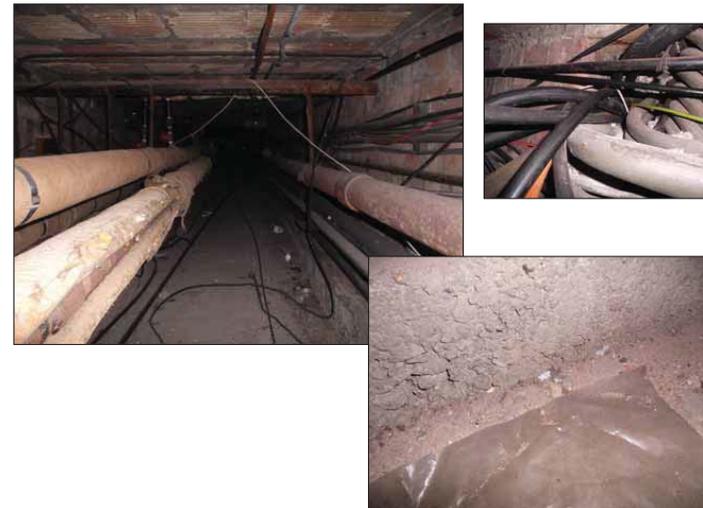
FINDING DETAILS					
Finding Code 07122014AGPA056		Item Debris on Floor	Recommendations Remove Prior to Demolition		
LOCATION					
Internal/External Internal Unoccupied	Floor Level Basement	Location Description Main Service Duct Running From Boiler Room towards Cheviot House	Extent Total 340sq.m	Identification Strongly Presumed	
MATERIAL ASSESSMENT					
Material Thermal Insulation	Asbestos Type Crocidolite, Amosite & Chrysotile	Condition High Damage: Or delamination of material	Accessibility Accessible, but in restricted access areas	Encapsulation Unsealed	Material Assessment 11
SURVEYORS COMMENTS					
REMEDIAL ACTION TAKEN					
Action			Date Works Completed

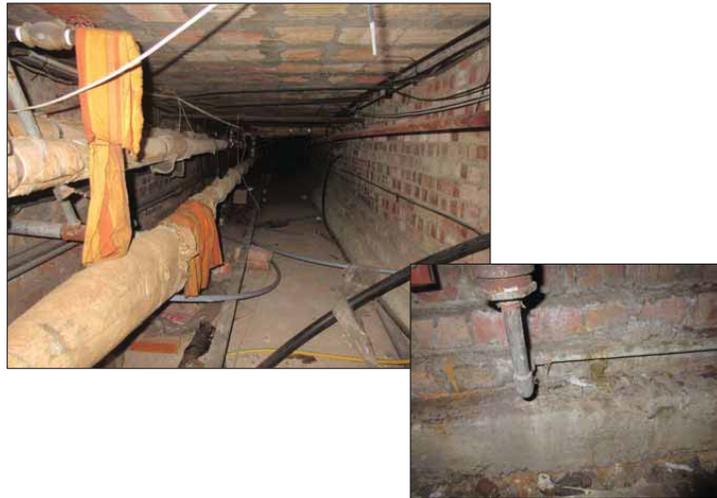
FINDING DETAILS					
Finding Code 07122014AGPA057		Item Debris on Floor	Recommendations Remove Prior to Demolition		
LOCATION					
Internal/External	Floor Level	Location Description	Extent	Identification	
Internal Unoccupied	Basement	Off Shoot of Main Service Duct Running From SKIN Entrance to Main Service Duct	17sq.m	Strongly Presumed	
MATERIAL ASSESSMENT					
Material	Asbestos Type	Condition	Accessibility	Encapsulation	Material Assessment
Thermal Insulation	Crocidolite, Amosite & Chrysotile	High Damage: Or delamination of material	Accessible, but in restricted access areas	Unsealed	11
SURVEYORS COMMENTS					
REMEDIAL ACTION TAKEN					
Action			Date Works Completed

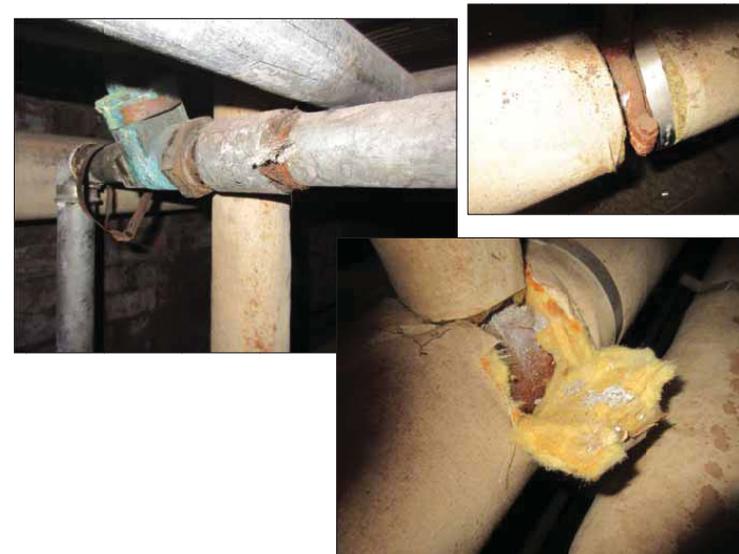
FINDING DETAILS					
Finding Code 07122014AGPA058		Item Debris on Pipe Joins	Recommendations Remove Prior to Demolition		
LOCATION					
Internal/External	Floor Level	Location Description	Extent	Identification	
Internal Unoccupied	Basement	Off Shoot of Main Service Duct Running From SKIN Entrance to Main Service Duct	34m	Strongly Presumed	
MATERIAL ASSESSMENT					
Material	Asbestos Type	Condition	Accessibility	Encapsulation	Material Assessment
Thermal Insulation	Crocidolite, Amosite & Chrysotile	High Damage: Or delamination of material	Accessible, but in restricted access areas	Unsealed	11
SURVEYORS COMMENTS					
REMEDIAL ACTION TAKEN					
Action			Date Works Completed

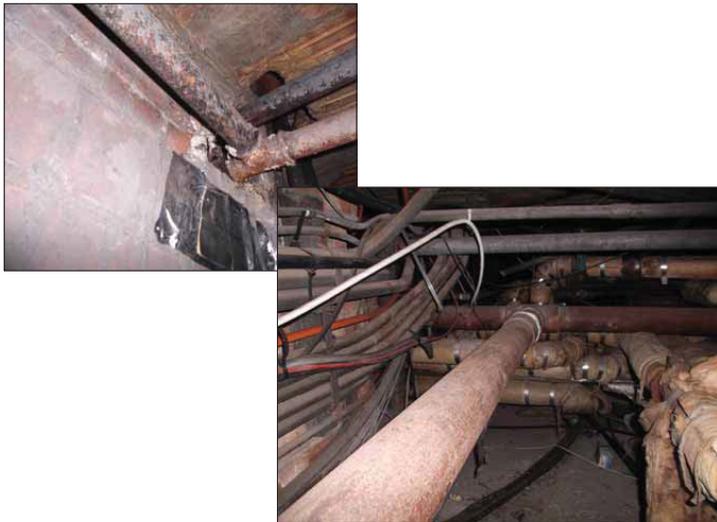
FINDING DETAILS					
Finding Code 07122014AGPA059		Item	Debris on Floor		
		Recommendations	Remove Prior to Demolition		
LOCATION					
Internal/External	Floor Level	Location Description		Extent	Identification
Internal Unoccupied	Basement	Main Service Duct Running From Boiler Room towards Cheviot House		Total 340sq. m	Strongly Presumed
MATERIAL ASSESSMENT					
Material	Asbestos Type	Condition	Accessibility	Encapsulation	Material Assessment
Thermal Insulation	Crocidolite, Amosite & Chrysotile	High Damage: Or delamination of material	Accessible, but in restricted access areas	Unsealed	11
SURVEYORS COMMENTS					
REMEDIAL ACTION TAKEN					
Action			Date Works Completed

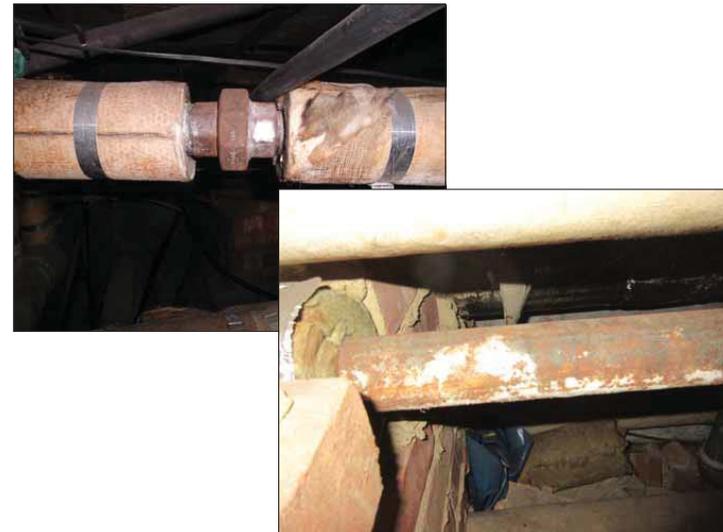
DETAILS					
Finding Code 07122014AGPA060		Item	Debris on Pipe Joins		
		Recommendations	Remove Prior to Demolition		
LOCATION					
Internal/External	Floor Level	Location Description		Extent	Identification
Internal Unoccupied	Basement	Main Service Duct Running From Boiler Room towards Cheviot House		72m	Strongly Presumed
MATERIAL ASSESSMENT					
Material	Asbestos Type	Condition	Accessibility	Encapsulation	Material Assessment
Thermal Insulation	Crocidolite, Amosite & Chrysotile	High Damage: Or delamination of material	Accessible, but in restricted access areas	Unsealed	11
SURVEYORS COMMENTS					
REMEDIAL ACTION TAKEN					
Action			Date Works Completed

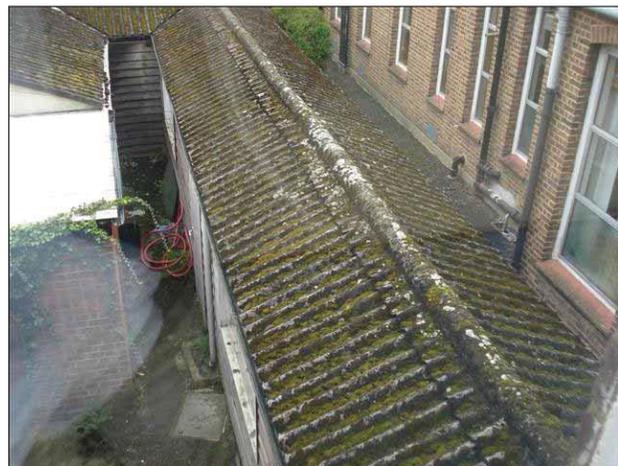
FINDING DETAILS					
Finding Code 20021999AGRJ013		Item Roof Ridge Tile	Recommendations Remove Prior to Demolition		
LOCATION					
Internal/External	Floor Level	Location Description	Extent	Identification	
External	Ground Floor	Roof to Physiotherapy Department Walkway	2sq.m	Identified	
MATERIAL ASSESSMENT					
Material	Asbestos Type	Condition	Accessibility	Encapsulation	Material Assessment
Cement	Amosite & Chrysotile	Low Damage: a few scratches or surface marks	Accessible, but in restricted access areas	Unsealed	6
SURVEYORS COMMENTS					
The asbestos cement roof is accessible from the ceiling void and externally.					
REMEDIAL ACTION TAKEN					
Action			Date Works Completed

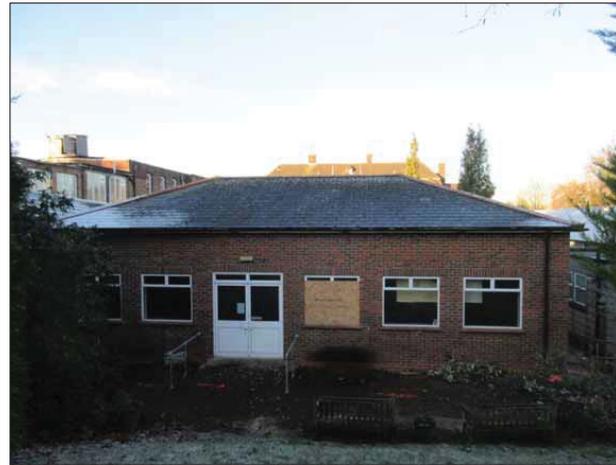
FINDING DETAILS					
Finding Code 08122014AGPA002		Item Composite Tile	Recommendations No action required		
LOCATION					
Internal/External	Floor Level	Location Description	Extent	Identification	
External	Roof	Rear Extension Rooms 00703G006/08/09/10/11/ & 12, Roofing Tile	Approx. 150sq.m	Identified	
MATERIAL ASSESSMENT					
Material	Asbestos Type	Condition	Accessibility	Encapsulation	Material Assessment
Cement	No Asbestos Detected	Low Damage: a few scratches or surface marks	Accessible, but in restricted access areas	Enclosed	0
SURVEYORS COMMENTS					
REMEDIAL ACTION TAKEN					
Action			Date Works Completed

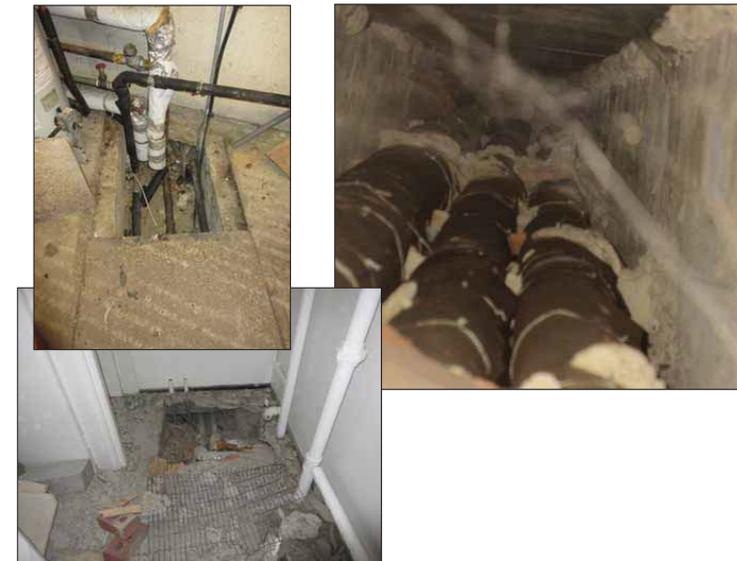
FINDING DETAILS					
Finding Code 08122014AGPA003		Item Thermal Insulation to Pipework	Recommendations Remove Prior to Demolition		
LOCATION					
Internal/External	Floor Level	Location Description	Extent	Identification	
Internal Unoccupied	Ground Floor	Room 00703G001, Floor Duct Continued from Boiler Room, Pipes (x3)	Each 10m	Identified	
MATERIAL ASSESSMENT					
Material	Asbestos Type	Condition	Accessibility	Encapsulation	Material Assessment
Thermal Insulation	Crocidolite, Amosite & Chrysotile	Low Damage: a few scratches or surface marks	Accessible, but in restricted access areas	Unsealed	9
SURVEYORS COMMENTS					
REMEDIAL ACTION TAKEN					
Action			Date Works Completed

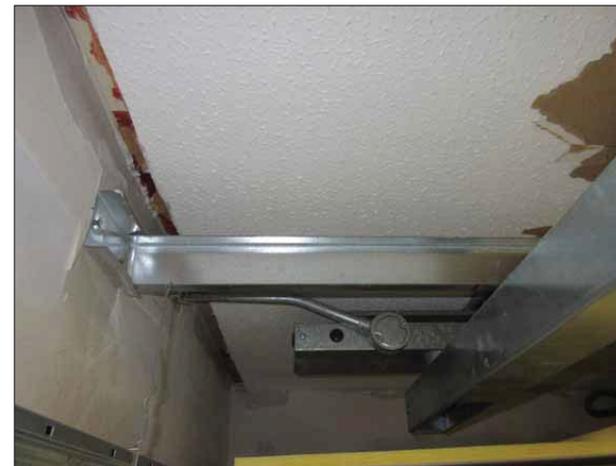
FINDING DETAILS					
Finding Code 06122014AGPA004		Item	Textured Coating		
		Recommendations	Remove Prior to Demolition		
LOCATION					
Internal/External	Floor Level	Location Description		Extent	Identification
Internal Occupied	Ground Floor	Room 00705G064A, Ceiling		6sq.m	Identified
MATERIAL ASSESSMENT					
Material	Asbestos Type	Condition	Accessibility	Encapsulation	Material Assessment
Textured Coating	Chrysotile (white)	Medium Damage: Significant breakage of materials	Accessible, but above head height	Enclosed	5
SURVEYORS COMMENTS					
REMEDIAL ACTION TAKEN					
Action			Date Works Completed
