## Appendix

<b>Name</b>	<b>Appendix No.</b>
Ready to Dig Searches and Responses	A
Arboricultural	B
Topographical Survey	C
Decontamination Survey	D
Habitat & Bat Survey	E
Asbestos	F

REFERENCE: 34638/PS  
ROUTE: Cotswold Road, Sutton  
OSGR: 525954,162355  
POSTCODE: SM2 5NF

**Ready to Dig – Utility Search Service**

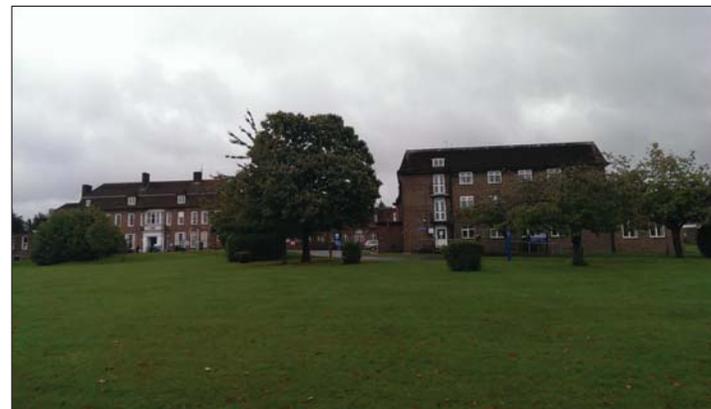
Figure 1: Northern Elevation of B1 (Front of Main block left, Cheviot House right)

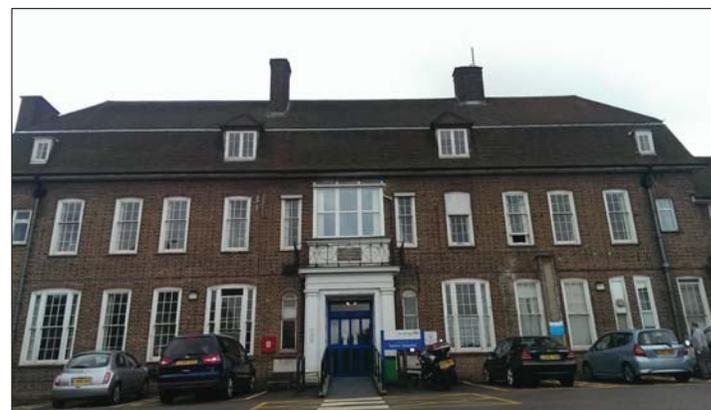
Figure 2: Northern elevation of Main Block.

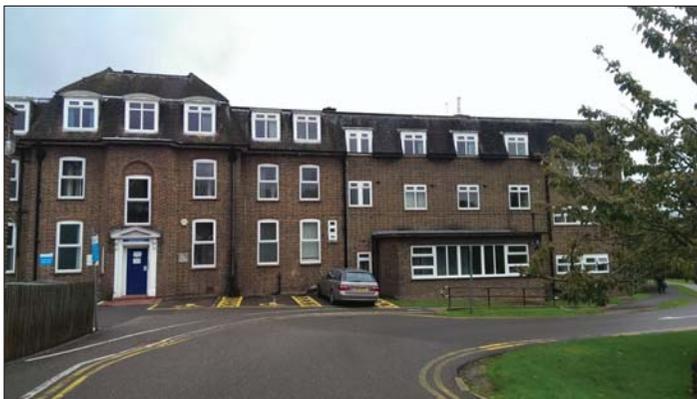
Figure 3: Eastern elevation of Cheviot House

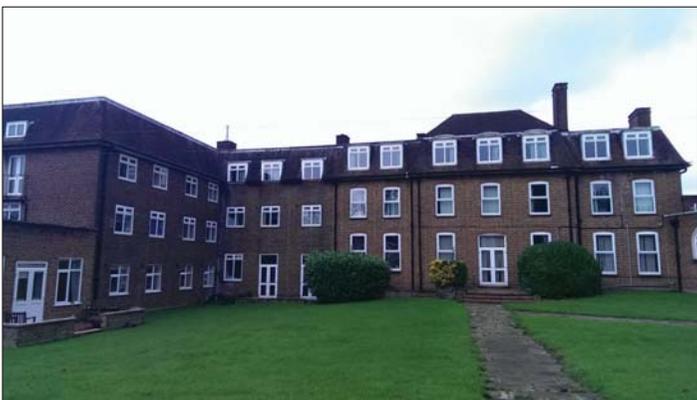
Figure 4: Western elevation of Cheviot House

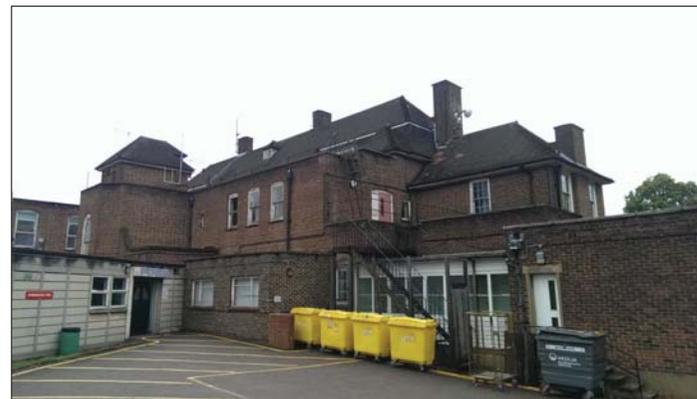
Figure 5: South-Eastern corner of the main block

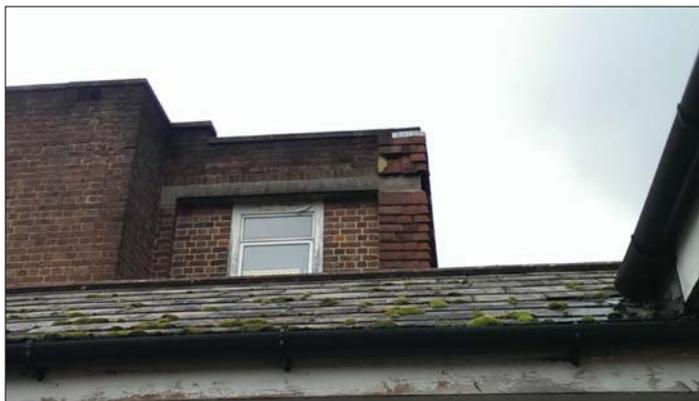
Figure 7: Loose tiles on Cheviot House

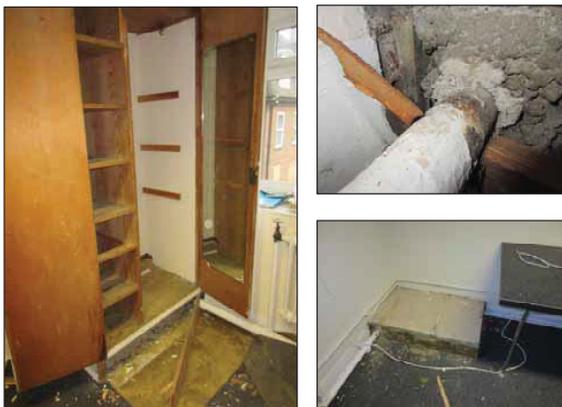
3.1.2 The ground, first and second floors all have perimeter heating pipes in each room. The pipes run through a concrete plinth (originally the base to a wardrobe/cupboard) in many areas. The heating pipe was installed, lagged with asbestos insulation and then the concrete plinth was created on top pipe thereby embedding the asbestos insulation within it.

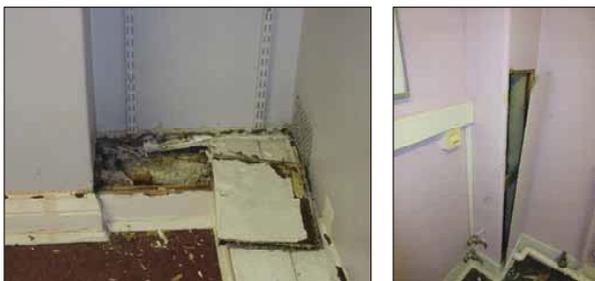
3.1.3 As the perimeter heating pipes link between floors it is located timber risers and boxing. The two pipes within the risers are lagged in hand applied asbestos thermal insulation.

3.1.4 Further heating pipework has been boxed in timber at floor and ceiling level. These pipes are also lagged in hand applied asbestos thermal insulation.

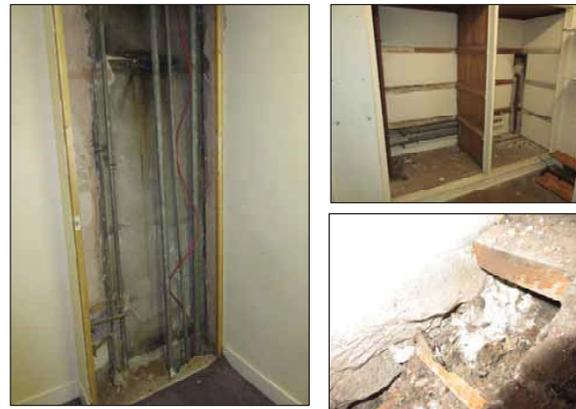
3.1.5 The original laundry room has built-in timber cupboards and a timber floor laid over the concrete floor. Asbestos thermal insulation debris was identified below the cupboard timber floor on the 2<sup>nd</sup> and 1<sup>st</sup> floors.

3.1.6 The ground floor original laundry room has asbestos thermal insulation debris at the bottom of the riser (to left hand side of door).

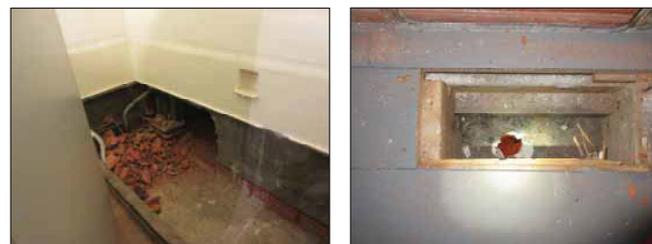
3.1.7 There is a floor void located above room 00701G021/22 and below room 007011024/25. The void has a timber floor and asbestos thermal insulation debris was identified below this floor.

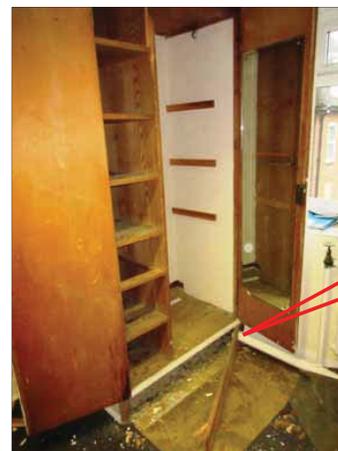
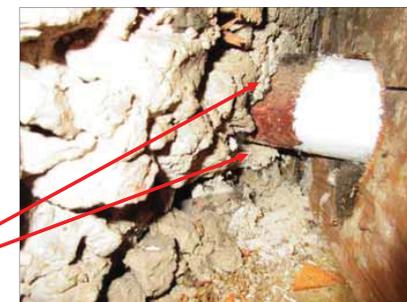
FINDING DETAILS					
Finding Code 04122014AGPA002		Item Thermal Insulation on Pipework	Recommendations Remove Prior to Demolition		
LOCATION					
Internal/External	Floor Level	Location Description	Extent	Identification	
Internal Unoccupied	Second Floor	Room 007012013, Perimeter Heating Pipes Below Timber Cupboard, Embedded in Poured Concrete	1m	Identified	
MATERIAL ASSESSMENT					
Material	Asbestos Type	Condition	Accessibility	Encapsulation	Material Assessment
Thermal Insulation	Crocidolite, Amosite & Chrysotile	Low Damage: a few scratches or surface marks	Accessible, but in restricted access areas	Enclosed	8
SURVEYORS COMMENTS					
REMEDIAL ACTION TAKEN					
Action			Date Works Completed

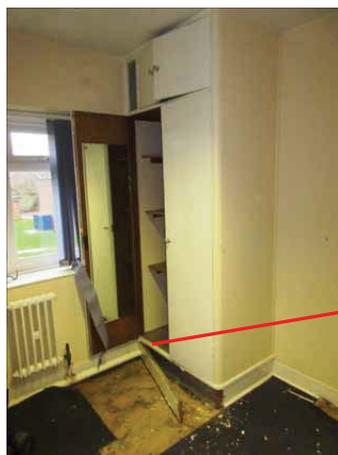
FINDING DETAILS					
Finding Code 04122014AGPA003		Item Thermal Insulation on Pipework	Recommendations Remove Prior to Demolition		
LOCATION					
Internal/External	Floor Level	Location Description	Extent	Identification	
Internal Unoccupied	Second Floor	Room 007012012, Perimeter Heating Pipes Below Timber Cupboard, Embedded in Poured Concrete	1m	Identified	
MATERIAL ASSESSMENT					
Material	Asbestos Type	Condition	Accessibility	Encapsulation	Material Assessment
Thermal Insulation	Crocidolite, Amosite & Chrysotile	Low Damage: a few scratches or surface marks	Accessible, but in restricted access areas	Enclosed	8
SURVEYORS COMMENTS					
REMEDIAL ACTION TAKEN					
Action			Date Works Completed

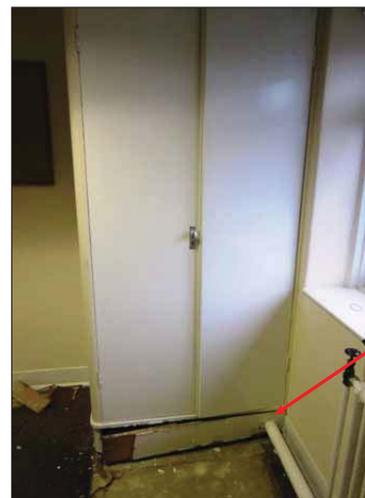
FINDING DETAILS					
Finding Code 04122014AGPA004		Item Thermal Insulation on Pipework	Recommendations Remove Prior to Demolition		
LOCATION					
Internal/External	Floor Level	Location Description	Extent	Identification	
Internal Unoccupied	Second Floor	Room 007012011, Perimeter Heating Pipes Below Timber Cupboard, Embedded in Poured Concrete	1m	Identified	
MATERIAL ASSESSMENT					
Material	Asbestos Type	Condition	Accessibility	Encapsulation	Material Assessment
Thermal Insulation	Crocidolite, Amosite & Chrysotile	Low Damage: a few scratches or surface marks	Accessible, but in restricted access areas	Enclosed	8
SURVEYORS COMMENTS					
REMEDIAL ACTION TAKEN					
Action			Date Works Completed

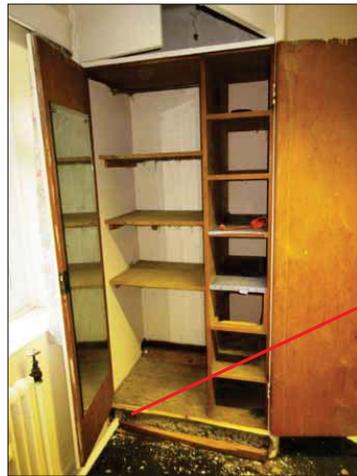
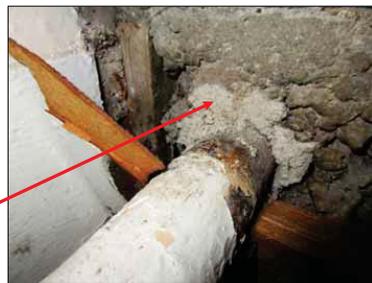
FINDING DETAILS					
Finding Code 04122014AGPA005		Item Thermal Insulation on Pipework	Recommendations Remove Prior to Demolition		
LOCATION					
Internal/External	Floor Level	Location Description	Extent	Identification	
Internal Unoccupied	Second Floor	Room 007012016, Perimeter Heating Pipes Below Timber Cupboard, Embedded in Poured Concrete	1m	Identified	
MATERIAL ASSESSMENT					
Material	Asbestos Type	Condition	Accessibility	Encapsulation	Material Assessment
Thermal Insulation	Crocidolite, Amosite & Chrysotile	Low Damage: a few scratches or surface marks	Accessible, but in restricted access areas	Enclosed	8
SURVEYORS COMMENTS					
REMEDIAL ACTION TAKEN					
Action			Date Works Completed

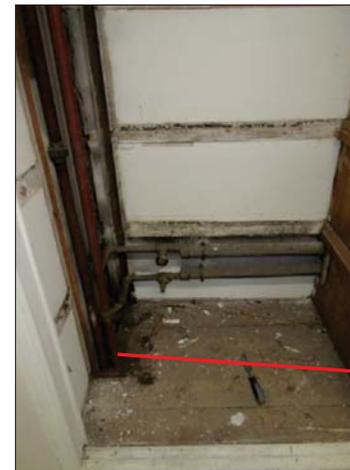
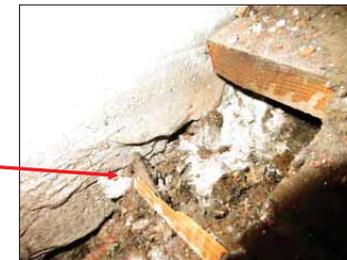
FINDING DETAILS					
Finding Code 04122014AGPA006		Item Thermal Insulation	Recommendations Remove Prior to Demolition		
LOCATION					
Internal/External	Floor Level	Location Description	Extent	Identification	
Internal Unoccupied	Second Floor	Room 007012010, Timber Cupboard, Debris Below Timber Floor in Poured Concrete Plinth	2sq.m	Identified	
MATERIAL ASSESSMENT					
Material	Asbestos Type	Condition	Accessibility	Encapsulation	Material Assessment
Thermal Insulation	Crocidolite, Amosite & Chrysotile	Low Damage: a few scratches or surface marks	Accessible, but in restricted access areas	Unsealed	9
SURVEYORS COMMENTS					
REMEDIAL ACTION TAKEN					
Action			Date Works Completed

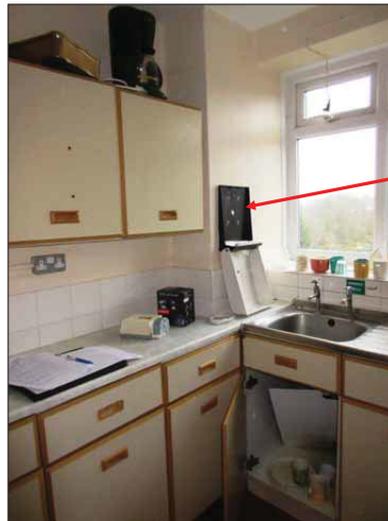
FINDING DETAILS					
Finding Code 04122014AGPA007		Item Thermal Insulation on Pipework	Recommendations Remove Prior to Demolition		
LOCATION					
Internal/External	Floor Level	Location Description	Extent	Identification	
Internal Unoccupied	Second Floor	Room 007012022, Vertical Riser to LHS of Window, Vertical Heating Pipe	3m	Identified	
MATERIAL ASSESSMENT					
Material	Asbestos Type	Condition	Accessibility	Encapsulation	Material Assessment
Thermal Insulation	Crocidolite, Amosite & Chrysotile	Low Damage: a few scratches or surface marks	Accessible, but in restricted access areas	Unsealed	9
SURVEYORS COMMENTS					
REMEDIAL ACTION TAKEN					
Action			Date Works Completed

Pipes inside riser

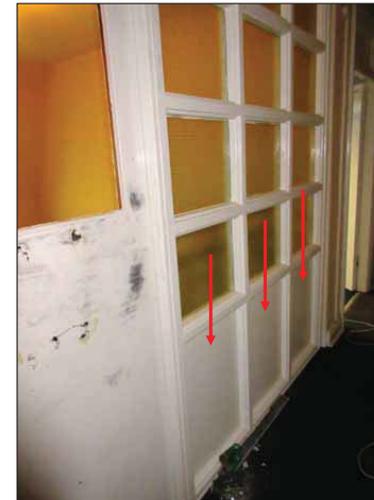
FINDING DETAILS					
Finding Code 04122014AGPA008		Item Asbestos Cement	Recommendations Remove Prior to Demolition		
LOCATION					
Internal/External	Floor Level	Location Description	Extent	Identification	
Internal Unoccupied	Second Floor	Corridor 007012C01, Partition At Top of Staircase, Low Level Wall Panels [x3 panels]	Each 1sq.m	Identified	
MATERIAL ASSESSMENT					
Material	Asbestos Type	Condition	Accessibility	Encapsulation	Material Assessment
Cement	Amosite & Chrysotile	Low Damage: a few scratches or surface marks	Accessible, but in restricted access areas	Enclosed	5
SURVEYORS COMMENTS					
REMEDIAL ACTION TAKEN					
Action			Date Works Completed

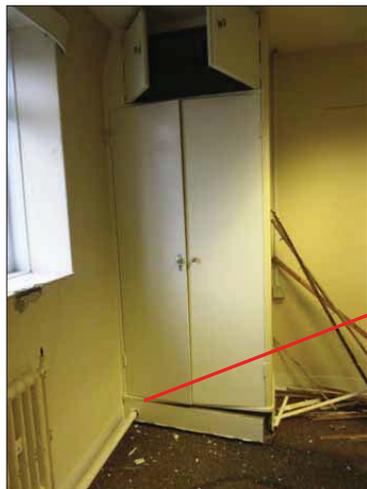
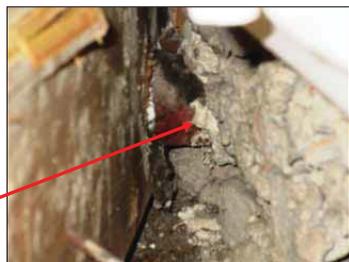
FINDING DETAILS					
Finding Code 04122014AGPA009		Item Thermal Insulation on Pipework	Recommendations Remove Prior to Demolition		
LOCATION					
Internal/External	Floor Level	Location Description	Extent	Identification	
Internal Unoccupied	Second Floor	Room 007012009, Perimeter Heating Pipes Below Timber Cupboard, Embedded in Poured Concrete	1m	Identified	
MATERIAL ASSESSMENT					
Material	Asbestos Type	Condition	Accessibility	Encapsulation	Material Assessment
Thermal Insulation	Crocidolite, Amosite & Chrysotile	Low Damage: a few scratches or surface marks	Accessible, but in restricted access areas	Enclosed	8
SURVEYORS COMMENTS					
REMEDIAL ACTION TAKEN					
Action			Date Works Completed

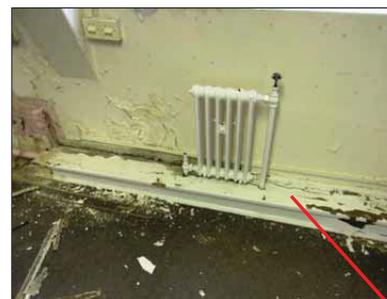
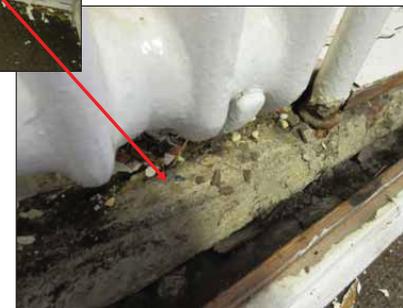
FINDING DETAILS					
Finding Code 04122014AGPA010		Item Thermal Insulation on Pipework	Recommendations Remove Prior to Demolition		
LOCATION					
Internal/External	Floor Level	Location Description	Extent	Identification	
Internal Unoccupied	Second Floor	Room 007012004, Perimeter Heating Pipes in Low Level Timber Boxing	3m	Identified	
MATERIAL ASSESSMENT					
Material	Asbestos Type	Condition	Accessibility	Encapsulation	Material Assessment
Thermal Insulation	Crocidolite, Amosite & Chrysotile	Low Damage: a few scratches or surface marks	Accessible, but in restricted access areas	Unsealed	9
SURVEYORS COMMENTS					
REMEDIAL ACTION TAKEN					
Action			Date Works Completed

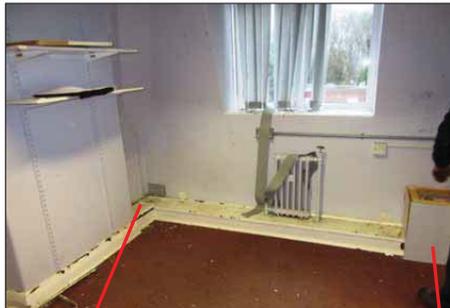
FINDING DETAILS					
Finding Code 04122014AGPA011		Item	Thermal Insulation on Pipework		
		Recommendations	Remove Prior to Demolition		
LOCATION					
Internal/External	Floor Level	Location Description		Extent	Identification
Internal Unoccupied	Second Floor	Room 007012005, Perimeter Heating Pipes in Low Level Timber Boxing		3m	Identified
MATERIAL ASSESSMENT					
Material	Asbestos Type	Condition	Accessibility	Encapsulation	Material Assessment
Thermal Insulation	Crocidolite, Amosite & Chrysotile	Low Damage: a few scratches or surface marks	Accessible, but in restricted access areas	Unsealed	9
SURVEYORS COMMENTS					
REMEDIAL ACTION TAKEN					
Action			Date Works Completed

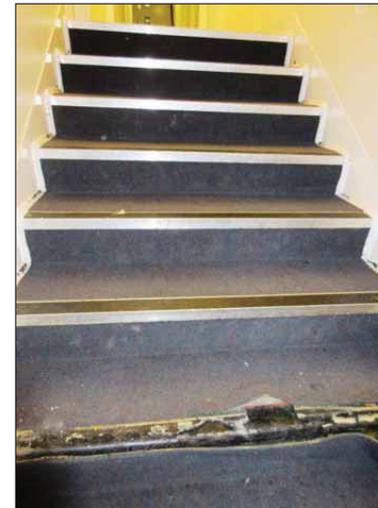
FINDING DETAILS					
Finding Code 04122014AGPA012		Item	Bitumen		
		Recommendations	No action required		
LOCATION					
Internal/External	Floor Level	Location Description		Extent	Identification
Internal Unoccupied	First Floor	Corridor 007011C03, Stairs Original Stair Nosing [x7 steps]		Each 1m	Identified
MATERIAL ASSESSMENT					
Material	Asbestos Type	Condition	Accessibility	Encapsulation	Material Assessment
Bitumen	No Asbestos Detected	Good Condition: No Visible Damage	Accessible, but in restricted access areas	Composite materials: reinforced plastics, resins, vinyl tiles.	0
SURVEYORS COMMENTS					
REMEDIAL ACTION TAKEN					
Action			Date Works Completed

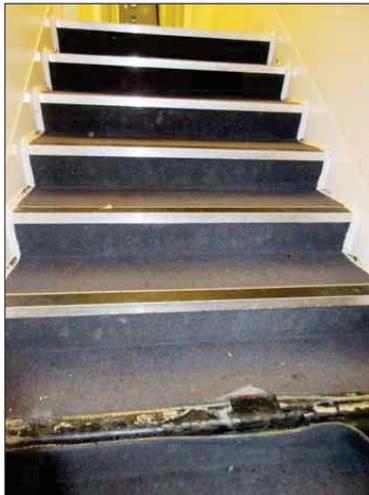
FINDING DETAILS					
Finding Code 04122014AGPA013		Item Bitumen	Recommendations No action required		
LOCATION					
Internal/External Internal Unoccupied	Floor Level Second Floor	Location Description Corridor 007012C02, Stairs Original Stair Nosing [x7 steps]	Extent Each 1m	Identification Identified	
MATERIAL ASSESSMENT					
Material Bitumen	Asbestos Type No Asbestos Detected	Condition Good Condition: No Visible Damage	Accessibility Accessible, but in restricted access areas	Encapsulation Composite materials: reinforced plastics, resins, vinyl tiles.	Material Assessment 0
SURVEYORS COMMENTS					
REMEDIAL ACTION TAKEN					
Action			Date Works Completed

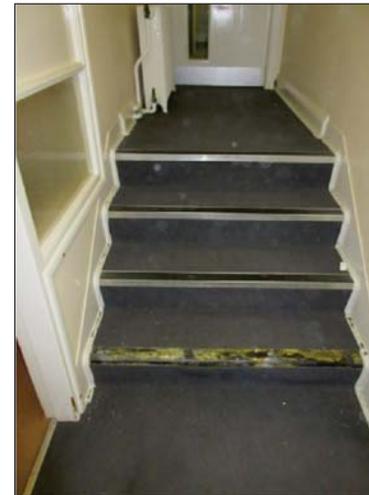
FINDING DETAILS					
Finding Code 04122014AGPA014		Item Bitumen	Recommendations No action required		
LOCATION					
Internal/External Internal Unoccupied	Floor Level Second Floor	Location Description Corridor 007011C02, Stairs Original Stair Nosing [x4 steps]	Extent Each 1m	Identification Identified	
MATERIAL ASSESSMENT					
Material Bitumen	Asbestos Type No Asbestos Detected	Condition Good Condition: No Visible Damage	Accessibility Accessible, but in restricted access areas	Encapsulation Composite materials: reinforced plastics, resins, vinyl tiles.	Material Assessment 0
SURVEYORS COMMENTS					
REMEDIAL ACTION TAKEN					
Action			Date Works Completed

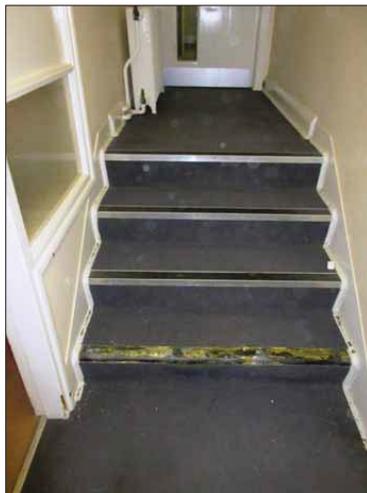
FINDING DETAILS					
Finding Code 04122014AGPA015		Item Bitumen	Recommendations No action required		
LOCATION					
Internal/External	Floor Level	Location Description		Extent	Identification
Internal Unoccupied	First Floor	Corridor 007011C03, Stairs Original Stair Nosing [x4 steps]		Each 1m	Identified
MATERIAL ASSESSMENT					
Material	Asbestos Type	Condition	Accessibility	Encapsulation	Material Assessment
Bitumen	No Asbestos Detected	Good Condition: No Visible Damage	Accessible, but in restricted access areas	Composite materials: reinforced plastics, resins, vinyl tiles.	0
SURVEYORS COMMENTS					
REMEDIAL ACTION TAKEN					
Action			Date Works Completed

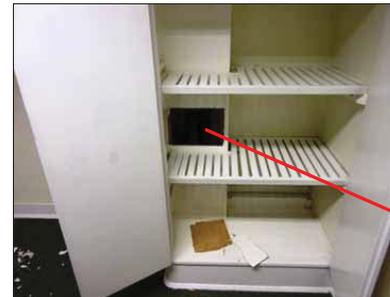
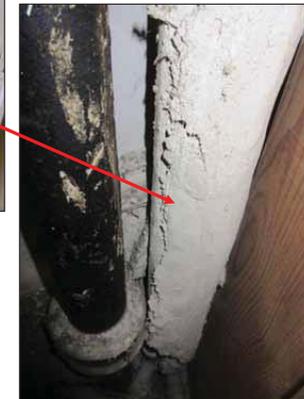
FINDING DETAILS					
Finding Code 04122014AGPA016		Item Thermal Insulation on Pipework	Recommendations Remove Prior to Demolition		
LOCATION					
Internal/External	Floor Level	Location Description		Extent	Identification
Internal Unoccupied	First Floor	Room 007011026, Vertical Riser, Vertical Heating Pipe		3m	Identified
MATERIAL ASSESSMENT					
Material	Asbestos Type	Condition	Accessibility	Encapsulation	Material Assessment
Thermal Insulation	Crocidolite, Amosite & Chrysotile	Low Damage: a few scratches or surface marks	Accessible, but in restricted access areas	Unsealed	9
SURVEYORS COMMENTS					
REMEDIAL ACTION TAKEN					
Action			Date Works Completed

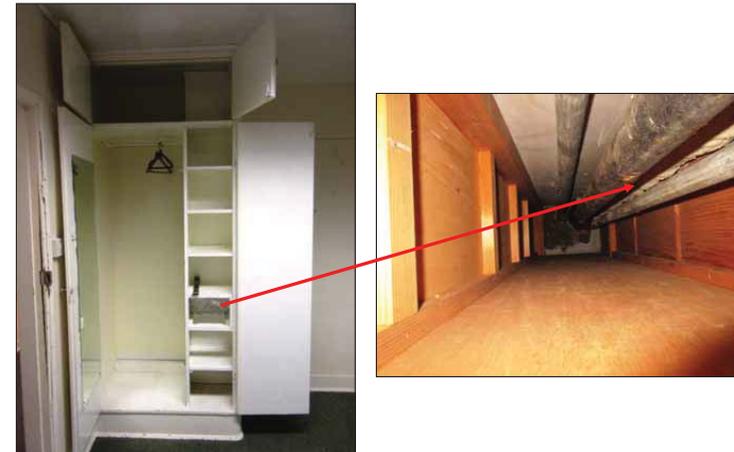
FINDING DETAILS					
Finding Code 04122014AGPA018		Item	Thermal Insulation on Pipework		
		Recommendations	Remove Prior to Demolition		
LOCATION					
Internal/External	Floor Level	Location Description	Extent	Identification	
Internal Unoccupied	First Floor	Room 007011025, Vertical Riser, Vertical Heating Pipe	3m	Identified	
MATERIAL ASSESSMENT					
Material	Asbestos Type	Condition	Accessibility	Encapsulation	Material Assessment
Thermal Insulation	Crocidolite, Amosite & Chrysotile	Low Damage: a few scratches or surface marks	Accessible, but in restricted access areas	Unsealed	9
SURVEYORS COMMENTS					
REMEDIAL ACTION TAKEN					
Action		Date Works Completed

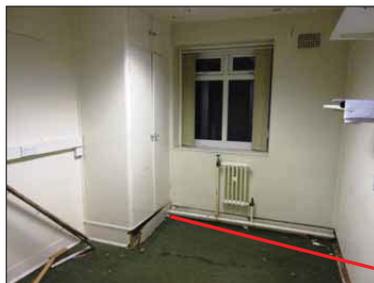
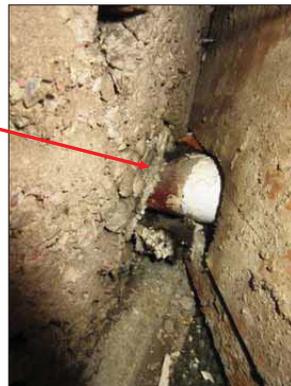
FINDING DETAILS					
Finding Code 04122014AGPA021		Item Thermal Insulation on Pipework			
		Recommendations Remove Prior to Demolition			
LOCATION					
Internal/External	Floor Level	Location Description	Extent	Identification	
Internal Unoccupied	First Floor	Room 007011011, Perimeter Heating Pipes Below Timber Cupboard, Embedded in Poured Concrete	1m	Identified	
MATERIAL ASSESSMENT					
Material	Asbestos Type	Condition	Accessibility	Encapsulation	Material Assessment
Thermal Insulation	Crocidolite, Amosite & Chrysotile	Low Damage: a few scratches or surface marks	Accessible, but in restricted access areas	Enclosed	8
SURVEYORS COMMENTS					
REMEDIAL ACTION TAKEN					
Action			Date Works Completed

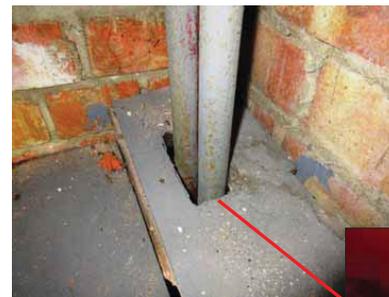
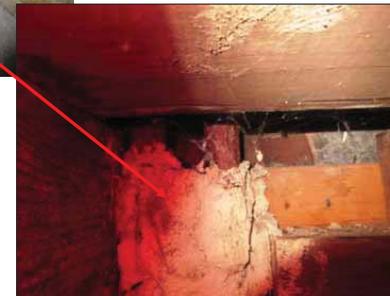
FINDING DETAILS					
Finding Code 04122014AGPA022		Item Thermal Insulation on Pipework			
		Recommendations Remove Prior to Demolition			
LOCATION					
Internal/External	Floor Level	Location Description	Extent	Identification	
Internal Unoccupied	First Floor	In Floor Void Below Room 007011024, Vertical Heating Pipes [2x 4" diameter]	Each 0.5m	Identified	
MATERIAL ASSESSMENT					
Material	Asbestos Type	Condition	Accessibility	Encapsulation	Material Assessment
Thermal Insulation	Crocidolite, Amosite & Chrysotile	Low Damage: a few scratches or surface marks	Accessible, but in restricted access areas	Unsealed	9
SURVEYORS COMMENTS					
REMEDIAL ACTION TAKEN					
Action			Date Works Completed

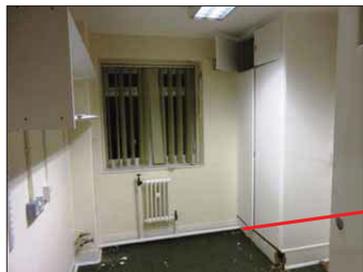
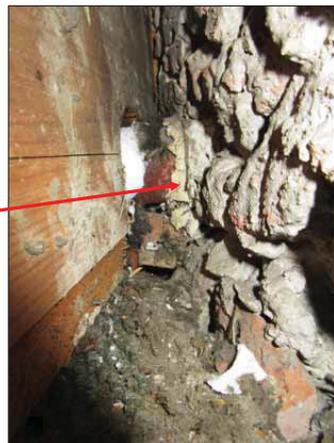
FINDING DETAILS					
Finding Code 04122014AGPA025		Item Thermal Insulation on Pipework	Recommendations Remove Prior to Demolition		
LOCATION					
Internal/External	Floor Level	Location Description	Extent	Identification	
Internal Unoccupied	First Floor	Room 007011012, Perimeter Heating Pipes Below Timber Cupboard, Embedded in Poured Concrete	1m	Identified	
MATERIAL ASSESSMENT					
Material	Asbestos Type	Condition	Accessibility	Encapsulation	Material Assessment
Thermal Insulation	Crocidolite, Amosite & Chrysotile	Low Damage: a few scratches or surface marks	Accessible, but in restricted access areas	Enclosed	8
SURVEYORS COMMENTS					
REMEDIAL ACTION TAKEN					
Action			Date Works Completed

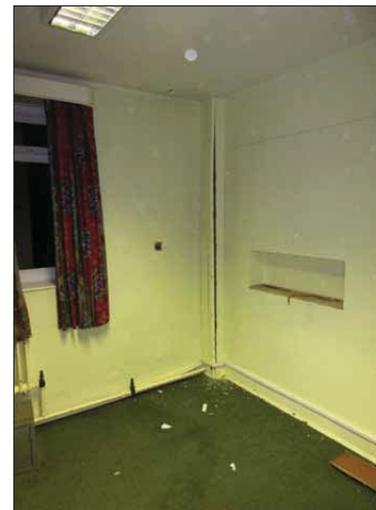
FINDING DETAILS					
Finding Code 04122014AGPA026		Item Thermal Insulation	Recommendations Remove Prior to Demolition		
LOCATION					
Internal/External	Floor Level	Location Description	Extent	Identification	
Internal Unoccupied	First Floor	Room 007011020, Vertical Riser to RHS of Window, Debris	3m	Identified	
MATERIAL ASSESSMENT					
Material	Asbestos Type	Condition	Accessibility	Encapsulation	Material Assessment
Thermal Insulation	Crocidolite, Amosite & Chrysotile	Low Damage: a few scratches or surface marks	Accessible, but in restricted access areas	Unsealed	9
SURVEYORS COMMENTS					
REMEDIAL ACTION TAKEN					
Action			Date Works Completed

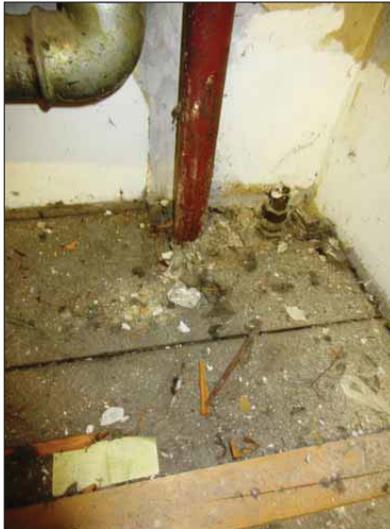
FINDING DETAILS					
Finding Code 04122014AGPA027		Item Thermal Insulation			
		Recommendations Remove Prior to Demolition			
LOCATION					
Internal/External	Floor Level	Location Description	Extent	Identification	
Internal Unoccupied	First Floor	Room 007011013, Timber Cupboard, Debris Below Timber Floor in Poured Concrete Plinth	2sq.m	Identified	
MATERIAL ASSESSMENT					
Material	Asbestos Type	Condition	Accessibility	Encapsulation	Material Assessment
Thermal Insulation	Crocidolite, Amosite & Chrysotile	Low Damage: a few scratches or surface marks	Accessible, but in restricted access areas	Enclosed	8
SURVEYORS COMMENTS					
REMEDIAL ACTION TAKEN					
Action			Date Works Completed

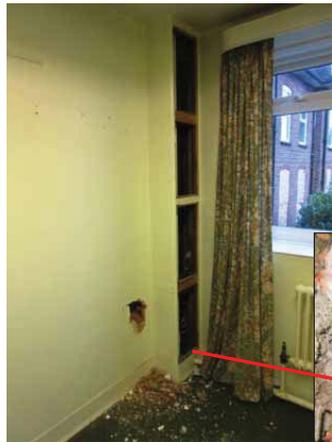
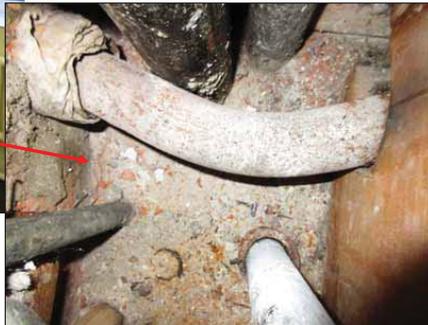
FINDING DETAILS					
Finding Code 04122014AGPA031		Item Thermal Insulation	Recommendations Remove Prior to Demolition		
LOCATION					
Internal/External	Floor Level	Location Description	Extent	Identification	
Internal Unoccupied	First Floor	Room 007011015, Vertical Riser to LHS of Window, Pipework; Fibrous Debris	50cm	Identified	
MATERIAL ASSESSMENT					
Material	Asbestos Type	Condition	Accessibility	Encapsulation	Material Assessment
Thermal Insulation	Crocidolite, Amosite & Chrysotile	Low Damage: a few scratches or surface marks	Accessible, but in restricted access areas	Unsealed	9
SURVEYORS COMMENTS					
REMEDIAL ACTION TAKEN					
Action			Date Works Completed

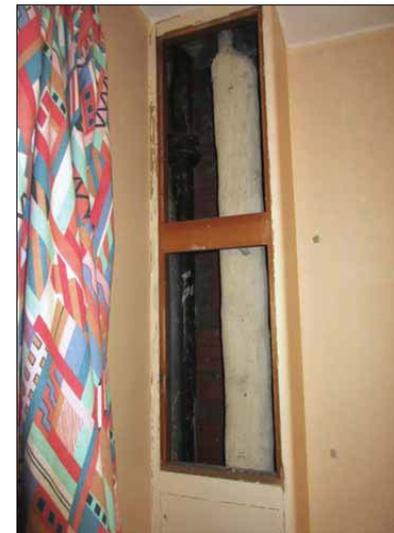
FINDING DETAILS					
Finding Code 04122014AGPA032		Item Thermal Insulation on Pipework	Recommendations Remove Prior to Demolition		
LOCATION					
Internal/External	Floor Level	Location Description	Extent	Identification	
Internal Unoccupied	Ground Floor	Room 00701G013, Vertical Riser to RHS of Window, Vertical Pipes [x2 pipes]	Each 3m	Identified	
MATERIAL ASSESSMENT					
Material	Asbestos Type	Condition	Accessibility	Encapsulation	Material Assessment
Thermal Insulation	Crocidolite, Amosite & Chrysotile	Low Damage: a few scratches or surface marks	Accessible, but in restricted access areas	Unsealed	9
SURVEYORS COMMENTS					
REMEDIAL ACTION TAKEN					
Action			Date Works Completed

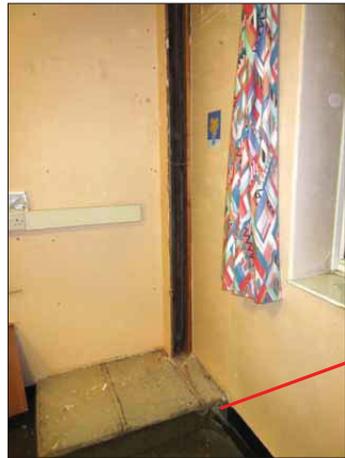
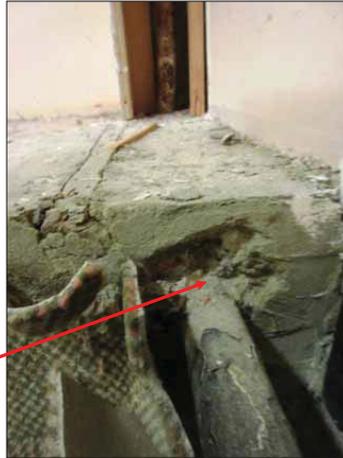
FINDING DETAILS					
Finding Code 04122014AGPA033		Item Thermal Insulation on Pipework			
		Recommendations Remove Prior to Demolition			
LOCATION					
Internal/External	Floor Level	Location Description	Extent	Identification	
Internal Unoccupied	Ground Floor	Room 00701G013, LHS of Window, Perimeter Heating Pipes Embedded in Poured Concrete Plinth	1m	Identified	
MATERIAL ASSESSMENT					
Material	Asbestos Type	Condition	Accessibility	Encapsulation	Material Assessment
Thermal Insulation	Crocidolite, Amosite & Chrysotile	Low Damage: a few scratches or surface marks	Accessible, but in restricted access areas	Enclosed	8
SURVEYORS COMMENTS					
REMEDIAL ACTION TAKEN					
Action			Date Works Completed

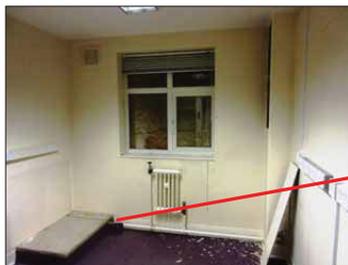
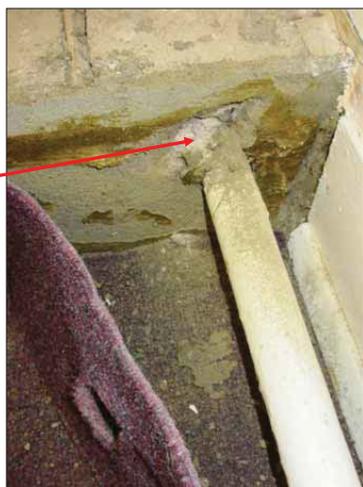
FINDING DETAILS					
Finding Code 04122014AGPA035		Item Thermal Insulation on Pipework	Recommendations Remove Prior to Demolition		
LOCATION					
Internal/External	Floor Level	Location Description	Extent	Identification	
Internal Unoccupied	Ground Floor	Room 00701G015, LHS of Window, Perimeter Heating Pipes Embedded in Poured Concrete Plinth	1m	Identified	
MATERIAL ASSESSMENT					
Material	Asbestos Type	Condition	Accessibility	Encapsulation	Material Assessment
Thermal Insulation	Crocidolite, Amosite & Chrysotile	Low Damage: a few scratches or surface marks	Accessible, but in restricted access areas	Enclosed	8
SURVEYORS COMMENTS					
REMEDIAL ACTION TAKEN					
Action			Date Works Completed

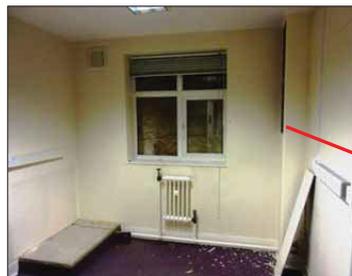
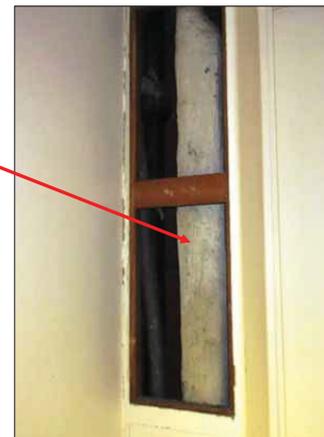
FINDING DETAILS					
Finding Code 04122014AGPA036		Item Thermal Insulation on Pipework	Recommendations Remove Prior to Demolition		
LOCATION					
Internal/External	Floor Level	Location Description	Extent	Identification	
Internal Unoccupied	Ground Floor	Room 00701G015, Vertical Riser to RHS of Window, Vertical Pipes [x2 pipes]	Each 3m	Identified	
MATERIAL ASSESSMENT					
Material	Asbestos Type	Condition	Accessibility	Encapsulation	Material Assessment
Thermal Insulation	Crocidolite, Amosite & Chrysotile	Low Damage: a few scratches or surface marks	Accessible, but in restricted access areas	Unsealed	9
SURVEYORS COMMENTS					
REMEDIAL ACTION TAKEN					
Action			Date Works Completed

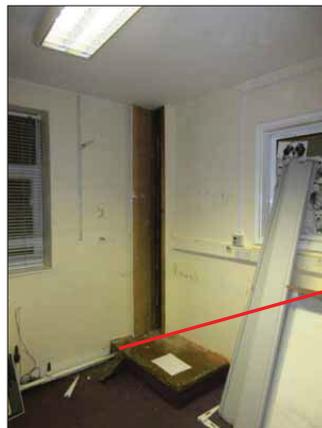
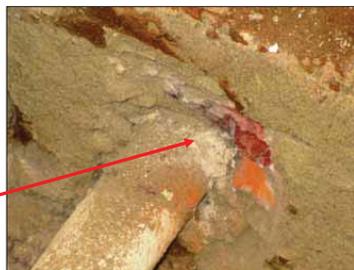
FINDING DETAILS					
Finding Code 04122014AGPA037		Item Thermal Insulation on Pipework			
		Recommendations Remove Prior to Demolition			
LOCATION					
Internal/External	Floor Level	Location Description		Extent	Identification
Internal Unoccupied	Ground Floor	Room 00701G016, RHS of Window, Perimeter Heating Pipes Embedded in Poured Concrete Plinth		1m	Identified
MATERIAL ASSESSMENT					
Material	Asbestos Type	Condition	Accessibility	Encapsulation	Material Assessment
Thermal Insulation	Crocidolite, Amosite & Chrysotile	Low Damage: a few scratches or surface marks	Accessible, but in restricted access areas	Enclosed	8
SURVEYORS COMMENTS					
REMEDIAL ACTION TAKEN					
Action			Date Works Completed

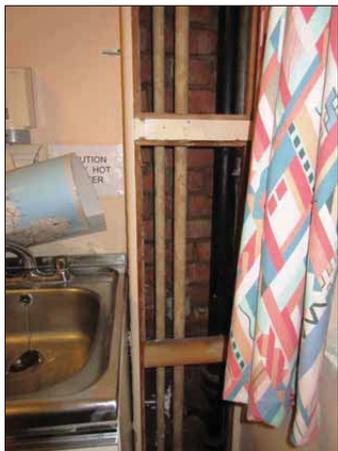
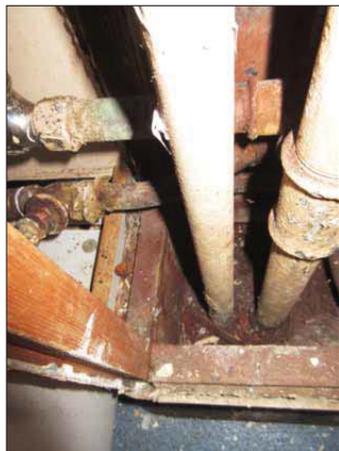
FINDING DETAILS					
Finding Code 04122014AGPA039		Item Thermal Insulation on Pipework			
		Recommendations Remove Prior to Demolition			
LOCATION					
Internal/External	Floor Level	Location Description	Extent	Identification	
Internal Unoccupied	Ground Floor	Room 00701G011, Vertical Riser to LHS of Window, Vertical Pipes [x2 pipes]; Residue	Each 3m	Identified	
MATERIAL ASSESSMENT					
Material	Asbestos Type	Condition	Accessibility	Encapsulation	Material Assessment
Thermal Insulation	Crocidolite, Amosite & Chrysotile	Low Damage: a few scratches or surface marks	Accessible, but in restricted access areas	Unsealed	9
SURVEYORS COMMENTS					
REMEDIAL ACTION TAKEN					
Action			Date Works Completed

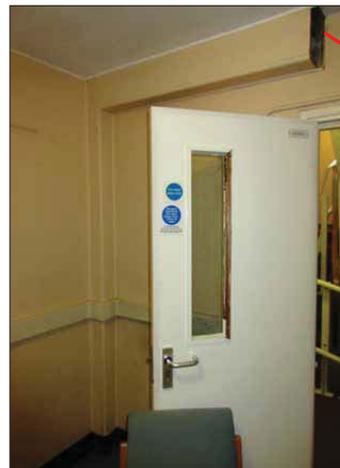
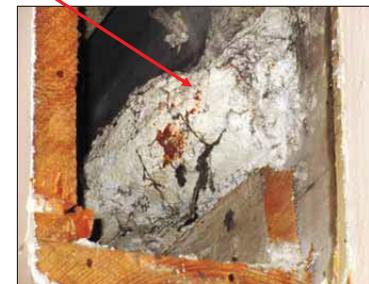
FINDING DETAILS					
Finding Code 04122014AGPA040		Item Thermal Insulation			
		Recommendations Remove Prior to Demolition			
LOCATION					
Internal/External	Floor Level	Location Description	Extent	Identification	
Internal Unoccupied	Ground Floor	Room 00701G011, High Level Horizontal and Vertical Timber Boxing, Heating Pipe	5m	Identified	
MATERIAL ASSESSMENT					
Material	Asbestos Type	Condition	Accessibility	Encapsulation	Material Assessment
Thermal Insulation	Crocidolite, Amosite & Chrysotile	Low Damage: a few scratches or surface marks	Accessible, but in restricted access areas	Unsealed	9
SURVEYORS COMMENTS					
REMEDIAL ACTION TAKEN					
Action			Date Works Completed

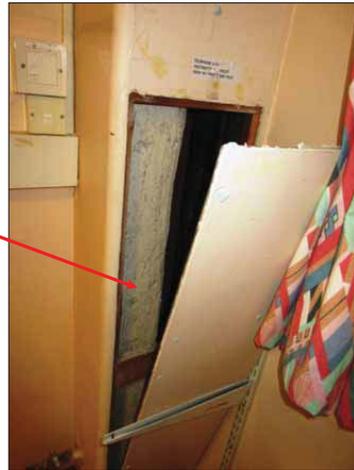
FINDING DETAILS					
Finding Code 04122014AGPA043		Item Thermal Insulation on Pipework			
		Recommendations Remove Prior to Demolition			
LOCATION					
Internal/External	Floor Level	Location Description	Extent	Identification	
Internal Unoccupied	Ground Floor	Room 00701G009, Vertical Riser to LHS of Window, Vertical Pipes [x2 pipes]	Each 3m	Identified	
MATERIAL ASSESSMENT					
Material	Asbestos Type	Condition	Accessibility	Encapsulation	Material Assessment
Thermal Insulation	Crocidolite, Amosite & Chrysotile	Low Damage: a few scratches or surface marks	Accessible, but in restricted access areas	Unsealed	9
SURVEYORS COMMENTS					
REMEDIAL ACTION TAKEN					
Action			Date Works Completed

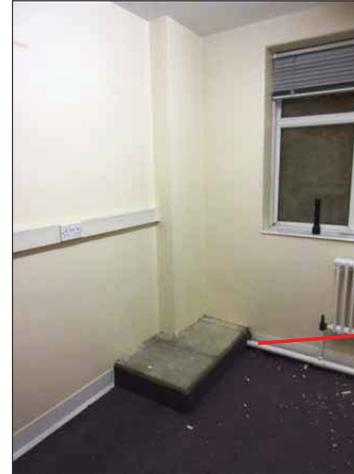
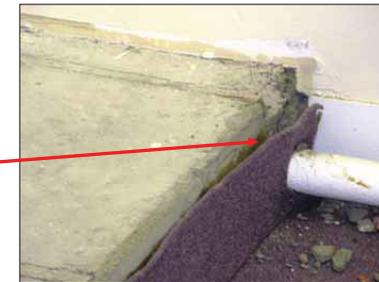
FINDING DETAILS					
Finding Code 04122014AGPA044		Item Thermal Insulation on Pipework			
		Recommendations Remove Prior to Demolition			
LOCATION					
Internal/External	Floor Level	Location Description	Extent	Identification	
Internal Unoccupied	Ground Floor	Room 00701G008, Perimeter Heating Pipes Embedded in Poured Concrete Plinth	1m	Identified	
MATERIAL ASSESSMENT					
Material	Asbestos Type	Condition	Accessibility	Encapsulation	Material Assessment
Thermal Insulation	Crocidolite, Amosite & Chrysotile	Low Damage: a few scratches or surface marks	Accessible, but in restricted access areas	Enclosed	8
SURVEYORS COMMENTS					
REMEDIAL ACTION TAKEN					
Action			Date Works Completed

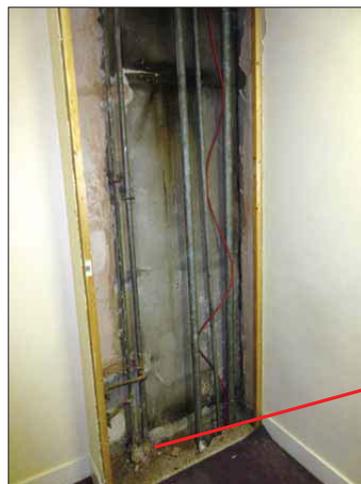
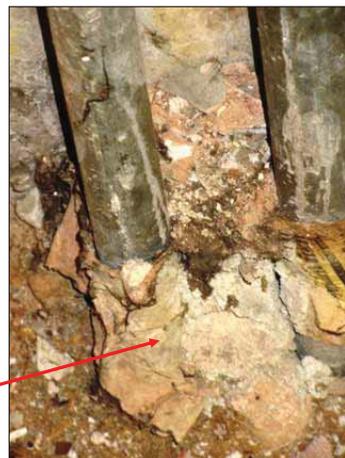
FINDING DETAILS					
Finding Code 04122014AGPA045		Item Thermal Insulation on Pipework			
		Recommendations Remove Prior to Demolition			
LOCATION					
Internal/External	Floor Level	Location Description	Extent	Identification	
Internal Unoccupied	Ground Floor	Room 00701G007, Vertical Riser to LHS of Window, Vertical Pipes [x2 pipes]	30cm	Identified	
MATERIAL ASSESSMENT					
Material	Asbestos Type	Condition	Accessibility	Encapsulation	Material Assessment
Thermal Insulation	Crocidolite, Amosite & Chrysotile	Low Damage: a few scratches or surface marks	Accessible, but in restricted access areas	Unsealed	9
SURVEYORS COMMENTS					
REMEDIAL ACTION TAKEN					
Action			Date Works Completed

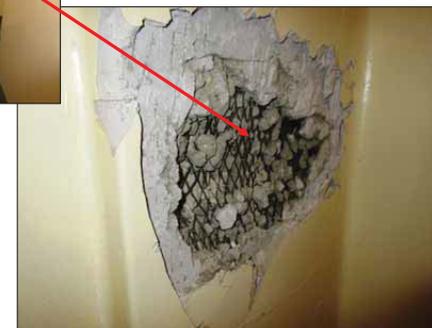
FINDING DETAILS					
Finding Code 04122014AGPA046		Item Thermal Insulation on Pipework			
		Recommendations Remove Prior to Demolition			
LOCATION					
Internal/External	Floor Level	Location Description	Extent	Identification	
Internal Unoccupied	Ground Floor	Room 00701G018, Vertical Riser [Chicken wire & Plaster] to LHS of Window, Vertical Pipes [x2 pipes]	Each 3m	Identified	
MATERIAL ASSESSMENT					
Material	Asbestos Type	Condition	Accessibility	Encapsulation	Material Assessment
Thermal Insulation	Crocidolite, Amosite & Chrysotile	Low Damage: a few scratches or surface marks	Accessible, but in restricted access areas	Unsealed	9
SURVEYORS COMMENTS					
Continues from SI023.					
REMEDIAL ACTION TAKEN					
Action			Date Works Completed

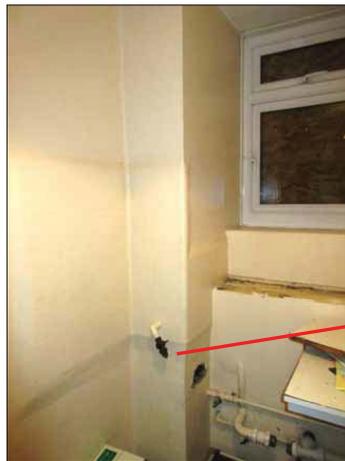
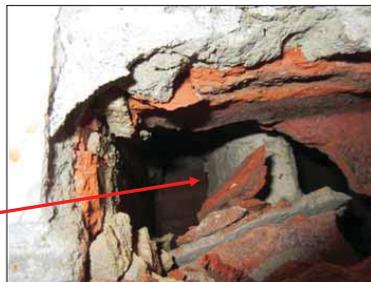
FINDING DETAILS					
Finding Code 04122014AGPA047		Item Thermal Insulation on Pipework	Recommendations Remove Prior to Demolition		
LOCATION					
Internal/External	Floor Level	Location Description	Extent	Identification	
Internal Unoccupied	Ground Floor	Room 00701G021, Vertical Riser[Brick] to LHS of Window, Vertical Pipes	4m	Identified	
MATERIAL ASSESSMENT					
Material	Asbestos Type	Condition	Accessibility	Encapsulation	Material Assessment
Thermal Insulation	Crocidolite, Amosite & Chrysotile	Low Damage: a few scratches or surface marks	Accessible, but in restricted access areas	Unsealed	9
SURVEYORS COMMENTS					
Continues from SI020. Not in void but void open to riser.					
REMEDIAL ACTION TAKEN					
Action			Date Works Completed

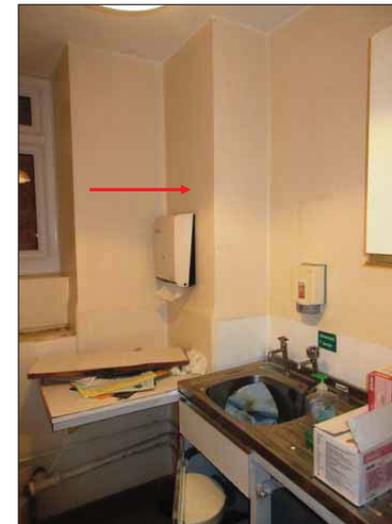
FINDING DETAILS					
Finding Code 04122014AGPA048		Item Thermal Insulation on Pipework	Recommendations Remove Prior to Demolition		
LOCATION					
Internal/External	Floor Level	Location Description	Extent	Identification	
Internal Unoccupied	Ground Floor	Room 00701G021, Vertical Riser[Brick] to RHS of Window, Vertical Pipes [x2 pipes]	Each 4m	Identified	
MATERIAL ASSESSMENT					
Material	Asbestos Type	Condition	Accessibility	Encapsulation	Material Assessment
Thermal Insulation	Crocidolite, Amosite & Chrysotile	Low Damage: a few scratches or surface marks	Accessible, but in restricted access areas	Unsealed	9
SURVEYORS COMMENTS					
Linked to SI022 from void above.					
REMEDIAL ACTION TAKEN					
Action			Date Works Completed

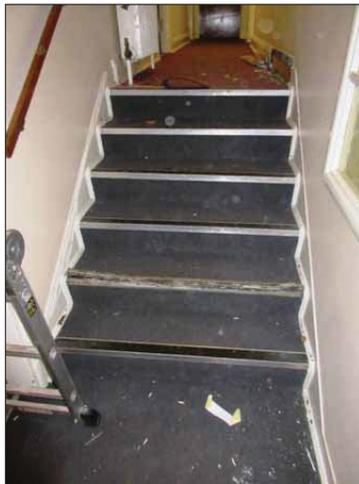
FINDING DETAILS					
Finding Code 04122014AGPA049		Item Bitumen	Recommendations No action required		
LOCATION					
Internal/External Internal Unoccupied	Floor Level Ground Floor	Location Description Corridor 00701GC03, Stairs Original Stair Nosing [x6 steps]	Extent Each 1m	Identification Identified	
MATERIAL ASSESSMENT					
Material Bitumen	Asbestos Type No Asbestos Detected	Condition Good Condition: No Visible Damage	Accessibility Accessible, but in restricted access areas	Encapsulation Composite materials: reinforced plastics, resins, vinyl tiles.	Material Assessment 0
SURVEYORS COMMENTS					
REMEDIAL ACTION TAKEN					
Action			Date Works Completed

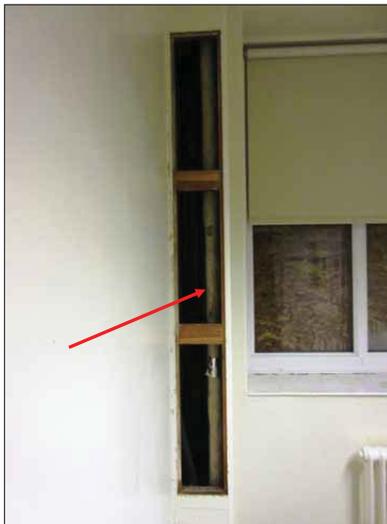
FINDING DETAILS					
Finding Code 04122014AGPA051		Item Thermal Insulation on Pipework	Recommendations Remove Prior to Demolition		
LOCATION					
Internal/External	Floor Level	Location Description	Extent	Identification	
Internal Unoccupied	Ground Floor	Room 00701G006, Vertical Riser to LHS of Window, Vertical Pipe	4m	Identified	
MATERIAL ASSESSMENT					
Material	Asbestos Type	Condition	Accessibility	Encapsulation	Material Assessment
Thermal Insulation	Crocidolite, Amosite & Chrysotile	Low Damage: a few scratches or surface marks	Accessible, but in restricted access areas	Unsealed	9
SURVEYORS COMMENTS					
REMEDIAL ACTION TAKEN					
Action			Date Works Completed

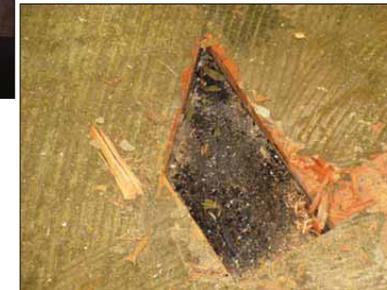
FINDING DETAILS					
Finding Code 04122014AGPA052		Item Bitumen Adhesive	Recommendations No action required		
LOCATION					
Internal/External	Floor Level	Location Description	Extent	Identification	
Internal Unoccupied	Ground Floor	Room 00701G022, Parquet Flooring, Adhesive	40sq.m	Identified	
MATERIAL ASSESSMENT					
Material	Asbestos Type	Condition	Accessibility	Encapsulation	Material Assessment
Bitumen	No Asbestos Detected	Good Condition: No Visible Damage	Accessible, but in restricted access areas	Composite materials: reinforced plastics, resins, vinyl tiles.	0
SURVEYORS COMMENTS					
REMEDIAL ACTION TAKEN					
Action			Date Works Completed

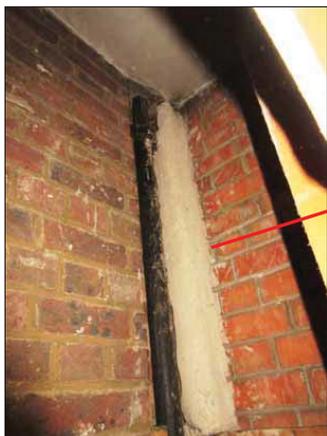
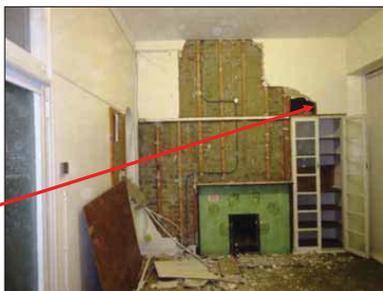
FINDING DETAILS					
Finding Code 04122014AGPA055		Item Thermal Insulation on Pipework	Recommendations Remove Prior to Demolition		
LOCATION					
Internal/External	Floor Level	Location Description	Extent	Identification	
Internal Unoccupied	Ground Floor	Room 00701G005, Vertical Riser to LHS of Window, Vertical Pipe	4m	Identified	
MATERIAL ASSESSMENT					
Material	Asbestos Type	Condition	Accessibility	Encapsulation	Material Assessment
Thermal Insulation	Crocidolite, Amosite & Chrysotile	Low Damage: a few scratches or surface marks	Accessible, but in restricted access areas	Unsealed	9
SURVEYORS COMMENTS					
REMEDIAL ACTION TAKEN					
Action			Date Works Completed

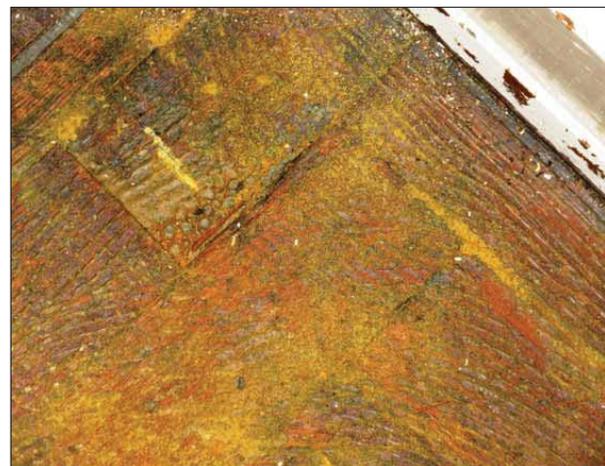
FINDING DETAILS					
Finding Code 04122014AGPA056		Item Bitumen Adhesive	Recommendations No action required		
LOCATION					
Internal/External	Floor Level	Location Description	Extent	Identification	
Internal Unoccupied	Ground Floor	Room 00701G023, Parquet Flooring, Adhesive	4.5sq. m	Identified	
MATERIAL ASSESSMENT					
Material	Asbestos Type	Condition	Accessibility	Encapsulation	Material Assessment
Bitumen	No Asbestos Detected	Good Condition: No Visible Damage	Accessible, but in restricted access areas	Composite materials: reinforced plastics, resins, vinyl tiles.	0
SURVEYORS COMMENTS					
REMEDIAL ACTION TAKEN					
Action			Date Works Completed

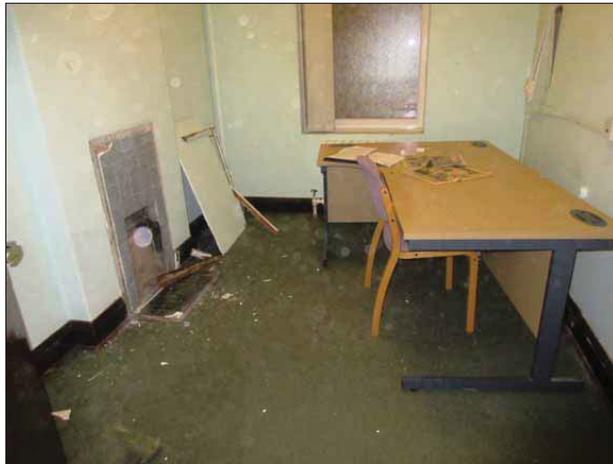
FINDING DETAILS					
Finding Code 04122014AGPA063		Item Bitumen Adhesive			
		Recommendations No action required			
LOCATION					
Internal/External	Floor Level	Location Description	Extent	Identification	
Internal Unoccupied	Ground Floor	Room 00701G001, Parquet Flooring, Adhesive	8sq.m	Identified	
MATERIAL ASSESSMENT					
Material	Asbestos Type	Condition	Accessibility	Encapsulation	Material Assessment
Bitumen	No Asbestos Detected	Good Condition: No Visible Damage	Accessible, but in restricted access areas	Composite materials: reinforced plastics, resins, vinyl tiles.	0
SURVEYORS COMMENTS					
REMEDIAL ACTION TAKEN					
Action			Date Works Completed

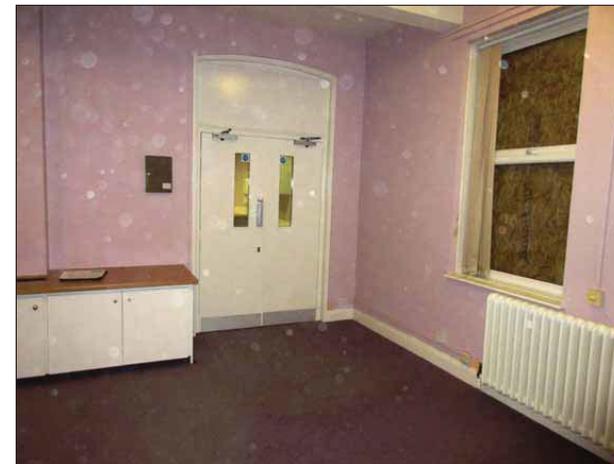
FINDING DETAILS					
Finding Code 04122014AGPA066		Item Bitumen Adhesive	Recommendations No action required		
LOCATION					
Internal/External Internal Unoccupied	Floor Level Ground Floor	Location Description Room 00701G028, Parquet Flooring, Adhesive	Extent 35sq.m	Identification Identified	
MATERIAL ASSESSMENT					
Material Bitumen	Asbestos Type No Asbestos Detected	Condition Good Condition: No Visible Damage	Accessibility Accessible, but in restricted access areas	Encapsulation Composite materials: reinforced plastics, resins, vinyl tiles.	Material Assessment 0
SURVEYORS COMMENTS					
REMEDIAL ACTION TAKEN					
Action			Date Works Completed

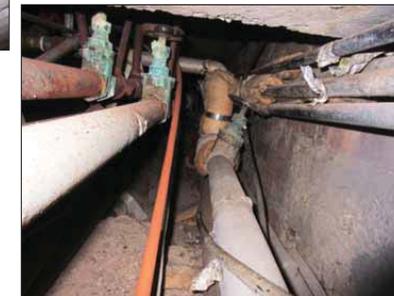
FINDING DETAILS					
Finding Code 04122014AGPA068		Item Thermal Insulation Debris			
		Recommendations Remove Prior to Demolition			
LOCATION					
Internal/External	Floor Level	Location Description		Extent	Identification
Internal Unoccupied	Ground Floor	Room 00701G027 into Room G028 and Room G002, Floor Duct, Floor Below Pipes		10m	Identified
MATERIAL ASSESSMENT					
Material	Asbestos Type	Condition	Accessibility	Encapsulation	Material Assessment
Thermal Insulation	Amosite & Chrysotile	High Damage: Or delamination of material	Accessible, but in restricted access areas	Unsealed	10
SURVEYORS COMMENTS					
REMEDIAL ACTION TAKEN					
Action			Date Works Completed

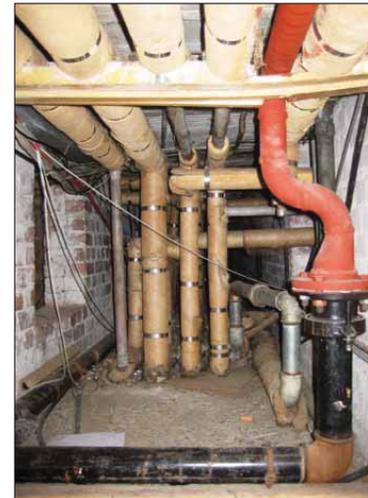
FINDING DETAILS					
Finding Code 04122014AGPA074		Item	Thermal Insulation Residue		
		Recommendations	Remove Prior to Demolition		
LOCATION					
Internal/External	Floor Level	Location Description		Extent	Identification
Internal Unoccupied	Basement	Undercroft to Cheviot House [South Wing] Below Rooms 00701G004-G006 and 00701G022-G026, Top High Level Horizontal Pipe		20m	Identified
MATERIAL ASSESSMENT					
Material	Asbestos Type	Condition	Accessibility	Encapsulation	Material Assessment
Thermal Insulation	Crocidolite, Amosite & Chrysotile	High Damage: Or delamination of material	Accessible, but in restricted access areas	Unsealed	11
SURVEYORS COMMENTS					
REMEDIAL ACTION TAKEN					
Action			Date Works Completed

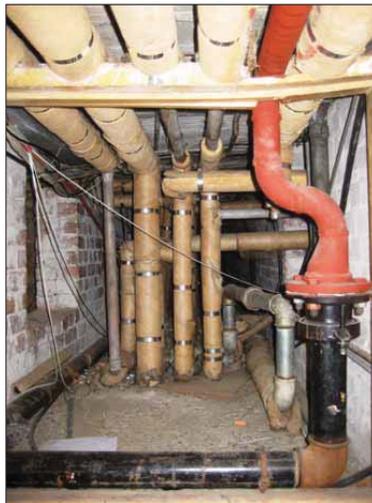
FINDING DETAILS					
Finding Code 04122014AGPA075		Item	Thermal Insulation Residue		
		Recommendations	Remove Prior to Demolition		
LOCATION					
Internal/External	Floor Level	Location Description		Extent	Identification
Internal Unoccupied	Basement	Undercroft to Cheviot House [South Wing] Below Rooms 00701G004-G006 and 00701G022-G026, Bottom High Level Horizontal Pipe		20m	Identified
MATERIAL ASSESSMENT					
Material	Asbestos Type	Condition	Accessibility	Encapsulation	Material Assessment
Thermal Insulation	Crocidolite, Amosite & Chrysotile	High Damage: Or delamination of material	Accessible, but in restricted access areas	Unsealed	11
SURVEYORS COMMENTS					
REMEDIAL ACTION TAKEN					
Action			Date Works Completed

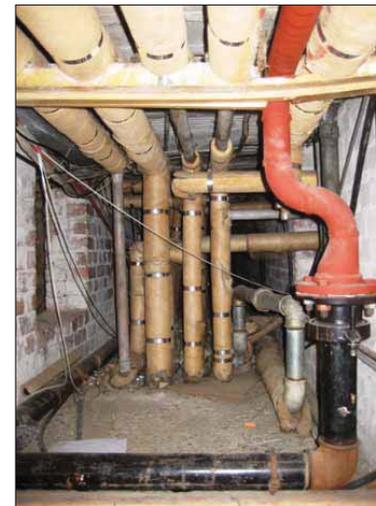
FINDING DETAILS					
Finding Code 04122014AGPA076		Item	Thermal Insulation Residue		
		Recommendations	Remove Prior to Demolition		
LOCATION					
Internal/External	Floor Level	Location Description		Extent	Identification
Internal Unoccupied	Basement	Undercroft to Cheviot House [South Wing] Below Rooms 00701G004-G006 and 00701G022-G026, Throughout		100sq. m	Identified
MATERIAL ASSESSMENT					
Material	Asbestos Type	Condition	Accessibility	Encapsulation	Material Assessment
Thermal Insulation	Crocidolite, Amosite & Chrysotile	High Damage: Or delamination of material	Accessible, but in restricted access areas	Unsealed	11
SURVEYORS COMMENTS					
REMEDIAL ACTION TAKEN					
Action			Date Works Completed
