## Appendix

<b>Name</b>	<b>Appendix No.</b>
Ready to Dig Searches and Responses	A
Arboricultural	B
Topographical Survey	C
Decontamination Survey	D
Habitat & Bat Survey	E
Asbestos	F

REFERENCE: 34638/PS  
ROUTE: Cotswold Road, Sutton  
OSGR: 525954,162355  
POSTCODE: SM2 5NF

**Ready to Dig – Utility Search Service**

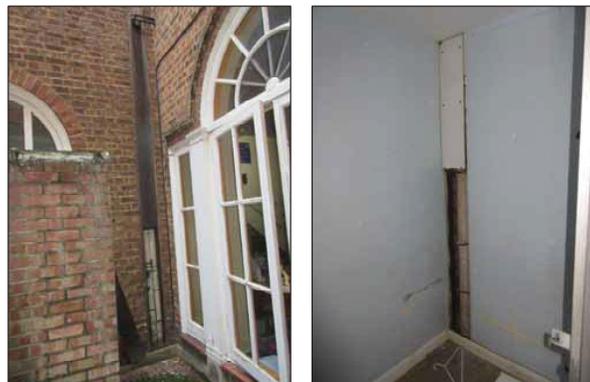
3.1.3 The ground floor has two vertical risers located in the lightwell's (one now filled in at ground floor level as a bathroom area). Each riser has two vertical pipes lagged in hand applied asbestos insulation. All other vertical risers had pipework which was either not lagged or lagged in non-asbestos materials.

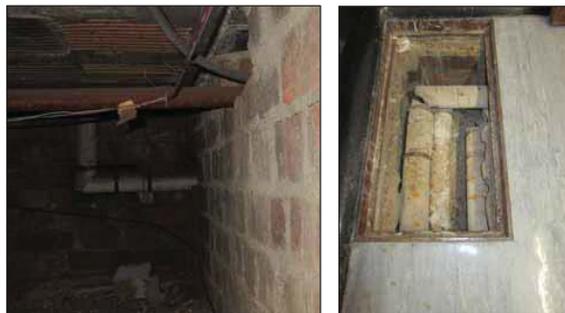
3.1.4 Further asbestos thermal insulation was identified on two pipes within a ground floor service duct. The pipes run around the room 00702G094 and join the main service duct. The floor duct has a concrete cover and below this is another duct cover infilled with asbestos thermal insulation. One section of pipe was located in the undercroft approximately below area 00702GC002 is lagged in asbestos thermal insulation.

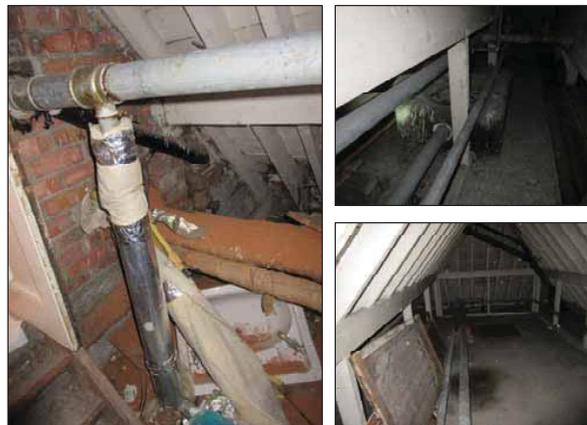
3.1.5 Asbestos thermal insulation is located in a first floor loft space where it has been partially removed from a number of pipes and is strongly believed to run under the asbestos cement and timber floor and on the first floor roof where the pipes are also wrapped in felt. The second floor loft has a square of asbestos thermal insulation lagging a small vessel.

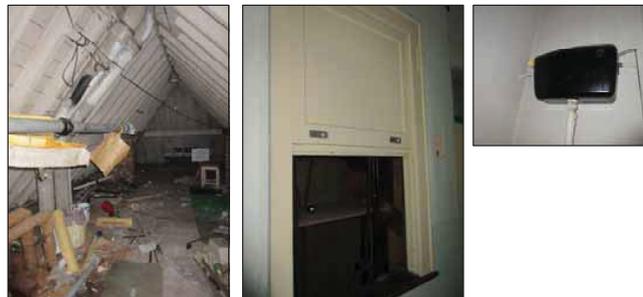
3.1.8 The first floor loft room (accessed from the 2<sup>nd</sup> floor) is boarded out with asbestos cement floor panels and has two asbestos cement flues and asbestos cement ceiling panel. Further asbestos cement panels line the lower rear wall of the ground to 1<sup>st</sup> floor Dumb Waiter.

3.1.9 An asbestos toilet cistern is located on the ground floor.

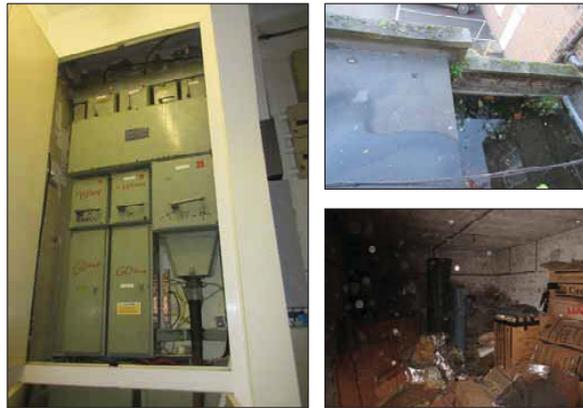
- 3.1.11 The fuse boards are strongly presumed to asbestos bakelite products, woven textiles as flash guards were identified on the first floor and the old fire and telephone controls box has an asbestos rope door seal.
- 3.1.12 The bitumen roof covering to the two small balcony flat roof areas of the Main Building was found to contain asbestos.
- 3.1.13 The basement boiler room has a roll of gasket material and an off-cut of this material were identified on the floor. Although it should be noted that the gaskets sampled on the pipework within the boiler room proved not to contain asbestos.

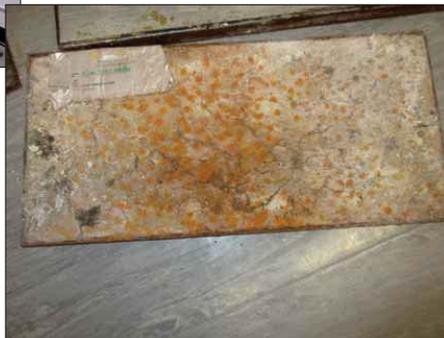
FINDING DETAILS					
Finding Code 07122014AGPA001		Item Asbestos Insulation Infill to Duct Cover	Recommendations Remove Prior to Demolition		
LOCATION					
Internal/External	Floor Level	Location Description	Extent	Identification	
Internal Unoccupied	Ground Floor	Room 00702G094, Floor Ducts, below radiator and in RHS corner, Below Concrete Duct Cover	Each 50sq. cm	Identified	
MATERIAL ASSESSMENT					
Material	Asbestos Type	Condition	Accessibility	Encapsulation	Material Assessment
Thermal Insulation	Crocidolite, Amosite & Chrysotile	Low Damage: a few scratches or surface marks	Accessible, but in restricted access areas	Enclosed	8
SURVEYORS COMMENTS					
REMEDIAL ACTION TAKEN					
Action			Date Works Completed

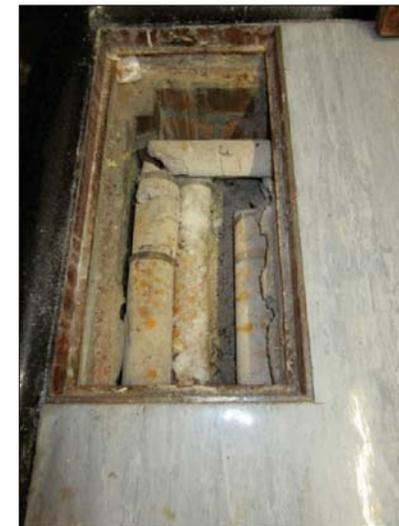
FINDING DETAILS					
Finding Code 07122014AGPA002		Item Thermal Insulation on Pipework	Recommendations Remove Prior to Demolition		
LOCATION					
Internal/External	Floor Level	Location Description	Extent	Identification	
Internal Unoccupied	Ground Floor	Room 00702G094, Floor Ducts, below radiator and in RHS corner, Below Duct Covers, Pipes x2	Each 6m	Identified	
MATERIAL ASSESSMENT					
Material	Asbestos Type	Condition	Accessibility	Encapsulation	Material Assessment
Thermal Insulation	Crocidolite, Amosite & Chrysotile	Low Damage: a few scratches or surface marks	Accessible, but in restricted access areas	Enclosed	8
SURVEYORS COMMENTS					
REMEDIAL ACTION TAKEN					
Action			Date Works Completed

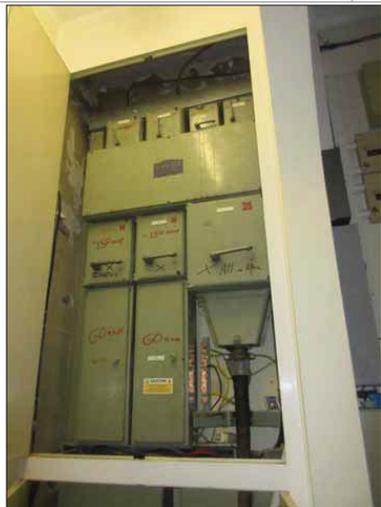
FINDING DETAILS					
Finding Code 07122014AGPA003		Item Arc Shield	Recommendations Remove Prior to Demolition		
LOCATION					
Internal/External Internal Unoccupied	Floor Level Ground Floor	Location Description Room 00702G099, Electrical Intake Cupboard, Fuse Boards,	Extent 6Boxes	Identification Strongly Presumed	
MATERIAL ASSESSMENT					
Material Bakelite	Asbestos Type Chrysotile (white)	Condition Good Condition: No Visible Damage	Accessibility Accessible, but in restricted access areas	Encapsulation Composite materials: reinforced plastics, resins, vinyl tiles.	Material Assessment 2
SURVEYORS COMMENTS					
REMEDIAL ACTION TAKEN					
Action			Date Works Completed

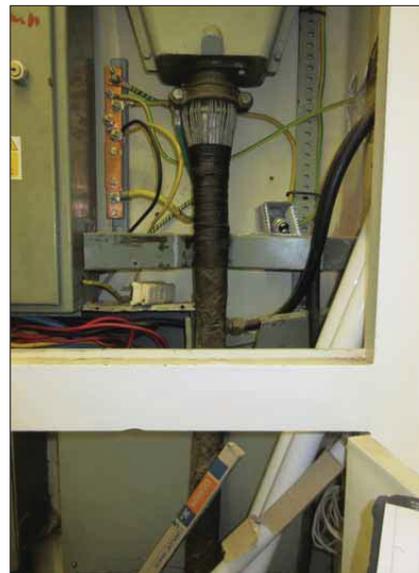
FINDING DETAILS					
Finding Code 07122014AGPA004		Item Wrap (above ground)	Recommendations No action required		
LOCATION					
Internal/External Internal Unoccupied	Floor Level Ground Floor	Location Description Room 00702G099, Electrical Intake Cupboard, Mains Power Cable	Extent 3m	Identification Identified	
MATERIAL ASSESSMENT					
Material Rope	Asbestos Type No Asbestos Detected	Condition Good Condition: No Visible Damage	Accessibility Accessible, but in restricted access areas	Encapsulation Enclosed	Material Assessment 0
SURVEYORS COMMENTS					
REMEDIAL ACTION TAKEN					
Action			Date Works Completed

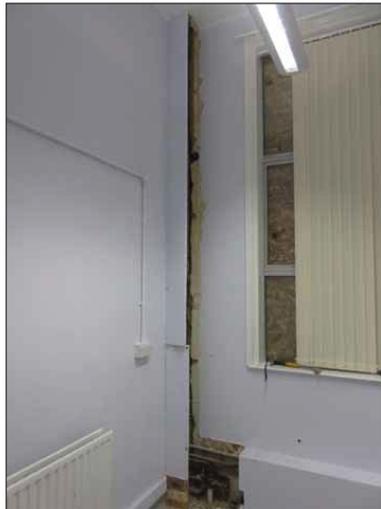
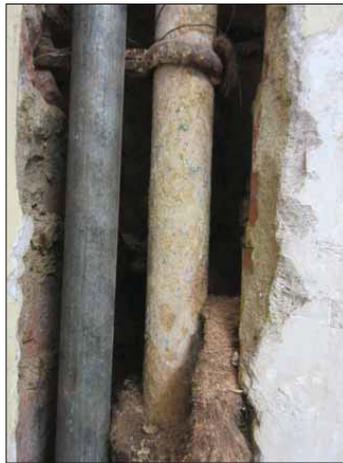
FINDING DETAILS					
Finding Code 07122014AGPA006		Item Thermal Insulation Debris (top of duct)	Recommendations No action required		
LOCATION					
Internal/External	Floor Level	Location Description	Extent	Identification	
Internal Unoccupied	Ground Floor	Room 00702G032, LHS Vertical Duct (as walk into room)	5m	Identified	
MATERIAL ASSESSMENT					
Material	Asbestos Type	Condition	Accessibility	Encapsulation	Material Assessment
Thermal Insulation	No Asbestos Detected	High Damage: Or delamination of material	Accessible, but in restricted access areas	Unsealed	0
SURVEYORS COMMENTS					
REMEDIAL ACTION TAKEN					
Action			Date Works Completed

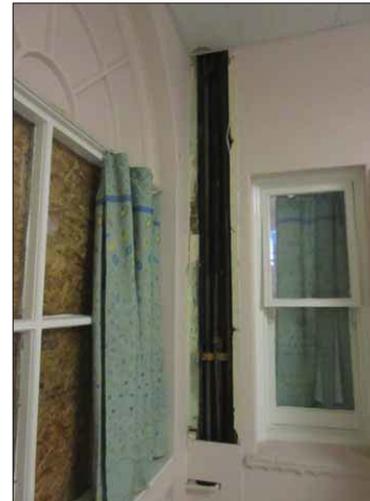
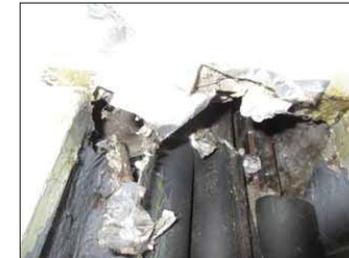
FINDING DETAILS					
Finding Code 07122014AGPA007		Item Thermal Insulation Debris (top of duct)	Recommendations No action required		
LOCATION					
Internal/External Internal Unoccupied	Floor Level Ground Floor	Location Description Room 00702G032, RHS Vertical Duct (as walk into room)	Extent 5m	Identification Strongly Presumed	
MATERIAL ASSESSMENT					
Material Thermal Insulation	Asbestos Type No Asbestos Detected	Condition High Damage: Or delamination of material	Accessibility Accessible, but in restricted access areas	Encapsulation Unsealed	Material Assessment 0
SURVEYORS COMMENTS					
REMEDIAL ACTION TAKEN					
Action			Date Works Completed

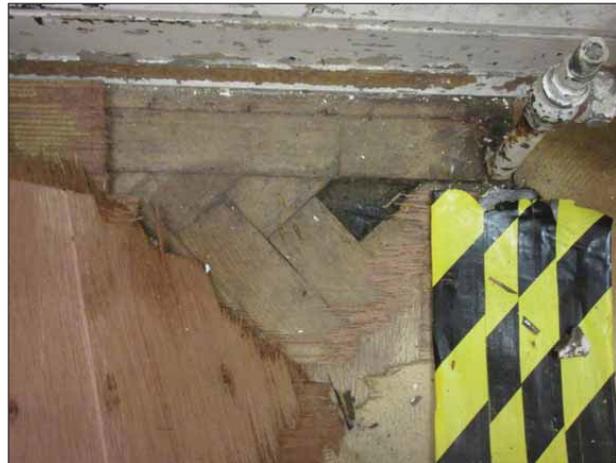
FINDING DETAILS					
Finding Code 07122014AGPA010		Item Bitumen Adhesive	Recommendations No action required		
LOCATION					
Internal/External Internal Unoccupied	Floor Level Ground Floor	Location Description Corridor 00702G004, Parquet Flooring	Extent 2.5sq.m	Identification Strongly Presumed	
MATERIAL ASSESSMENT					
Material Bitumen	Asbestos Type No Asbestos Detected	Condition Good Condition: No Visible Damage	Accessibility Accessible, but in restricted access areas	Encapsulation Enclosed	Material Assessment 0
SURVEYORS COMMENTS					
REMEDIAL ACTION TAKEN					
Action			Date Works Completed

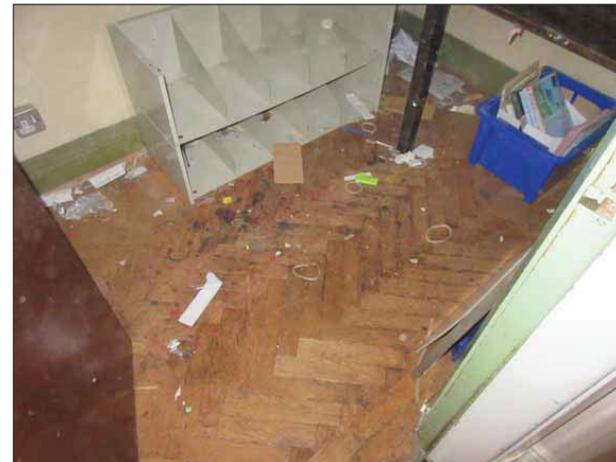
FINDING DETAILS					
Finding Code 07122014AGPA011		Item Bitumen Adhesive	Recommendations No action required		
LOCATION					
Internal/External	Floor Level	Location Description	Extent	Identification	
Internal Unoccupied	Ground Floor	Corridor 00702G025, Parquet Flooring	10.5sq. m	Strongly Presumed	
MATERIAL ASSESSMENT					
Material	Asbestos Type	Condition	Accessibility	Encapsulation	Material Assessment
Bitumen	No Asbestos Detected	Good Condition: No Visible Damage	Accessible, but in restricted access areas	Enclosed	0
SURVEYORS COMMENTS					
REMEDIAL ACTION TAKEN					
Action			Date Works Completed

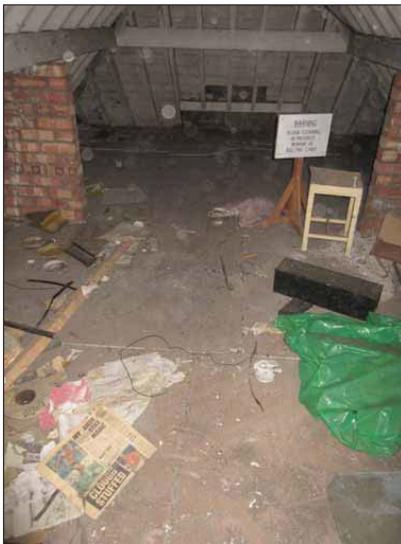
FINDING DETAILS					
Finding Code 07122014AGPA024		Item Thermal Insulation to Pipework	Recommendations Remove Prior to Demolition		
LOCATION					
Internal/External	Floor Level	Location Description	Extent	Identification	
Internal Unoccupied	Second Floor	Loft Room 007022013, Wall to Room 007022010, Horizontal Pipe	1.5m	Identified	
MATERIAL ASSESSMENT					
Material	Asbestos Type	Condition	Accessibility	Encapsulation	Material Assessment
Thermal Insulation	Crocidolite, Amosite & Chrysotile	Medium Damage: Significant breakage of materials	Accessible, but in restricted access areas	Unsealed	10
SURVEYORS COMMENTS					
REMEDIAL ACTION TAKEN					
Action			Date Works Completed

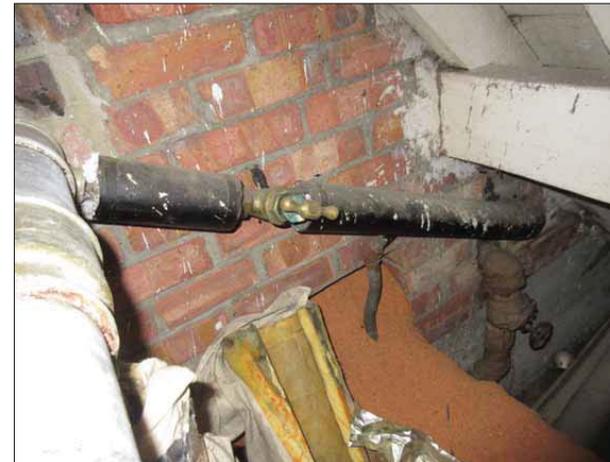
FINDING DETAILS					
Finding Code 07122014AGPA025		Item Thermal Insulation to Pipework			
		Recommendations Remove Prior to Demolition			
LOCATION					
Internal/External	Floor Level	Location Description		Extent	Identification
Internal Unoccupied	Second Floor	Loft Room 007022013, Mid Level Horizontal Pipe as it runs out of Mansard Roof		50cm	Identified
MATERIAL ASSESSMENT					
Material	Asbestos Type	Condition	Accessibility	Encapsulation	Material Assessment
Thermal Insulation	Crocidolite, Amosite & Chrysotile	Medium Damage: Significant breakage of materials	Accessible, but in restricted access areas	Unsealed	10
SURVEYORS COMMENTS					
Pipe insulated with MMMF in other areas					
REMEDIAL ACTION TAKEN					
Action			Date Works Completed

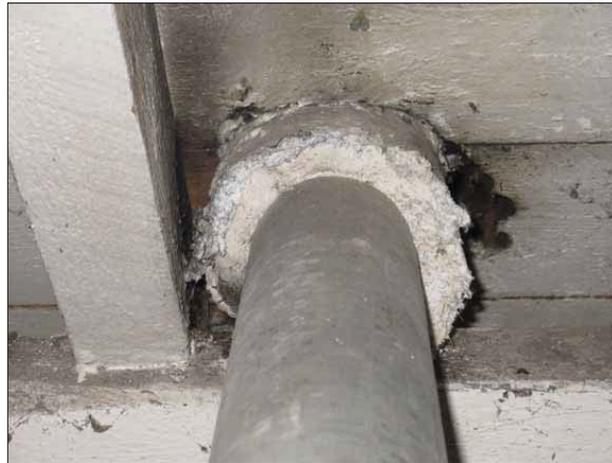
FINDING DETAILS					
Finding Code 07122014AGPA026		Item Thermal Insulation to Pipework			
		Recommendations Remove Prior to Demolition			
LOCATION					
Internal/External	Floor Level	Location Description		Extent	Identification
Internal Unoccupied	Second Floor	Loft Room 007022013, Low Level Horizontal Pipe as it runs into timber floor		50cm	Identified
MATERIAL ASSESSMENT					
Material	Asbestos Type	Condition	Accessibility	Encapsulation	Material Assessment
Thermal Insulation	Crocidolite, Amosite & Chrysotile	Medium Damage: Significant breakage of materials	Accessible, but in restricted access areas	Unsealed	10
SURVEYORS COMMENTS					
REMEDIAL ACTION TAKEN					
Action			Date Works Completed

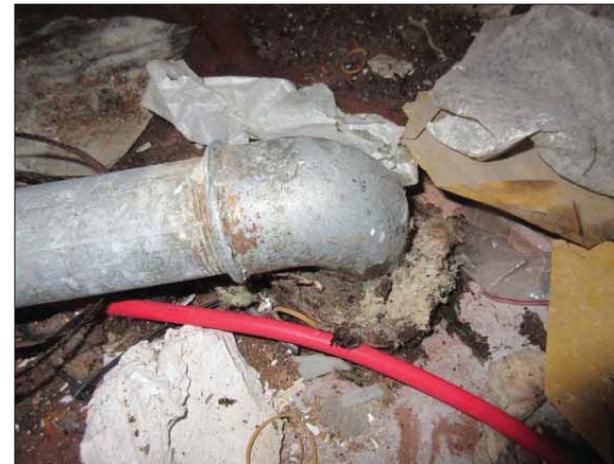
FINDING DETAILS					
Finding Code 07122014AGPA027		Item	Flue (no CowI)		
		Recommendations	Remove Prior to Demolition		
LOCATION					
Internal/External	Floor Level	Location Description		Extent	Identification
Internal Unoccupied	Second Floor	Loft Room 007022013, LHS of Door; LHS Flue Pipe (does not run below floor nor onto roof)		3m	Strongly Presumed
MATERIAL ASSESSMENT					
Material	Asbestos Type	Condition	Accessibility	Encapsulation	Material Assessment
Cement	Chrysotile (white)	Low Damage: a few scratches or surface marks	Accessible, but in restricted access areas	Unsealed	5
SURVEYORS COMMENTS					
REMEDIAL ACTION TAKEN					
Action			Date Works Completed

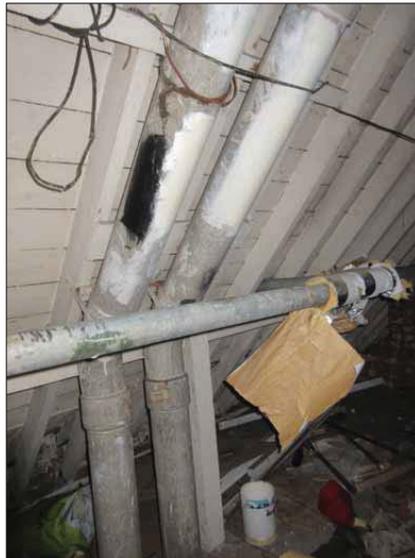
FINDING DETAILS					
Finding Code 07122014AGPA028		Item	Flue (no CowI)		
		Recommendations	Remove Prior to Demolition		
LOCATION					
Internal/External	Floor Level	Location Description		Extent	Identification
Internal Unoccupied	Second Floor	Loft Room 007022013, LHS of Door; RHS Flue Pipe (does not run below floor nor onto roof)		3m	Strongly Presumed
MATERIAL ASSESSMENT					
Material	Asbestos Type	Condition	Accessibility	Encapsulation	Material Assessment
Cement	Chrysotile (white)	Low Damage: a few scratches or surface marks	Accessible, but in restricted access areas	Unsealed	5
SURVEYORS COMMENTS					
REMEDIAL ACTION TAKEN					
Action			Date Works Completed

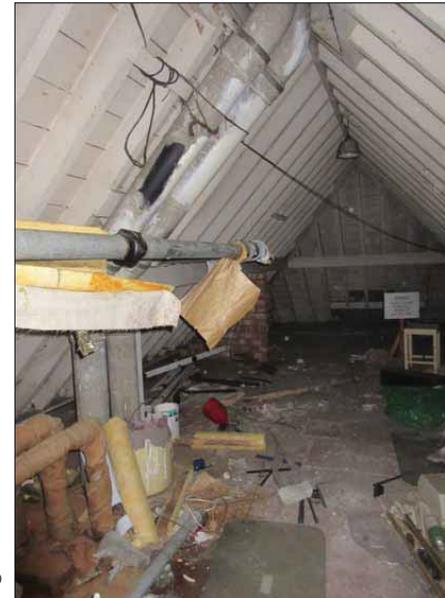
FINDING DETAILS					
Finding Code 07122014AGPA029		Item Lining Panel	Recommendations Remove Prior to Demolition		
LOCATION					
Internal/External	Floor Level	Location Description	Extent	Identification	
Internal Unoccupied	Second Floor	Loft Room 007022013, LHS of Door; Roof [as Flue Pipes run through them]	50sq. cm	Strongly Presumed	
MATERIAL ASSESSMENT					
Material	Asbestos Type	Condition	Accessibility	Encapsulation	Material Assessment
Cement	Chrysotile (white)	Low Damage: a few scratches or surface marks	Accessible, but in restricted access areas	Unsealed	5
SURVEYORS COMMENTS					
REMEDIAL ACTION TAKEN					
Action			Date Works Completed

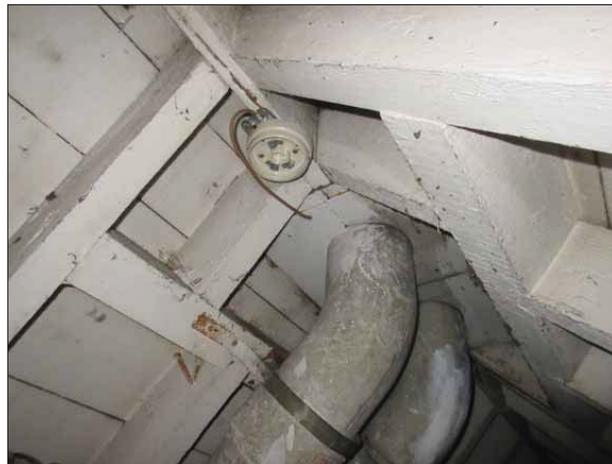
FINDING DETAILS					
Finding Code 07122014AGPA030		Item Lining Panel	Recommendations No action required		
LOCATION					
Internal/External	Floor Level	Location Description	Extent	Identification	
Internal Unoccupied	Second Floor	Roof, Lift Motor Room, Lining Panels	20sq.m	Identified	
MATERIAL ASSESSMENT					
Material	Asbestos Type	Condition	Accessibility	Encapsulation	Material Assessment
Insulating Board	No Asbestos Detected	Low Damage: a few scratches or surface marks	Accessible, but in restricted access areas	Unsealed	0
SURVEYORS COMMENTS					
REMEDIAL ACTION TAKEN					
Action			Date Works Completed

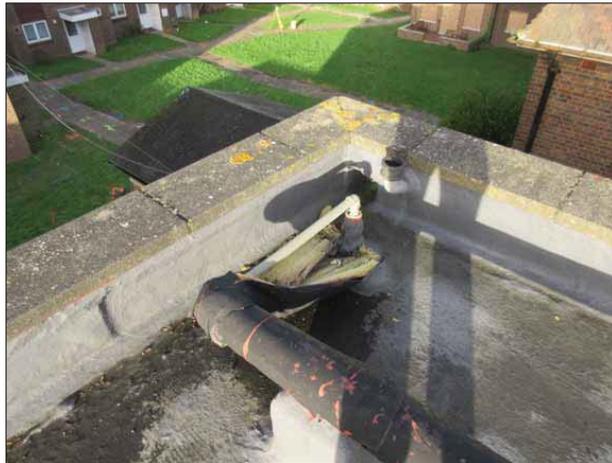
FINDING DETAILS					
Finding Code 07122014AGPA032		Item Thermal Insulation Pipework	Recommendations Remove Prior to Demolition		
LOCATION					
Internal/External	Floor Level	Location Description	Extent	Identification	
External	First Floor	Roof above First Floor Room 007021028, Horizontal Pipe as it turns into roof	5m	Identified	
MATERIAL ASSESSMENT					
Material	Asbestos Type	Condition	Accessibility	Encapsulation	Material Assessment
Thermal Insulation	Crocidolite, Amosite & Chrysotile	High Damage: Or delamination of material	Accessible, but in restricted access areas	Unsealed	11
SURVEYORS COMMENTS					
REMEDIAL ACTION TAKEN					
Action			Date Works Completed

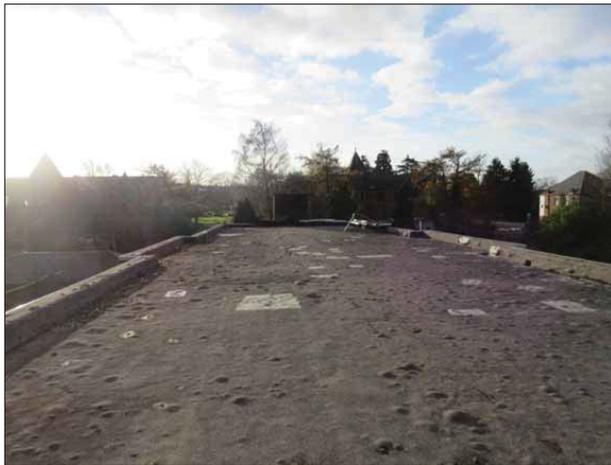
FINDING DETAILS					
Finding Code 07122014AGPA033		Item Bitumen Cover to Roof	Recommendations No action required		
LOCATION					
Internal/External	Floor Level	Location Description	Extent	Identification	
External	First Floor	Roof to 1st Floor Areas	Total Amount 1125sq. m	Identified	
MATERIAL ASSESSMENT					
Material	Asbestos Type	Condition	Accessibility	Encapsulation	Material Assessment
Bitumen	No Asbestos Detected	Low Damage: a few scratches or surface marks	Accessible, but in restricted access areas	Enclosed	0
SURVEYORS COMMENTS					
Sample 1 of 3					
REMEDIAL ACTION TAKEN					
Action			Date Works Completed

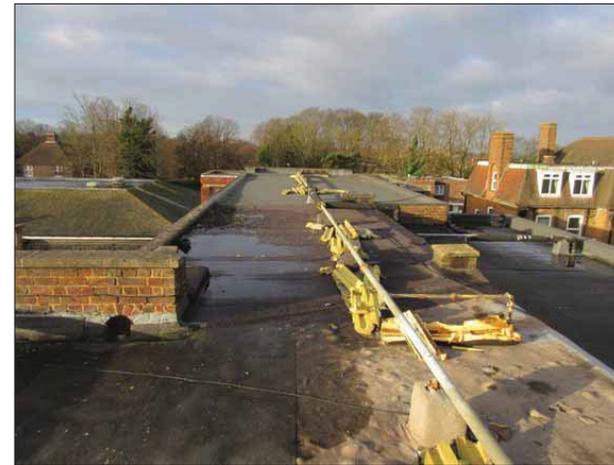
FINDING DETAILS					
Finding Code 07122014AGPA034		Item Bitumen Cover to Roof	Recommendations No action required		
LOCATION					
Internal/External	Floor Level	Location Description	Extent	Identification	
Internal Unoccupied	First Floor	Roof to 1st Floor Areas	Total Amount 1125sq. m	Identified	
MATERIAL ASSESSMENT					
Material	Asbestos Type	Condition	Accessibility	Encapsulation	Material Assessment
Bitumen	No Asbestos Detected	Low Damage: a few scratches or surface marks	Accessible, but in restricted access areas	Enclosed	0
SURVEYORS COMMENTS					
Sample 2 of 3					
REMEDIAL ACTION TAKEN					
Action			Date Works Completed

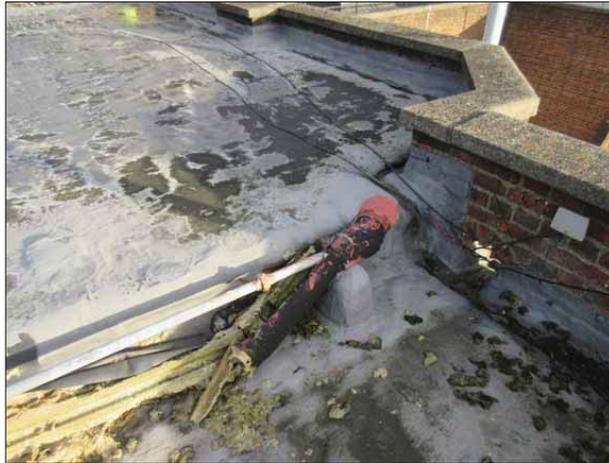
FINDING DETAILS					
Finding Code 07122014AGPA035		Item Bitumen Cover to Roof	Recommendations No action required		
LOCATION					
Internal/External	Floor Level	Location Description	Extent	Identification	
Internal Unoccupied	First Floor	Roof to 1st Floor Areas	Total Amount 1125sq. m	Identified	
MATERIAL ASSESSMENT					
Material	Asbestos Type	Condition	Accessibility	Encapsulation	Material Assessment
Bitumen	No Asbestos Detected	Low Damage: a few scratches or surface marks	Accessible, but in restricted access areas	Enclosed	0
SURVEYORS COMMENTS					
Sample 3 of 3					
REMEDIAL ACTION TAKEN					
Action			Date Works Completed

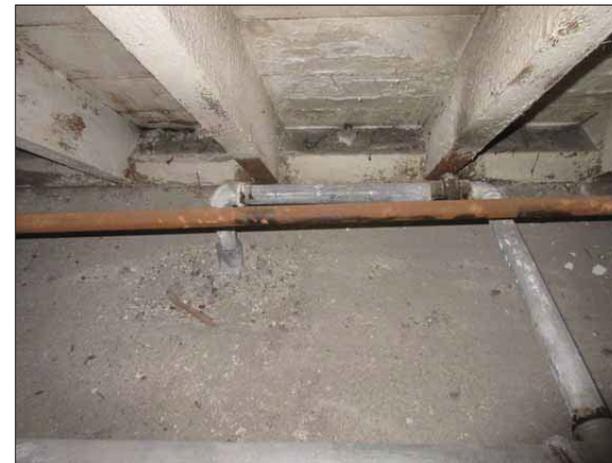
FINDING DETAILS					
Finding Code 07122014AGPA036		Item Thermal Insulation Pipework	Recommendations Remove Prior to Demolition		
LOCATION					
Internal/External	Floor Level	Location Description	Extent	Identification	
Internal Unoccupied	Second Floor	Loft Space Above Rooms 007022001-012 and Corridor 007022C01, Horizontal Pipework [x2 pipes]	Each 75m	Strongly Presumed	
MATERIAL ASSESSMENT					
Material	Asbestos Type	Condition	Accessibility	Encapsulation	Material Assessment
Thermal Insulation	Crocidolite, Amosite & Chrysotile	High Damage: Or delamination of material	Accessible, but in restricted access areas	Unsealed	11
SURVEYORS COMMENTS					
Some areas more visible than others					
REMEDIAL ACTION TAKEN					
Action			Date Works Completed

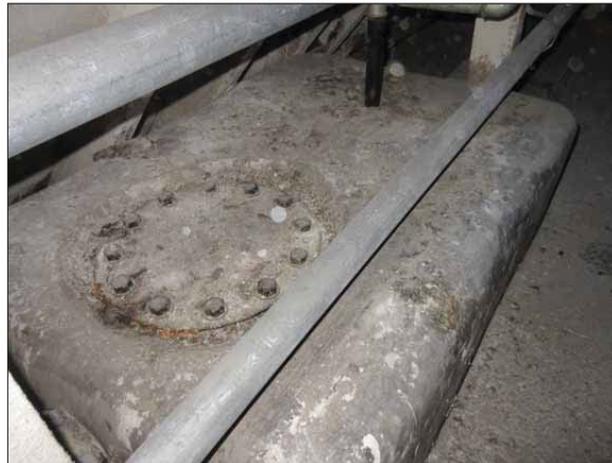
FINDING DETAILS					
Finding Code 07122014AGPA037		Item Thermal Insulation	Recommendations Remove Prior to Demolition		
LOCATION					
Internal/External	Floor Level	Location Description	Extent	Identification	
Internal Unoccupied	Second Floor	Loft Space Above Rooms 007022001-012 and Corridor 007022C01, Behind Water Tanks, Square Plinth	3sq.m	Identified	
MATERIAL ASSESSMENT					
Material	Asbestos Type	Condition	Accessibility	Encapsulation	Material Assessment
Thermal Insulation	Crocidolite, Amosite & Chrysotile	High Damage: Or delamination of material	Accessible, but in restricted access areas	Unsealed	11
SURVEYORS COMMENTS					
REMEDIAL ACTION TAKEN					
Action			Date Works Completed

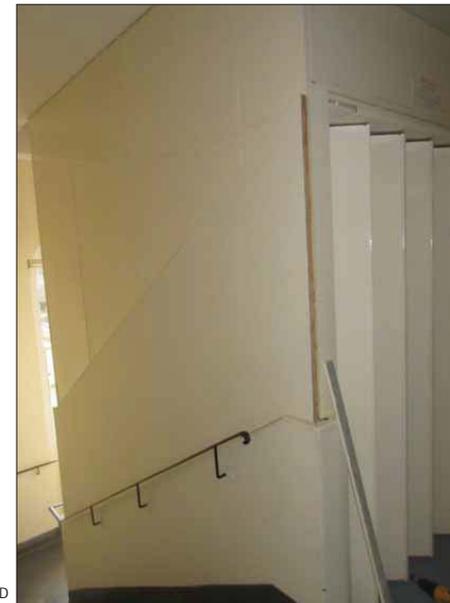
DETAILS					
Finding Code 07122014AGPA038		Item External Cladding Panels	Recommendations No action required		
LOCATION					
Internal/External	Floor Level	Location Description	Extent	Identification	
Internal Unoccupied	Ground Floor	Main Entrance, Staircase, Ground to First Floor, Lift	10sq.m	Identified	
MATERIAL ASSESSMENT					
Material	Asbestos Type	Condition	Accessibility	Encapsulation	Material Assessment
Cement	No Asbestos Detected	Good Condition: No Visible Damage	Accessible, but in restricted access areas	Enclosed	0
SURVEYORS COMMENTS					
REMEDIAL ACTION TAKEN					
Action			Date Works Completed

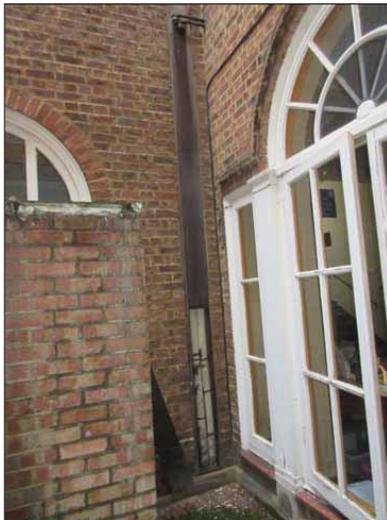
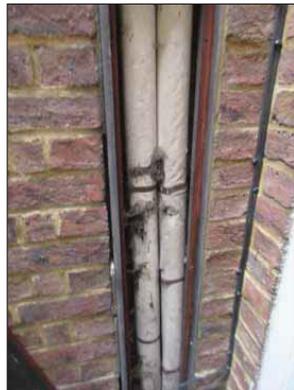
FINDING DETAILS					
Finding Code 07122014AGPA039		Item	Thermal Insulation Pipework		
		Recommendations	Remove Prior to Demolition		
LOCATION					
Internal/External	Floor Level	Location Description		Extent	Identification
External	Ground Floor	Main Entrance 00702GC02, LHS Lightwell, Vertical Wall Risers, Pipework [x2 pipes]		Each 7m	Strongly Presumed
MATERIAL ASSESSMENT					
Material	Asbestos Type	Condition	Accessibility	Encapsulation	Material Assessment
Thermal Insulation	Crocidolite, Amosite & Chrysotile	Medium Damage: Significant breakage of materials	Accessible, but in restricted access areas	Enclosed	9
SURVEYORS COMMENTS					
REMEDIAL ACTION TAKEN					
Action			Date Works Completed

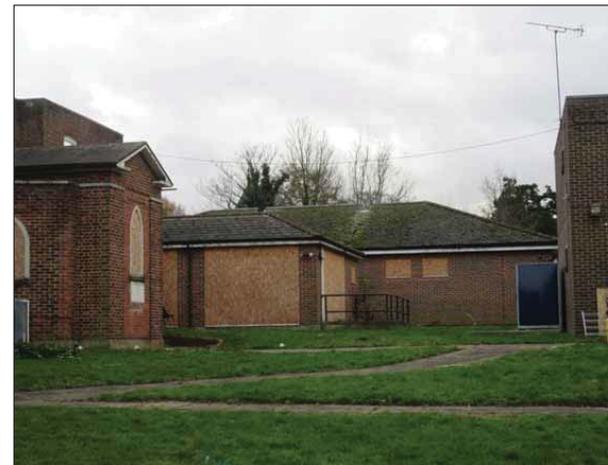
FINDING DETAILS					
Finding Code 07122014AGPA040		Item	Tiles		
		Recommendations	No action required		
LOCATION					
Internal/External	Floor Level	Location Description		Extent	Identification
External	Ground Floor	Theatres Link Corridor 00702GC015, Roof		20sq.m	Identified
MATERIAL ASSESSMENT					
Material	Asbestos Type	Condition	Accessibility	Encapsulation	Material Assessment
Cement	No Asbestos Detected	Low Damage: a few scratches or surface marks	Accessible, but in restricted access areas	Enclosed	0
SURVEYORS COMMENTS					
REMEDIAL ACTION TAKEN					
Action			Date Works Completed

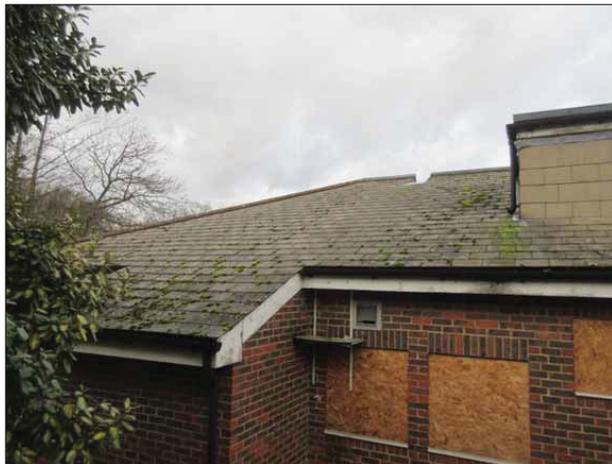
FINDING DETAILS					
Finding Code 07122014AGPA041		Item	Roof Tile		
		Recommendations	No action required		
LOCATION					
Internal/External	Floor Level	Location Description		Extent	Identification
External	Ground Floor	Theatres, Main Roof		500sq. m	Identified
MATERIAL ASSESSMENT					
Material	Asbestos Type	Condition	Accessibility	Encapsulation	Material Assessment
Cement	No Asbestos Detected	Low Damage: a few scratches or surface marks	Accessible, but in restricted access areas	Enclosed	0
SURVEYORS COMMENTS					
REMEDIAL ACTION TAKEN					
Action			Date Works Completed

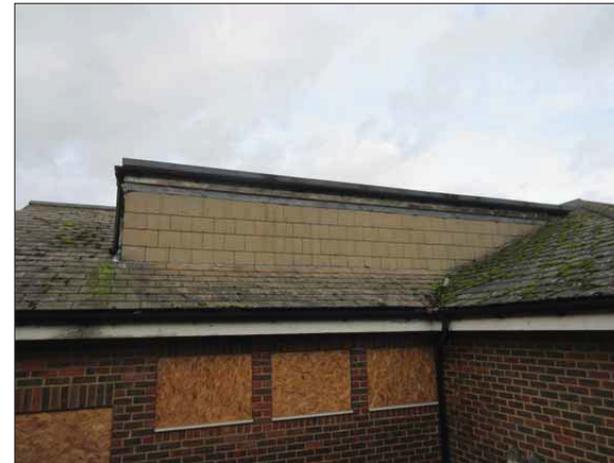
DETAILS					
Finding Code 07122014AGPA042		Item	Roof Tile		
		Recommendations	No action required		
LOCATION					
Internal/External	Floor Level	Location Description		Extent	Identification
External	Ground Floor	Theatres, Loft Mansard Roof		130sq. m	Identified
MATERIAL ASSESSMENT					
Material	Asbestos Type	Condition	Accessibility	Encapsulation	Material Assessment
Cement	No Asbestos Detected	Low Damage: a few scratches or surface marks	Accessible, but in restricted access areas	Enclosed	0
SURVEYORS COMMENTS					
REMEDIAL ACTION TAKEN					
Action			Date Works Completed

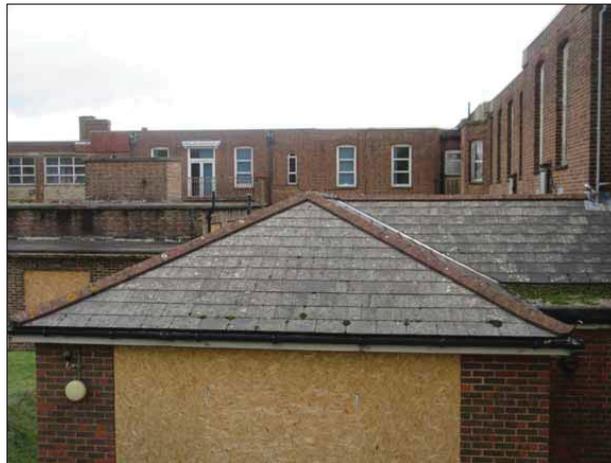
FINDING DETAILS					
Finding Code 07122014AGPA043		Item Roof Tile	Recommendations No action required		
LOCATION					
Internal/External	Floor Level	Location Description	Extent	Identification	
External	Ground Floor	Day Ward Extension, Roof	40sq.m	Identified	
MATERIAL ASSESSMENT					
Material	Asbestos Type	Condition	Accessibility	Encapsulation	Material Assessment
Cement	No Asbestos Detected	Low Damage: a few scratches or surface marks	Accessible, but in restricted access areas	Enclosed	0
SURVEYORS COMMENTS					
REMEDIAL ACTION TAKEN					
Action			Date Works Completed

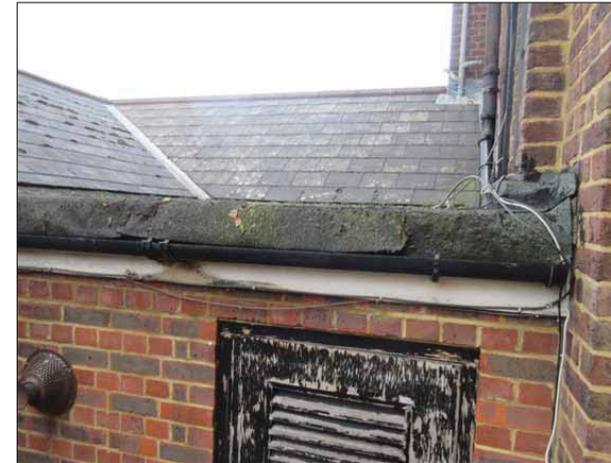
FINDING DETAILS					
Finding Code 07122014AGPA044		Item Roofing Felt	Recommendations No action required		
LOCATION					
Internal/External	Floor Level	Location Description	Extent	Identification	
External	Ground Floor	Day Ward Extension, Roof	6sq.m	Identified	
MATERIAL ASSESSMENT					
Material	Asbestos Type	Condition	Accessibility	Encapsulation	Material Assessment
Bitumen	No Asbestos Detected	Low Damage: a few scratches or surface marks	Accessible, but in restricted access areas	Enclosed	0
SURVEYORS COMMENTS					
REMEDIAL ACTION TAKEN					
Action			Date Works Completed

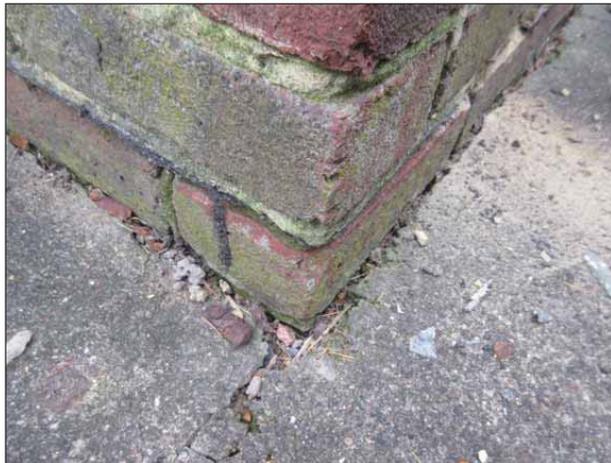
FINDING DETAILS					
Finding Code 07122014AGPA045		Item Damp Proof Course			
		Recommendations No action required			
LOCATION					
Internal/External	Floor Level	Location Description	Extent	Identification	
External	Ground Floor	Day Ward Extension Rooms 00702G032/33	15sq.m	Identified	
MATERIAL ASSESSMENT					
Material	Asbestos Type	Condition	Accessibility	Encapsulation	Material Assessment
Bitumen	No Asbestos Detected	Good Condition: No Visible Damage	Accessible, but in restricted access areas	Enclosed	0
SURVEYORS COMMENTS					
REMEDIAL ACTION TAKEN					
Action			Date Works Completed

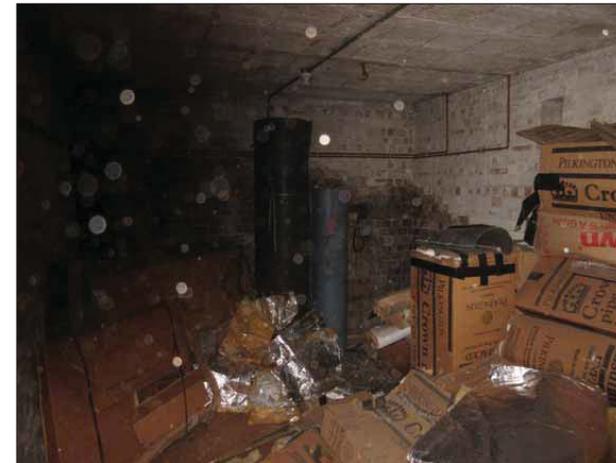
DETAILS					
Finding Code 07122014AGPA046		Item Gasket Material Debris			
		Recommendations Remove Prior to Demolition			
LOCATION					
Internal/External	Floor Level	Location Description	Extent	Identification	
Internal Unoccupied	Basement	Room 00702B005, Floor	15m	Identified	
MATERIAL ASSESSMENT					
Material	Asbestos Type	Condition	Accessibility	Encapsulation	Material Assessment
Gasket	Chrysotile (white)	Medium Damage: Significant breakage of materials	Accessible, but in restricted access areas	Enclosed	6
SURVEYORS COMMENTS					
REMEDIAL ACTION TAKEN					
Action			Date Works Completed

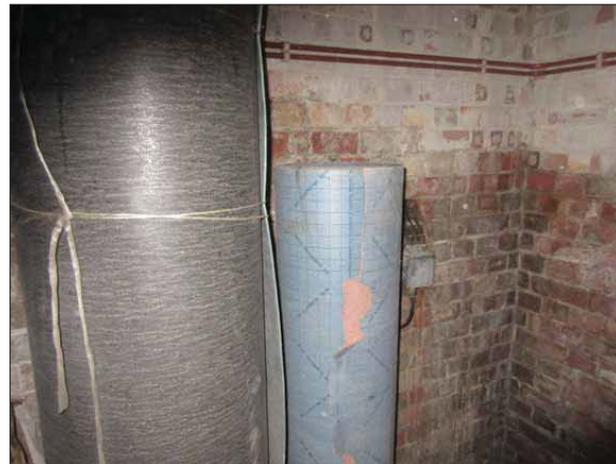
FINDING DETAILS					
Finding Code 07122014AGPA047		Item Gasket Material	Recommendations Remove Prior to Demolition		
LOCATION					
Internal/External Internal Unoccupied	Floor Level Basement	Location Description Room 00702B005, Floor; Roll of Gasket Material	Extent 10m	Identification Identified	
MATERIAL ASSESSMENT					
Material Gasket	Asbestos Type Chrysotile (white)	Condition Low Damage: a few scratches or surface marks	Accessibility Accessible, but in restricted access areas	Encapsulation Enclosed	Material Assessment 5
SURVEYORS COMMENTS					
REMEDIAL ACTION TAKEN					
Action			Date Works Completed

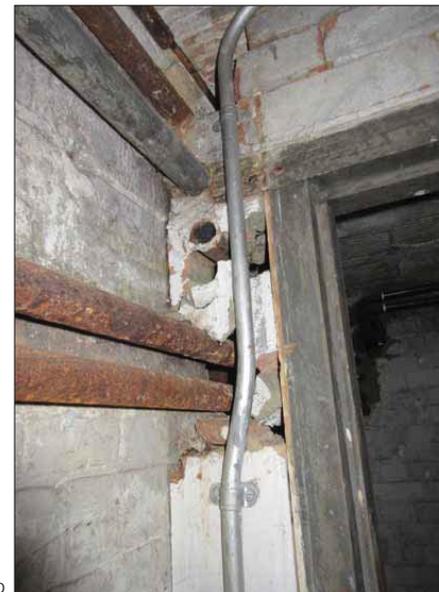
FINDING DETAILS					
Finding Code 07122014AGPA048		Item Debris From Removed Pipe	Recommendations Remove Prior to Demolition		
LOCATION					
Internal/External Internal Unoccupied	Floor Level Basement	Location Description Room 00702B006, Partition Wall	Extent 5sq.cm	Identification Identified	
MATERIAL ASSESSMENT					
Material Thermal Insulation	Asbestos Type Crocidolite, Amosite & Chrysotile	Condition High Damage: Or delamination of material	Accessibility Accessible, but in restricted access areas	Encapsulation Unsealed	Material Assessment 11
SURVEYORS COMMENTS					
REMEDIAL ACTION TAKEN					
Action			Date Works Completed

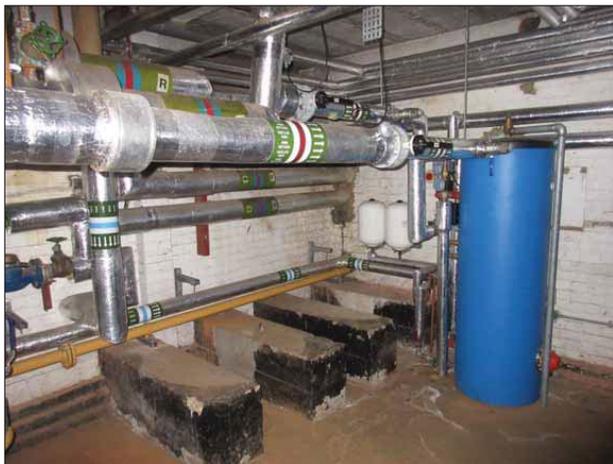
DETAILS					
Finding Code 07122014AGPA049		Item Thermal Insulation Debris			
		Recommendations Remove Prior to Demolition			
LOCATION					
Internal/External Internal Unoccupied	Floor Level Basement	Location Description Room 00702B001, Wall Behind Pipework	Extent 46sq.m	Identification Identified	
MATERIAL ASSESSMENT					
Material Thermal Insulation	Asbestos Type Crocidolite, Amosite & Chrysotile	Condition High Damage: Or delamination of material	Accessibility Accessible, but in restricted access areas	Encapsulation Unsealed	Material Assessment 11
SURVEYORS COMMENTS					
REMEDIAL ACTION TAKEN					
Action			Date Works Completed

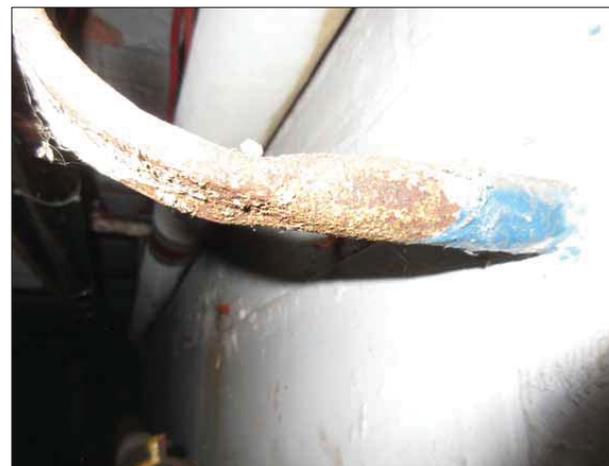
FINDING DETAILS					
Finding Code 07122014AGPA050		Item Thermal Insulation Debris			
		Recommendations Remove Prior to Demolition			
LOCATION					
Internal/External Internal Unoccupied	Floor Level Basement	Location Description Room 00702B001, Redundant Pipe Hangers	Extent 1sq.m	Identification Identified	
MATERIAL ASSESSMENT					
Material Thermal Insulation	Asbestos Type Crocidolite, Amosite & Chrysotile	Condition High Damage: Or delamination of material	Accessibility Accessible, but in restricted access areas	Encapsulation Unsealed	Material Assessment 11
SURVEYORS COMMENTS					
REMEDIAL ACTION TAKEN					
Action			Date Works Completed

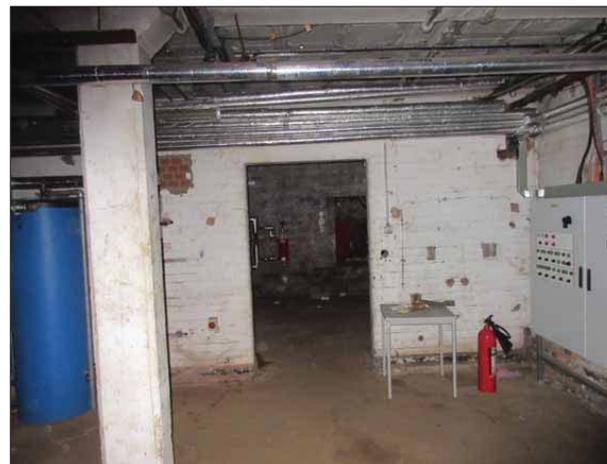
FINDING DETAILS					
Finding Code 07122014AGPA052		Item Thermal Insulation Debris			
		Recommendations Remove Prior to Demolition			
LOCATION					
Internal/External	Floor Level	Location Description	Extent	Identification	
Internal Unoccupied	Basement	Room 00702B001, Walls	46sq.m	Identified	
MATERIAL ASSESSMENT					
Material	Asbestos Type	Condition	Accessibility	Encapsulation	Material Assessment
Thermal Insulation	Amosite & Chrysotile	High Damage: Or delamination of material	Accessible, but in restricted access areas	Unsealed	10
SURVEYORS COMMENTS					
REMEDIAL ACTION TAKEN					
Action			Date Works Completed

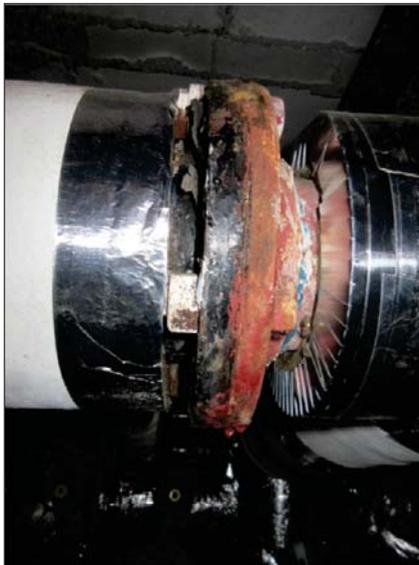
DETAILS					
Finding Code 07122014AGPA053		Item Gasket	Recommendations Remove Prior to Demolition		
LOCATION					
Internal/External Internal Unoccupied	Floor Level Basement	Location Description Room 00702B001, Heating Pipe Return, Flanges	Extent 1sq.m	Identification Identified	
MATERIAL ASSESSMENT					
Material Gasket	Asbestos Type No Asbestos Detected	Condition Low Damage: a few scratches or surface marks	Accessibility Accessible, but in restricted access areas	Encapsulation Unsealed	Material Assessment 0
SURVEYORS COMMENTS					
REMEDIAL ACTION TAKEN					
Action			Date Works Completed

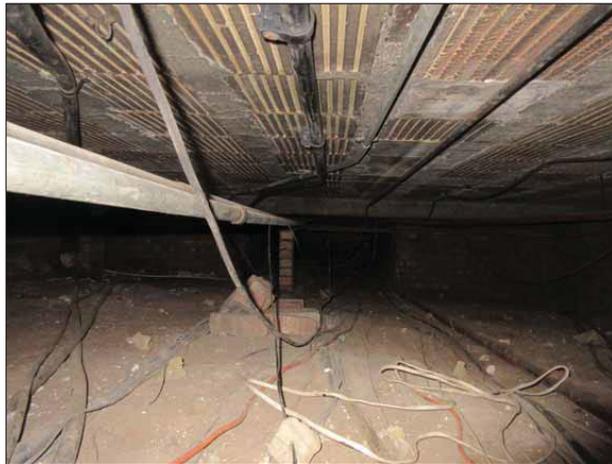
FINDING DETAILS					
Finding Code 07122014AGPA055		Item Debris on Floor to Entrance only	Recommendations Remove Prior to Demolition		
LOCATION					
Internal/External Internal Unoccupied	Floor Level Basement	Location Description Main Service Duct , Undercroft to X-Ray Dept	Extent 1sq.m	Identification Strongly Presumed	
MATERIAL ASSESSMENT					
Material Thermal Insulation	Asbestos Type Crocidolite, Amosite & Chrysotile	Condition High Damage: Or delamination of material	Accessibility Accessible, but in restricted access areas	Encapsulation Enclosed	Material Assessment 10
SURVEYORS COMMENTS					
REMEDIAL ACTION TAKEN					
Action			Date Works Completed

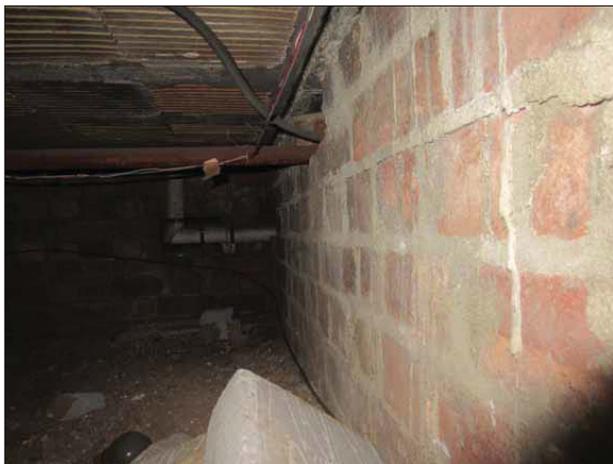
FINDING DETAILS					
Finding Code 07122014AGPA061		Item Thermal Insulation to Pipework	Recommendations Remove Prior to Demolition		
LOCATION					
Internal/External	Floor Level	Location Description	Extent	Identification	
Internal Unoccupied	Basement	Main Service Duct Running From Boiler Room towards Cheviot House Undercroft Below 00702GC002 Pipework	1.5m	Strongly Presumed	
MATERIAL ASSESSMENT					
Material	Asbestos Type	Condition	Accessibility	Encapsulation	Material Assessment
Thermal Insulation	Crocidolite, Amosite & Chrysotile	High Damage: Or delamination of material	Accessible, but in restricted access areas	Unsealed	11
SURVEYORS COMMENTS					
REMEDIAL ACTION TAKEN					
Action			Date Works Completed

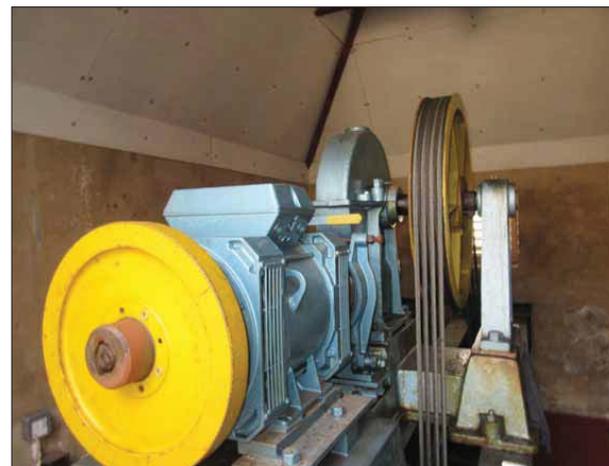
FINDING DETAILS					
Finding Code 07122014AGPA062		Item Brake Shoes	Recommendations Remove Prior to Demolition		
LOCATION					
Internal/External	Floor Level	Location Description	Extent	Identification	
Internal Unoccupied	Roof	First Floor Roof, Lift Motor Room, Lift Motor	2no.	Strongly Presumed	
MATERIAL ASSESSMENT					
Material	Asbestos Type	Condition	Accessibility	Encapsulation	Material Assessment
Bitumen	Chrysotile (white)	Low Damage: a few scratches or surface marks	Accessible, but in restricted access areas	Enclosed	4
SURVEYORS COMMENTS					
REMEDIAL ACTION TAKEN					
Action			Date Works Completed

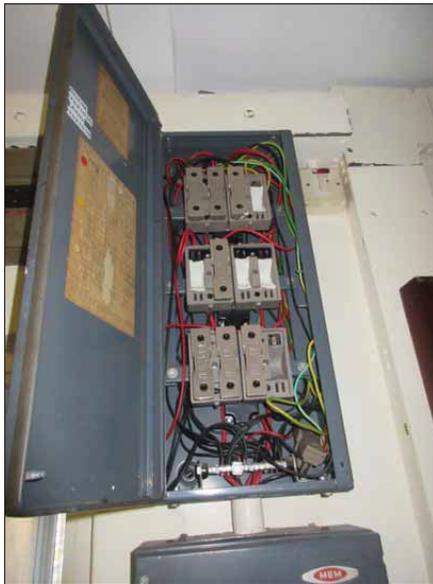
FINDING DETAILS					
Finding Code 07122014AGPA063		Item Flash Guards			
		Recommendations Remove Prior to Demolition			
LOCATION					
Internal/External Internal Unoccupied	Floor Level First Floor	Location Description Corridor 007021C04, Wall Mounted High Level Fuse Board	Extent 12no.	Identification Strongly Presumed	
MATERIAL ASSESSMENT					
Material Rope	Asbestos Type Chrysotile (white)	Condition Low Damage: a few scratches or surface marks	Accessibility Accessible, but in restricted access areas	Encapsulation Enclosed	Material Assessment 5
SURVEYORS COMMENTS					
REMEDIAL ACTION TAKEN					
Action			Date Works Completed

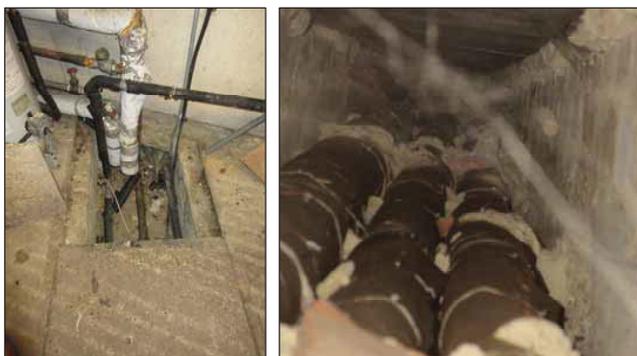
3.1.2 There is an offshoot subterranean service duct which runs from the Main Building externally below concrete slabs and into the Physiotherapy boiler room. The duct then continues into the Physiotherapy toilet room 00703G001 through in a straight line to rooms 00703G017/G018/G020. There are three pipes lagged in asbestos thermal insulation within this duct.

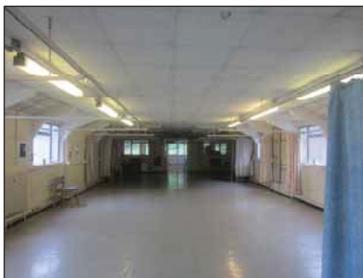
3.1.4 The suspended ceiling has an asbestos insulation board (AIB) upstand panel, either side of the ceiling structure.

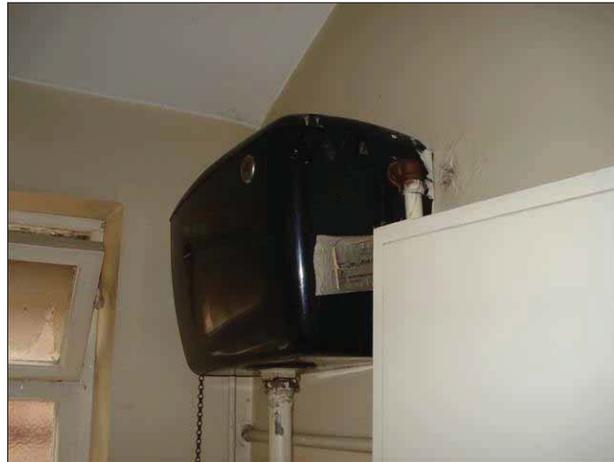
FINDING DETAILS					
Finding Code 20021999AGRJ001		Item Toilet Cistern			
		Recommendations Remove Prior to Demolition			
LOCATION					
Internal/External	Floor Level	Location Description	Extent	Identification	
Internal Unoccupied	Ground Floor	Room 00703G001, Toilet, Right Hand Side Cubicle	1no.	Identified	
MATERIAL ASSESSMENT					
Material	Asbestos Type	Condition	Accessibility	Encapsulation	Material Assessment
Reinforced Plastic/Resin	Amosite (brown)	Good Condition: No Visible Damage	Accessible, but in restricted access areas	Enclosed	4
SURVEYORS COMMENTS					
REMEDIAL ACTION TAKEN					
Action			Date Works Completed

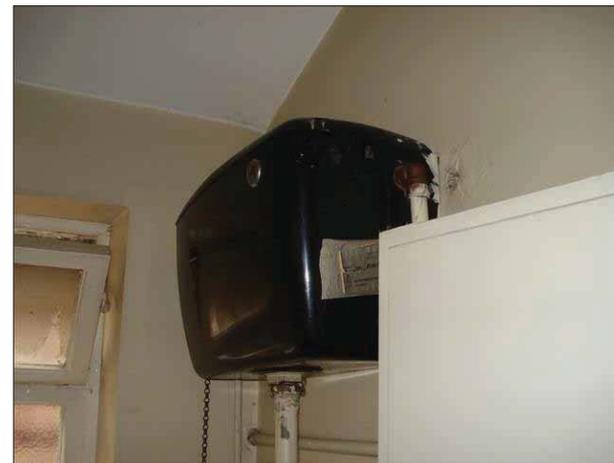
FINDING DETAILS					
Finding Code 20021999AGRJ002		Item Toilet Cistern			
		Recommendations Remove Prior to Demolition			
LOCATION					
Internal/External	Floor Level	Location Description	Extent	Identification	
Internal Unoccupied	Ground Floor	Room 00703G001, Toilet, Left Hand Side Cubicle	1no.	Identified	
MATERIAL ASSESSMENT					
Material	Asbestos Type	Condition	Accessibility	Encapsulation	Material Assessment
Reinforced Plastic/Resin	Amosite (brown)	Good Condition: No Visible Damage	Accessible, but in restricted access areas	Enclosed	4
SURVEYORS COMMENTS					
REMEDIAL ACTION TAKEN					
Action			Date Works Completed

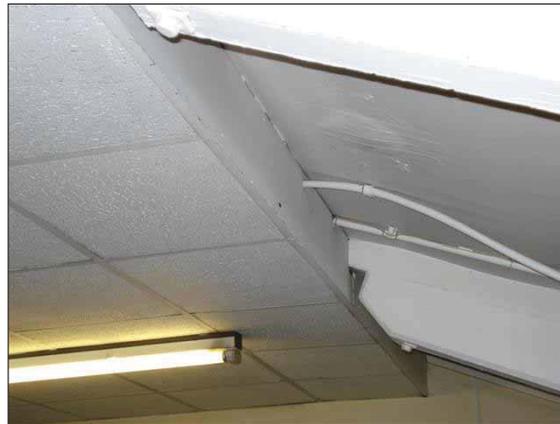
FINDING DETAILS					
Finding Code 20021999AGRJ003		Item Suspended Ceiling Fascia, Vertical Upstand Panels	Recommendations Remove Prior to Demolition		
LOCATION					
Internal/External	Floor Level	Location Description	Extent	Identification	
Internal Unoccupied	Ground Floor	Room 00703G016, West Side of Room, Ceiling (11m x 0.3m)	3.3sq.m	Identified	
MATERIAL ASSESSMENT					
Material	Asbestos Type	Condition	Accessibility	Encapsulation	Material Assessment
Insulating Board	Amosite (brown)	Good Condition: No Visible Damage	Accessible, but in restricted access areas	Enclosed	5
SURVEYORS COMMENTS					
If access is required above the suspended ceiling, it is recommended that access is only made in the middle section of the ceiling and not at the edges.					
REMEDIAL ACTION TAKEN					
Action			Date Works Completed

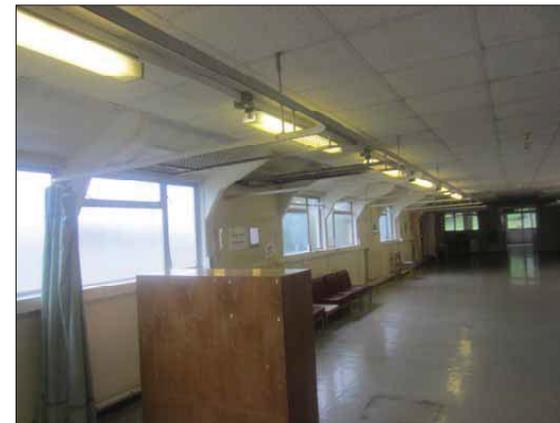
FINDING DETAILS					
Finding Code 20021999AGRJ004		Item Suspended Ceiling Fascia, Vertical Upstand Panels	Recommendations Remove Prior to Demolition		
LOCATION					
Internal/External	Floor Level	Location Description	Extent	Identification	
Internal Unoccupied	Ground Floor	Room 00703G016, East Side of Room, Ceiling (21m x 0.3m)	6.3sq.m	Identified	
MATERIAL ASSESSMENT					
Material	Asbestos Type	Condition	Accessibility	Encapsulation	Material Assessment
Insulating Board	Amosite (brown)	Good Condition: No Visible Damage	Accessible, but in restricted access areas	Enclosed	5
SURVEYORS COMMENTS					
If access is required above the suspended ceiling, it is recommended that access is only made in the middle section of the ceiling and not at the edges.					
REMEDIAL ACTION TAKEN					
Action			Date Works Completed
