## Appendix

<b>Name</b>	<b>Appendix No.</b>
Ready to Dig Searches and Responses	A
Arboricultural	B
Topographical Survey	C
Decontamination Survey	D
Habitat & Bat Survey	E
Asbestos	F

REFERENCE: 34638/PS  
ROUTE: Cotswold Road, Sutton  
OSGR: 525954,162355  
POSTCODE: SM2 5NF

**Ready to Dig – Utility Search Service**

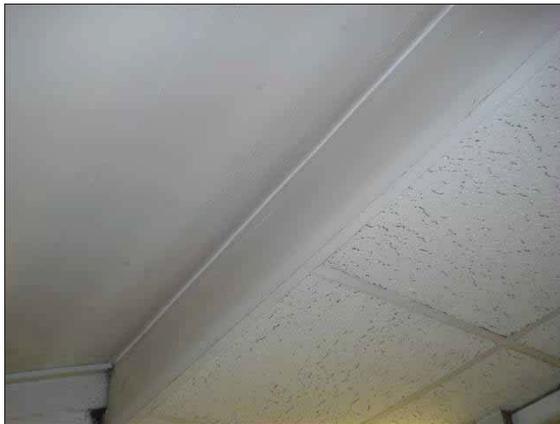
FINDING DETAILS					
Finding Code 20021999AGRJ005		Item	Suspended Ceiling Fascia, Vertical Upstand Panels		
		Recommendations	Remove Prior to Demolition		
LOCATION					
Internal/External	Floor Level	Location Description		Extent	Identification
Internal Unoccupied	Ground Floor	Room 00703G013, West Side of Room, Ceiling (3m x 0.3m)		0.9sq.m	Identified
MATERIAL ASSESSMENT					
Material	Asbestos Type	Condition	Accessibility	Encapsulation	Material Assessment
Insulating Board	Amosite (brown)	Good Condition: No Visible Damage	Accessible, but in restricted access areas	Enclosed	5
SURVEYORS COMMENTS					
If access is required above the suspended ceiling, it is recommended that access is only made in the middle section of the ceiling and not at the edges.					
REMEDIAL ACTION TAKEN					
Action			Date Works Completed

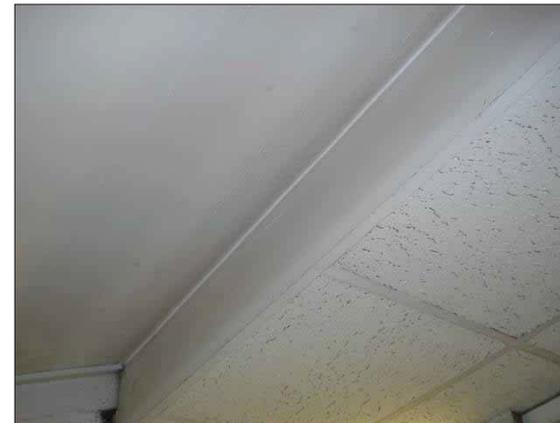
FINDING DETAILS					
Finding Code 20021999AGRJ006		Item	Suspended Ceiling Fascia, Vertical Upstand Panels		
		Recommendations	Remove Prior to Demolition		
LOCATION					
Internal/External	Floor Level	Location Description		Extent	Identification
Internal Unoccupied	Ground Floor	Room 00703G014, West Side of Room, Ceiling (2m x 0.3m)		0.6sq.m	Identified
MATERIAL ASSESSMENT					
Material	Asbestos Type	Condition	Accessibility	Encapsulation	Material Assessment
Insulating Board	Amosite (brown)	Good Condition: No Visible Damage	Accessible, but in restricted access areas	Enclosed	5
SURVEYORS COMMENTS					
If access is required above the suspended ceiling, it is recommended that access is only made in the middle section of the ceiling and not at the edges.					
REMEDIAL ACTION TAKEN					
Action			Date Works Completed

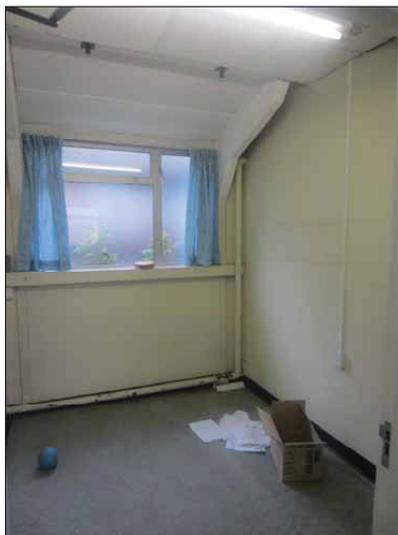
FINDING DETAILS					
Finding Code 20021999AGRJ007		Item	Suspended Ceiling Fascia, Vertical Upstand Panels		
		Recommendations	Remove Prior to Demolition		
LOCATION					
Internal/External	Floor Level	Location Description		Extent	Identification
Internal Unoccupied	Ground Floor	Room 00703G015, West Side of Room, Ceiling (4m x 0.3m)		1.2sq.m	Identified
MATERIAL ASSESSMENT					
Material	Asbestos Type	Condition	Accessibility	Encapsulation	Material Assessment
Insulating Board	Amosite (brown)	Good Condition: No Visible Damage	Accessible, but in restricted access areas	Enclosed	5
SURVEYORS COMMENTS					
If access is required above the suspended ceiling, it is recommended that access is only made in the middle section of the ceiling and not at the edges.					
REMEDIAL ACTION TAKEN					
Action			Date Works Completed

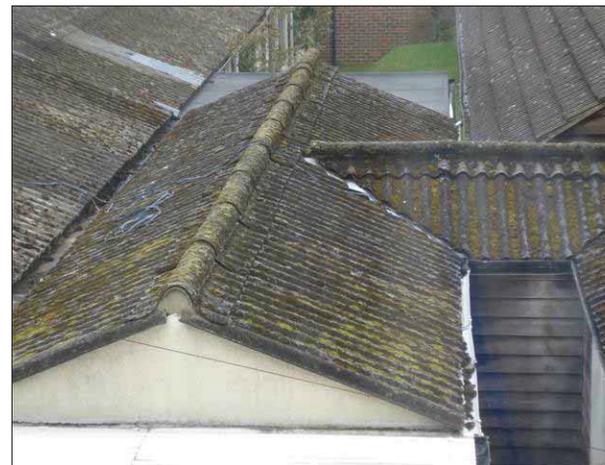
FINDING DETAILS					
Finding Code 20021999AGRJ008		Item	Roofing Sheets		
		Recommendations	Remove Prior to Demolition		
LOCATION					
Internal/External	Floor Level	Location Description		Extent	Identification
External	Ground Floor	Roof to Physiotherapy Department W.C.s		20sq.m	Identified
MATERIAL ASSESSMENT					
Material	Asbestos Type	Condition	Accessibility	Encapsulation	Material Assessment
Cement	Chrysotile (white)	Low Damage: a few scratches or surface marks	Accessible, but in restricted access areas	Unsealed	5
SURVEYORS COMMENTS					
The asbestos cement roof is accessible from the ceiling void and externally.					
REMEDIAL ACTION TAKEN					
Action			Date Works Completed

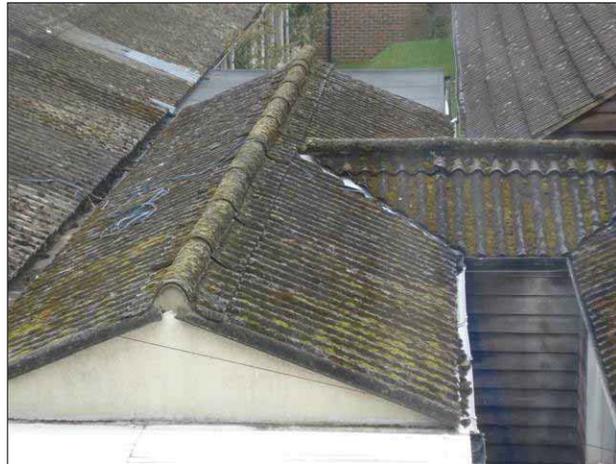
FINDING DETAILS					
Finding Code 20021999AGRJ009		Item Roof Ridge Tile	Recommendations Remove Prior to Demolition		
LOCATION					
Internal/External	Floor Level	Location Description	Extent	Identification	
External	Ground Floor	Roof to Physiotherapy Department W.C.s	5sq.m	Identified	
MATERIAL ASSESSMENT					
Material	Asbestos Type	Condition	Accessibility	Encapsulation	Material Assessment
Cement	Amosite & Chrysotile	Low Damage: a few scratches or surface marks	Accessible, but in restricted access areas	Unsealed	6
SURVEYORS COMMENTS					
The asbestos cement roof is accessible from the ceiling void and externally.					
REMEDIAL ACTION TAKEN					
Action			Date Works Completed

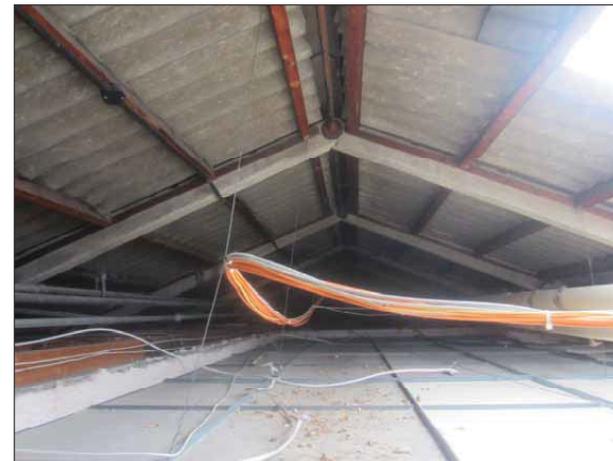
FINDING DETAILS					
Finding Code 20021999AGRJ010		Item Roofing Sheets	Recommendations Remove Prior to Demolition		
LOCATION					
Internal/External	Floor Level	Location Description	Extent	Identification	
External	Ground Floor	Roof to Physiotherapy Department	28sq.m	Identified	
MATERIAL ASSESSMENT					
Material	Asbestos Type	Condition	Accessibility	Encapsulation	Material Assessment
Cement	Chrysotile (white)	Low Damage: a few scratches or surface marks	Accessible, but in restricted access areas	Unsealed	5
SURVEYORS COMMENTS					
The asbestos cement roof is accessible from the ceiling void and externally.					
REMEDIAL ACTION TAKEN					
Action			Date Works Completed

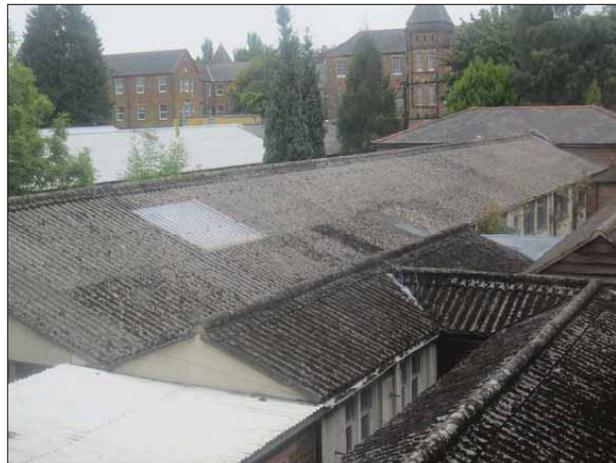
FINDING DETAILS					
Finding Code 20021999AGRJ011		Item Roof Ridge Tile			
		Recommendations Remove Prior to Demolition			
LOCATION					
Internal/External	Floor Level	Location Description	Extent	Identification	
External	Ground Floor	Roof to Physiotherapy Department	10sq.m	Identified	
MATERIAL ASSESSMENT					
Material	Asbestos Type	Condition	Accessibility	Encapsulation	Material Assessment
Cement	Amosite & Chrysotile	Low Damage: a few scratches or surface marks	Accessible, but in restricted access areas	Unsealed	6
SURVEYORS COMMENTS					
The asbestos cement roof is accessible from the ceiling void and externally.					
REMEDIAL ACTION TAKEN					
Action			Date Works Completed

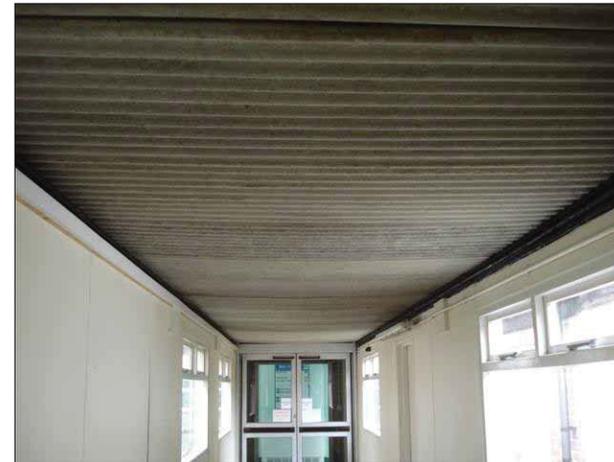
FINDING DETAILS					
Finding Code 20021999AGRJ012		Item Roofing Sheets			
		Recommendations Remove Prior to Demolition			
LOCATION					
Internal/External	Floor Level	Location Description	Extent	Identification	
External	Ground Floor	Roof to Physiotherapy Department Walkway	10sq.m	Identified	
MATERIAL ASSESSMENT					
Material	Asbestos Type	Condition	Accessibility	Encapsulation	Material Assessment
Cement	Chrysotile (white)	Low Damage: a few scratches or surface marks	Accessible, but in restricted access areas	Unsealed	5
SURVEYORS COMMENTS					
The asbestos cement roof is accessible from the ceiling void and externally.					
REMEDIAL ACTION TAKEN					
Action			Date Works Completed

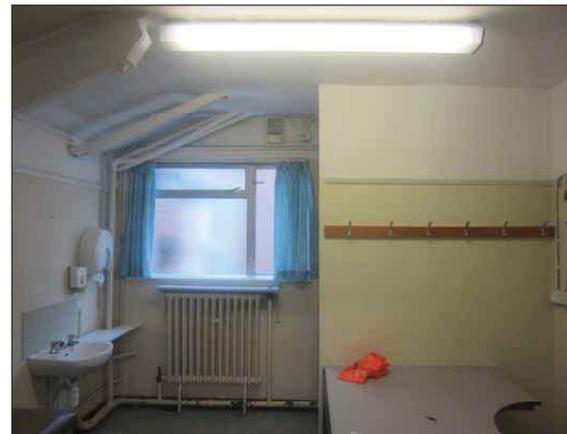
FINDING DETAILS					
Finding Code 23092013AGPA001		Item Debris	Recommendations No action required		
LOCATION					
Internal/External	Floor Level	Location Description	Extent	Identification	
Internal Unoccupied	Ground Floor	Room 00703G002, Wall Picture Rail	4m	Identified	
MATERIAL ASSESSMENT					
Material	Asbestos Type	Condition	Accessibility	Encapsulation	Material Assessment
Insulating Board	No Asbestos Detected	High Damage: Or delamination of material	Accessible, but in restricted access areas	Unsealed	0
SURVEYORS COMMENTS					
REMEDIAL ACTION TAKEN					
Action			Date Works Completed

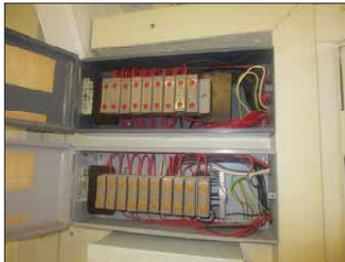
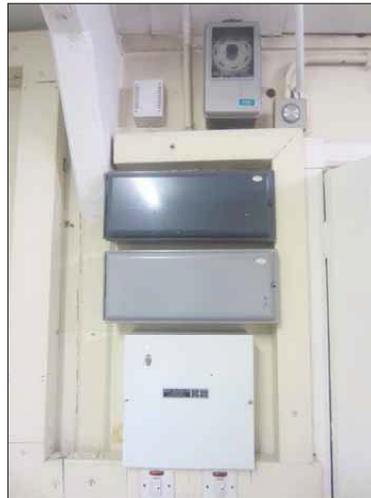
FINDING DETAILS					
Finding Code 23092013AGPA002		Item Flash Guards			
		Recommendations Remove Prior to Demolition			
LOCATION					
Internal/External	Floor Level	Location Description	Extent	Identification	
Internal Unoccupied	Ground Floor	Room 00703G016, Wall Adjacent Room 00703G018, Fuse Board	19no.	Strongly Presumed	
MATERIAL ASSESSMENT					
Material	Asbestos Type	Condition	Accessibility	Encapsulation	Material Assessment
Woven Textile	Chrysotile (white)	Good Condition: No Visible Damage	Accessible, but in restricted access areas	Enclosed	4
SURVEYORS COMMENTS					
The asbestos flash guard's are located within the fuse carriers to both fuse boards					
REMEDIAL ACTION TAKEN					
Action			Date Works Completed

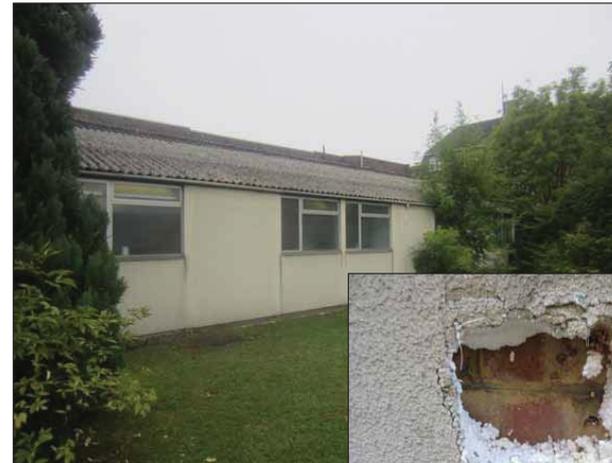
FINDING DETAILS					
Finding Code 08122014AGPA001		Item Textured Finish			
		Recommendations No action required			
LOCATION					
Internal/External	Floor Level	Location Description	Extent	Identification	
External	Ground Floor	Entire Original Building, Cladding	Approx 300sq.m	Identified	
MATERIAL ASSESSMENT					
Material	Asbestos Type	Condition	Accessibility	Encapsulation	Material Assessment
Textured Coating	No Asbestos Detected	Medium Damage: Significant breakage of materials	Accessible, but in restricted access areas	Enclosed	0
SURVEYORS COMMENTS					
REMEDIAL ACTION TAKEN					
Action			Date Works Completed

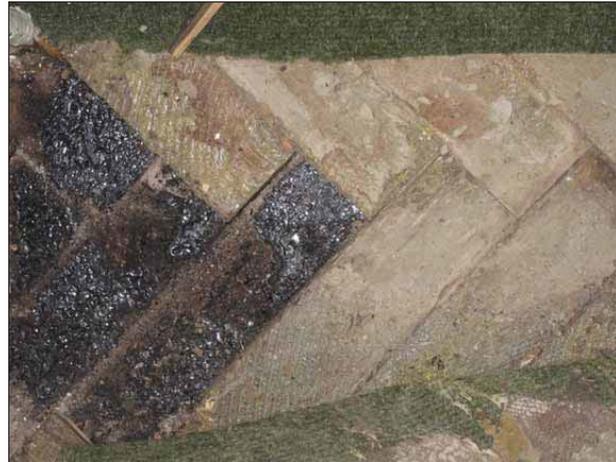
FINDING DETAILS					
Finding Code 08122014AGPA004		Item Bitumen Adhesive	Recommendations No action required		
LOCATION					
Internal/External	Floor Level	Location Description	Extent	Identification	
Internal Unoccupied	Ground Floor	Room 00703G003, Parquet Flooring	18sq.m	Identified	
MATERIAL ASSESSMENT					
Material	Asbestos Type	Condition	Accessibility	Encapsulation	Material Assessment
Bitumen	No Asbestos Detected	Good Condition: No Visible Damage	Accessible, but in restricted access areas	Enclosed	0
SURVEYORS COMMENTS					
REMEDIAL ACTION TAKEN					
Action			Date Works Completed

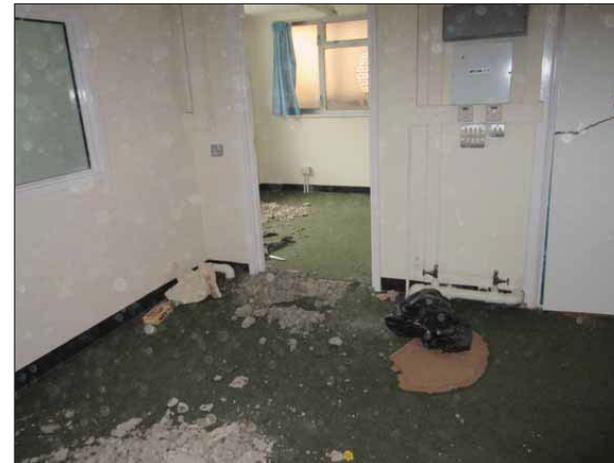
FINDING DETAILS					
Finding Code 08122014AGPA005		Item Bitumen Adhesive	Recommendations No action required		
LOCATION					
Internal/External	Floor Level	Location Description	Extent	Identification	
Internal Unoccupied	Ground Floor	Room 00703G016, Parquet Flooring	30sq.m	Identified	
MATERIAL ASSESSMENT					
Material	Asbestos Type	Condition	Accessibility	Encapsulation	Material Assessment
Bitumen	No Asbestos Detected	Good Condition: No Visible Damage	Accessible, but in restricted access areas	Enclosed	0
SURVEYORS COMMENTS					
REMEDIAL ACTION TAKEN					
Action			Date Works Completed

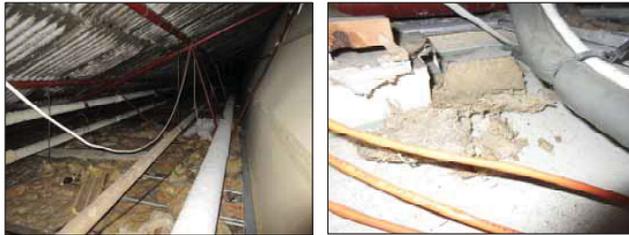
3.1.2 The loft spaces area located directly above the original hardboard ceiling panels. The heating pipes running around the lofts are lagged in asbestos thermal insulation. Some sections of the insulation has been damaged over the years and has subsequently contaminated the machine-made mineral fibre (MMM)F ceiling insulation.

- 4.1.4 **Asbestos Thermal Insulation** products including debris and residue items must be removed by a contractor licensed to work with asbestos. The works will require a statutory 14-day notification to the Enforcing Authority. Full asbestos removal enclosures will be required for all of the asbestos thermal insulation incidents detailed within this report. A 4-stage certificate of reoccupation will be required for each enclosure and additional [minimal] personal, background and leak air testing is strongly recommended. Continued air monitoring throughout the works will not be required if the building remains unoccupied during the asbestos removal works.

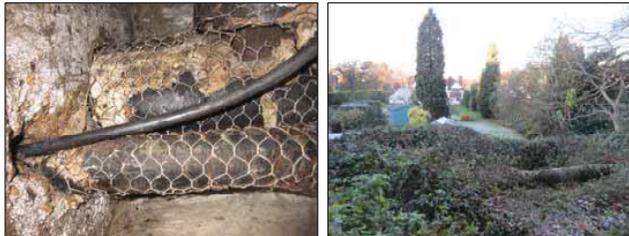
3.1.3 External to this department is a concrete service duct below the turfed area containing two pipes lagged in asbestos thermal insulation. It runs from the covered walkway, along the building, turns left and continues below the grass in front of C Block and becomes surface mounted to the rear of the private housing. The pipes continues above ground running parallel to Malvern Ward in dense undergrowth and turns right into the Old Boiler Room around the redundant tank.

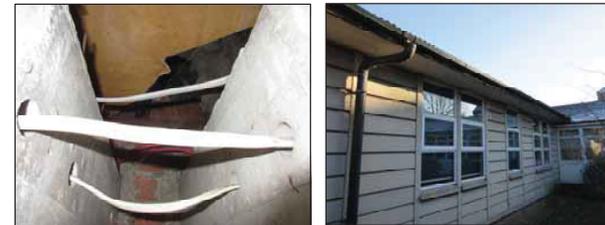
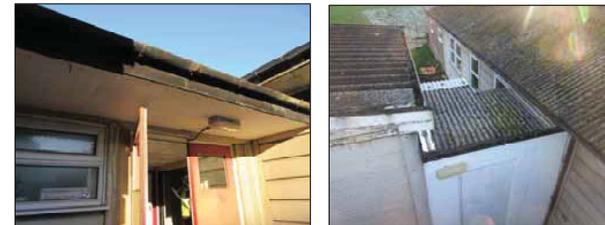
3.1.8 Both link corridors (flat roof areas) have asbestos cement ceilings located above the expanded metal and plaster ceiling. Due to the continued occupation of this department it was not possible to determine if these ceiling panels run throughout the flat roof areas or if they are a continuation of the external soffits. Further investigation will be required once the building has been vacated.

3.1.9 The external soffit boards are cement and a number of door canopies are lined with asbestos cement sheets.

- 4.1.6 **Asbestos Cement** products can be removed under local restrictive conditions including introducing a respirator zone. These cement items will not require notification to the Enforcing Authority. An independent visual inspection will be required on completion of the removal. We strongly recommend that personnel and reassurance air testing is undertaken during and on completion of these works. These works will require the production of risk assessments and method statements and operatives will require appropriate asbestos training. If it is likely that the asbestos cement roof sheets will become damaged during the removal process and release lots of asbestos fibres (due to their age), the works will require notification under the Notifiable Non-Licensed Work regime using the form>NNLWASB1.

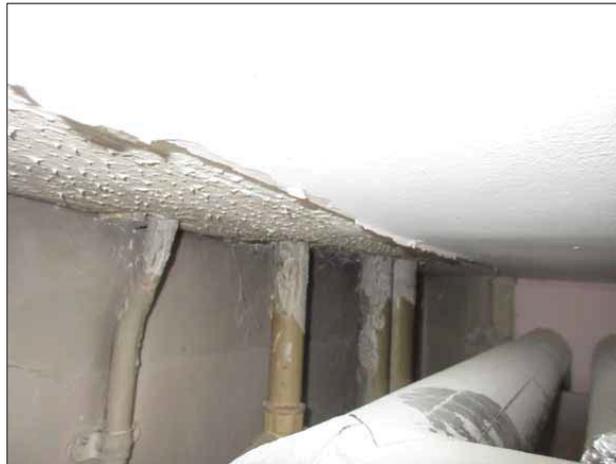
FINDING DETAILS					
Finding Code 06122014AGPA001		Item Textured Coating	Recommendations Remove Prior to Demolition		
LOCATION					
Internal/External Internal Occupied	Floor Level Ground Floor	Location Description Room 00705GC03, Ceiling	Extent 12sq.m	Identification Identified	
MATERIAL ASSESSMENT					
Material Textured Coating	Asbestos Type Chrysotile (white)	Condition Medium Damage: Significant breakage of materials	Accessibility Accessible, but above head height	Encapsulation Enclosed	Material Assessment 5
SURVEYORS COMMENTS					
REMEDIAL ACTION TAKEN					
Action			Date Works Completed

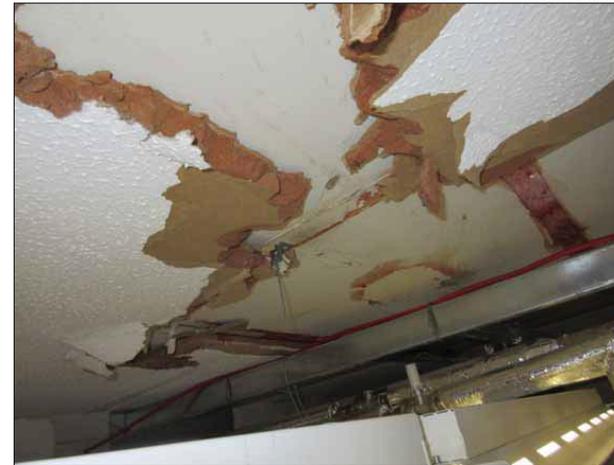
FINDING DETAILS					
Finding Code 06122014AGPA002		Item Textured Coating	Recommendations Remove Prior to Demolition		
LOCATION					
Internal/External Internal Occupied	Floor Level Ground Floor	Location Description Room 00705G063, Ceiling	Extent 6sq.m	Identification Identified	
MATERIAL ASSESSMENT					
Material Textured Coating	Asbestos Type Chrysotile (white)	Condition Medium Damage: Significant breakage of materials	Accessibility Accessible, but above head height	Encapsulation Enclosed	Material Assessment 5
SURVEYORS COMMENTS					
REMEDIAL ACTION TAKEN					
Action			Date Works Completed

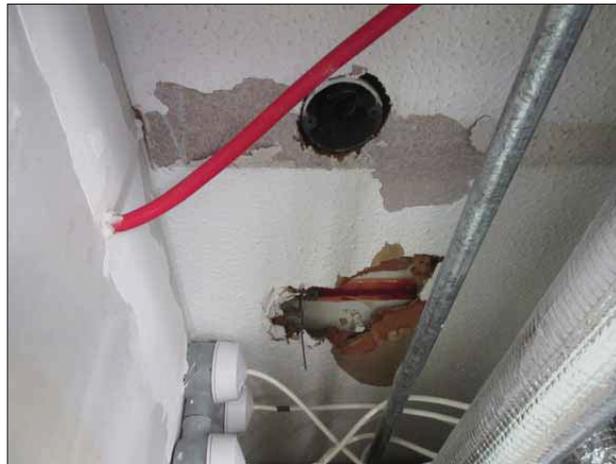
FINDING DETAILS					
Finding Code 06122014AGPA003		Item	Textured Coating		
		Recommendations	Remove Prior to Demolition		
LOCATION					
Internal/External	Floor Level	Location Description		Extent	Identification
Internal Occupied	Ground Floor	Room 00705G064, Ceiling		6sq.m	Identified
MATERIAL ASSESSMENT					
Material	Asbestos Type	Condition	Accessibility	Encapsulation	Material Assessment
Textured Coating	Chrysotile (white)	Medium Damage: Significant breakage of materials	Accessible, but above head height	Enclosed	5
SURVEYORS COMMENTS					
REMEDIAL ACTION TAKEN					
Action			Date Works Completed

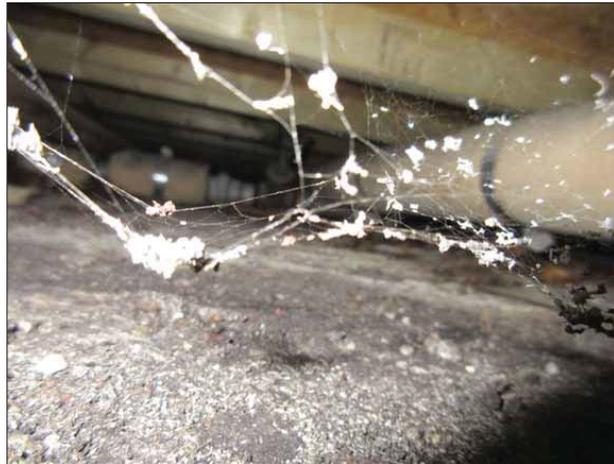
FINDING DETAILS					
Finding Code 06122014AGPA005		Item Thermal Insulation to Pipework	Recommendations Remove Prior to Demolition		
LOCATION					
Internal/External	Floor Level	Location Description	Extent	Identification	
Internal Occupied	Ground Floor	Room 00705G090, Ceiling Void, Horizontal Pipe	3m	Identified	
MATERIAL ASSESSMENT					
Material	Asbestos Type	Condition	Accessibility	Encapsulation	Material Assessment
Thermal Insulation	Amosite & Chrysotile	Low Damage: a few scratches or surface marks	Accessible, but above head height	Enclosed	7
SURVEYORS COMMENTS					
REMEDIAL ACTION TAKEN					
Action			Date Works Completed

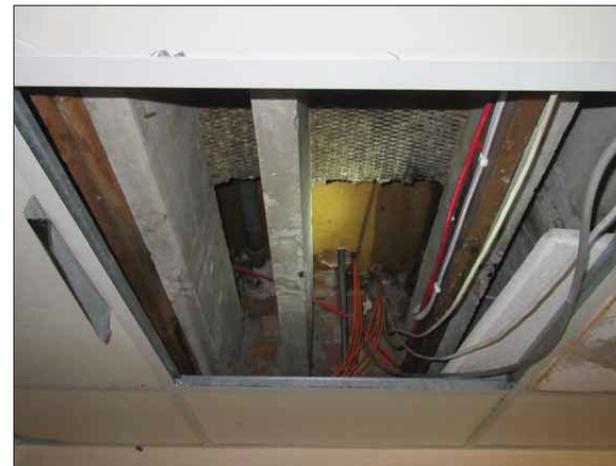
FINDING DETAILS					
Finding Code 06122014AGPA006		Item Ceiling Panel	Recommendations Remove Prior to Demolition		
LOCATION					
Internal/External	Floor Level	Location Description	Extent	Identification	
Internal Occupied	Ground Floor	Room 00705G090, Ceiling Void, above suspended ceiling	1sq.m	Identified	
MATERIAL ASSESSMENT					
Material	Asbestos Type	Condition	Accessibility	Encapsulation	Material Assessment
Cement	Chrysotile (white)	Medium Damage: Significant breakage of materials	Accessible, but above head height	Enclosed	5
SURVEYORS COMMENTS					
REMEDIAL ACTION TAKEN					
Action			Date Works Completed

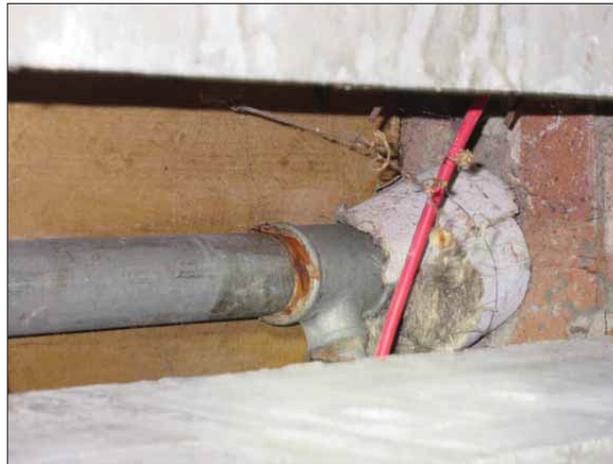
Representative Photo

FINDING DETAILS					
Finding Code 06122014AGPA007		Item	Thermal Insulation to Pipework		
		Recommendations	Remove Prior to Demolition		
LOCATION					
Internal/External	Floor Level	Location Description		Extent	Identification
Internal Occupied	Ground Floor	Room 00705G092, Ceiling Void, Horizontal Pipe		5m	Strongly Presumed
MATERIAL ASSESSMENT					
Material	Asbestos Type	Condition	Accessibility	Encapsulation	Material Assessment
Thermal Insulation	Amosite & Chrysotile	Low Damage: a few scratches or surface marks	Accessible, but above head height	Enclosed	7
SURVEYORS COMMENTS					
REMEDIAL ACTION TAKEN					
Action			Date Works Completed

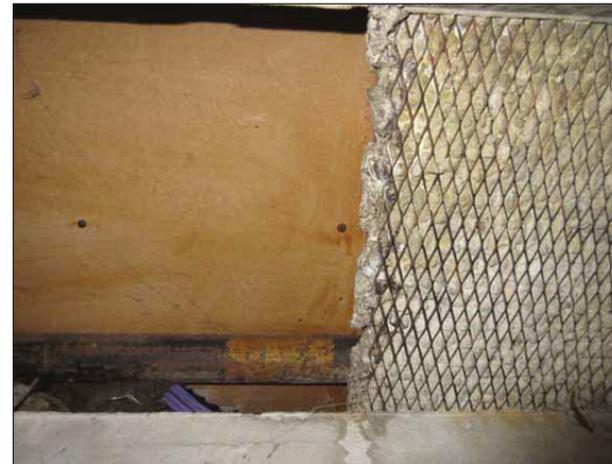
Representative Photo

FINDING DETAILS					
Finding Code 06122014AGPA008		Item	Ceiling Panel		
		Recommendations	Remove Prior to Demolition		
LOCATION					
Internal/External	Floor Level	Location Description		Extent	Identification
Internal Occupied	Ground Floor	Room 00705G092, Ceiling Void, above suspended ceiling		6sq.m	Strongly Presumed
MATERIAL ASSESSMENT					
Material	Asbestos Type	Condition	Accessibility	Encapsulation	Material Assessment
Cement	Chrysotile (white)	Medium Damage: Significant breakage of materials	Accessible, but above head height	Enclosed	5
SURVEYORS COMMENTS					
REMEDIAL ACTION TAKEN					
Action			Date Works Completed

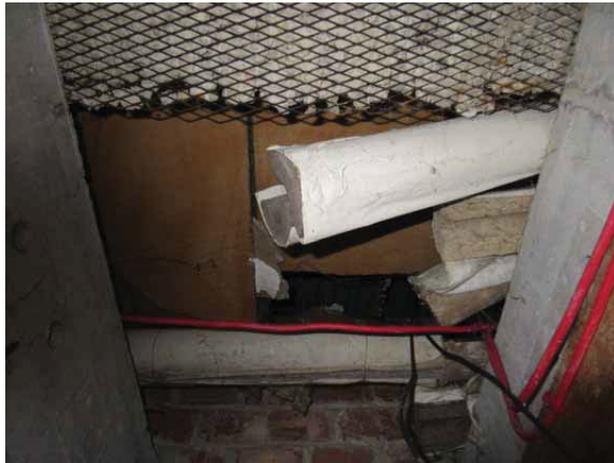
Representative Photo

FINDING DETAILS					
Finding Code 06122014AGPA009		Item	Thermal Insulation to Pipework		
		Recommendations	Remove Prior to Demolition		
LOCATION					
Internal/External	Floor Level	Location Description		Extent	Identification
Internal Occupied	Ground Floor	Room 00705G093, Ceiling Void, Horizontal Pipe		5m	Strongly Presumed
MATERIAL ASSESSMENT					
Material	Asbestos Type	Condition	Accessibility	Encapsulation	Material Assessment
Thermal Insulation	Amosite & Chrysotile	Low Damage: a few scratches or surface marks	Accessible, but above head height	Enclosed	7
SURVEYORS COMMENTS					
REMEDIAL ACTION TAKEN					
Action			Date Works Completed

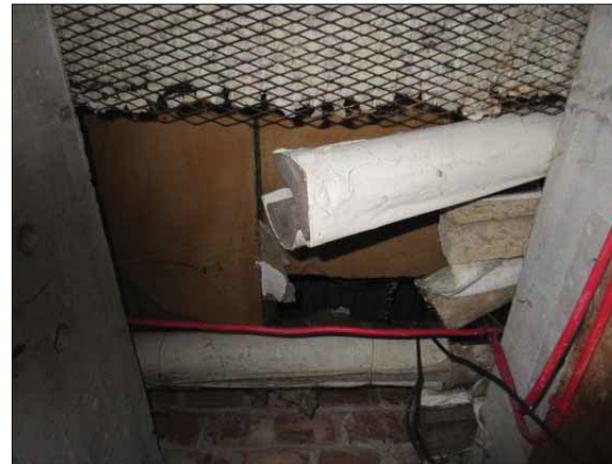
Representative Photo

FINDING DETAILS					
Finding Code 06122014AGPA010		Item	Ceiling Panel		
		Recommendations	Remove Prior to Demolition		
LOCATION					
Internal/External	Floor Level	Location Description		Extent	Identification
Internal Occupied	Ground Floor	Room 00705G093, Ceiling Void, above suspended ceiling		10sq.m	Strongly Presumed
MATERIAL ASSESSMENT					
Material	Asbestos Type	Condition	Accessibility	Encapsulation	Material Assessment
Cement	Chrysotile (white)	Medium Damage: Significant breakage of materials	Accessible, but above head height	Enclosed	5
SURVEYORS COMMENTS					
REMEDIAL ACTION TAKEN					
Action			Date Works Completed

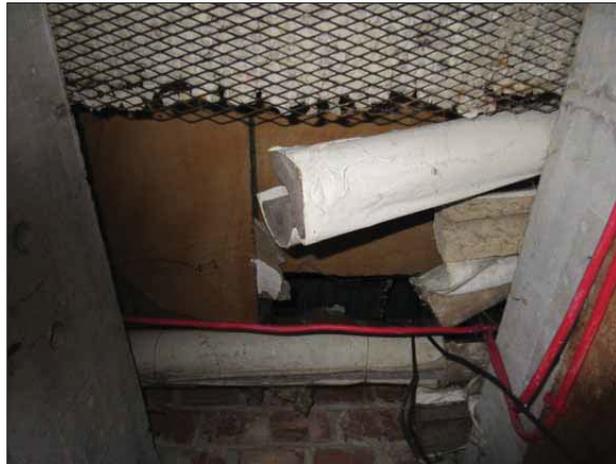
Representative Photo

FINDING DETAILS					
Finding Code 06122014AGPA011		Item	Thermal Insulation to Pipework		
		Recommendations	Remove Prior to Demolition		
LOCATION					
Internal/External	Floor Level	Location Description		Extent	Identification
Internal Occupied	Ground Floor	Room 00705G087, Ceiling Void, Horizontal Pipe		2m	Strongly Presumed
MATERIAL ASSESSMENT					
Material	Asbestos Type	Condition	Accessibility	Encapsulation	Material Assessment
Thermal Insulation	Amosite & Chrysotile	Low Damage: a few scratches or surface marks	Accessible, but above head height	Enclosed	7
SURVEYORS COMMENTS					
REMEDIAL ACTION TAKEN					
Action			Date Works Completed

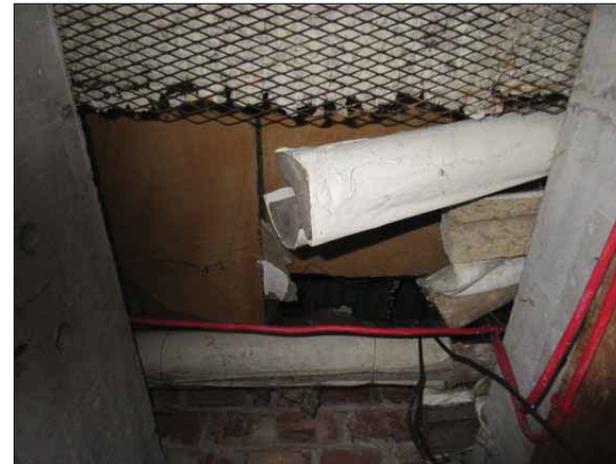
Representative Photo

FINDING DETAILS					
Finding Code 06122014AGPA012		Item	Ceiling Panel		
		Recommendations	Remove Prior to Demolition		
LOCATION					
Internal/External	Floor Level	Location Description		Extent	Identification
Internal Occupied	Ground Floor	Room 00705G087, Ceiling Void, above suspended ceiling		5sq.m	Strongly Presumed
MATERIAL ASSESSMENT					
Material	Asbestos Type	Condition	Accessibility	Encapsulation	Material Assessment
Cement	Chrysotile (white)	Medium Damage: Significant breakage of materials	Accessible, but above head height	Enclosed	5
SURVEYORS COMMENTS					
REMEDIAL ACTION TAKEN					
Action			Date Works Completed

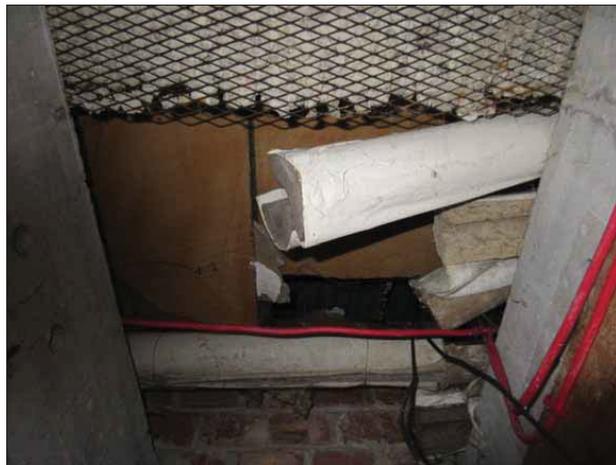
Representative Photo

FINDING DETAILS					
Finding Code 06122014AGPA013		Item	Thermal Insulation to Pipework		
		Recommendations	Remove Prior to Demolition		
LOCATION					
Internal/External	Floor Level	Location Description		Extent	Identification
Internal Occupied	Ground Floor	Room 00705G088, Ceiling Void, Horizontal Pipe		1m	Strongly Presumed
MATERIAL ASSESSMENT					
Material	Asbestos Type	Condition	Accessibility	Encapsulation	Material Assessment
Thermal Insulation	Amosite & Chrysotile	Low Damage: a few scratches or surface marks	Accessible, but above head height	Enclosed	7
SURVEYORS COMMENTS					
REMEDIAL ACTION TAKEN					
Action			Date Works Completed

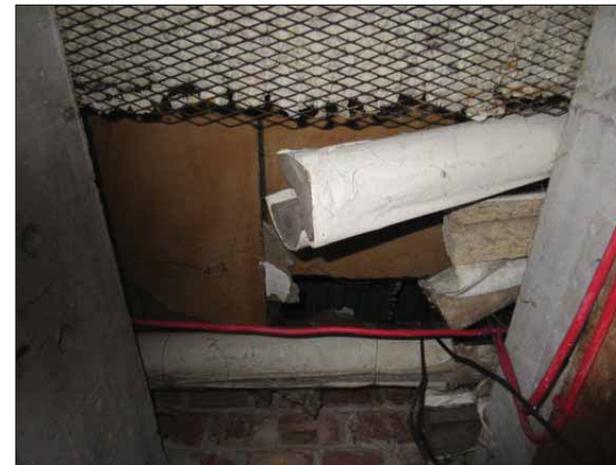
Representative Photo

FINDING DETAILS					
Finding Code 06122014AGPA014		Item	Ceiling Panel		
		Recommendations	Remove Prior to Demolition		
LOCATION					
Internal/External	Floor Level	Location Description		Extent	Identification
Internal Occupied	Ground Floor	Room 00705G088, Ceiling Void, above suspended ceiling		1sq.m	Strongly Presumed
MATERIAL ASSESSMENT					
Material	Asbestos Type	Condition	Accessibility	Encapsulation	Material Assessment
Cement	Chrysotile (white)	Medium Damage: Significant breakage of materials	Accessible, but above head height	Enclosed	5
SURVEYORS COMMENTS					
REMEDIAL ACTION TAKEN					
Action			Date Works Completed

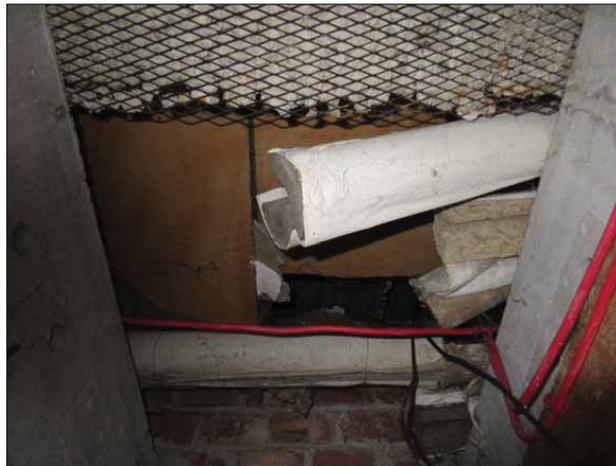
Representative Photo

FINDING DETAILS					
Finding Code 06122014AGPA015		Item Thermal Insulation to Pipework	Recommendations Remove Prior to Demolition		
LOCATION					
Internal/External Internal Occupied	Floor Level Ground Floor	Location Description Room 00705G089, Ceiling Void, Horizontal Pipe	Extent 1m	Identification Strongly Presumed	
MATERIAL ASSESSMENT					
Material Thermal Insulation	Asbestos Type Amosite & Chrysotile	Condition Low Damage: a few scratches or surface marks	Accessibility Accessible, but above head height	Encapsulation Enclosed	Material Assessment 7
SURVEYORS COMMENTS					
REMEDIAL ACTION TAKEN					
Action			Date Works Completed

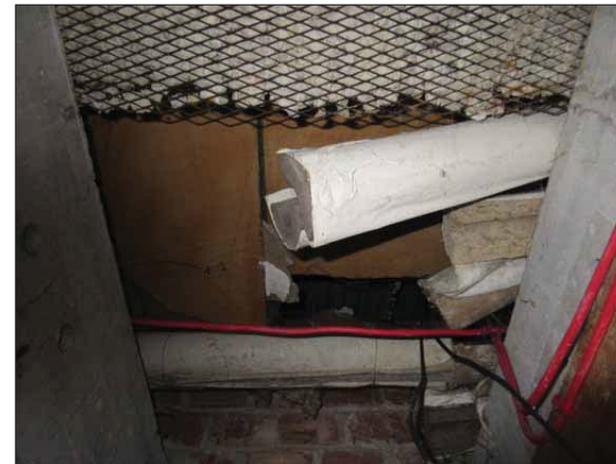
Representative Photo

FINDING DETAILS					
Finding Code 06122014AGPA016		Item Ceiling Panel	Recommendations Remove Prior to Demolition		
LOCATION					
Internal/External Internal Occupied	Floor Level Ground Floor	Location Description Room 00705G089, Ceiling Void, above suspended ceiling	Extent 3sq.m	Identification Strongly Presumed	
MATERIAL ASSESSMENT					
Material Cement	Asbestos Type Chrysotile (white)	Condition Medium Damage: Significant breakage of materials	Accessibility Accessible, but above head height	Encapsulation Enclosed	Material Assessment 5
SURVEYORS COMMENTS					
REMEDIAL ACTION TAKEN					
Action			Date Works Completed

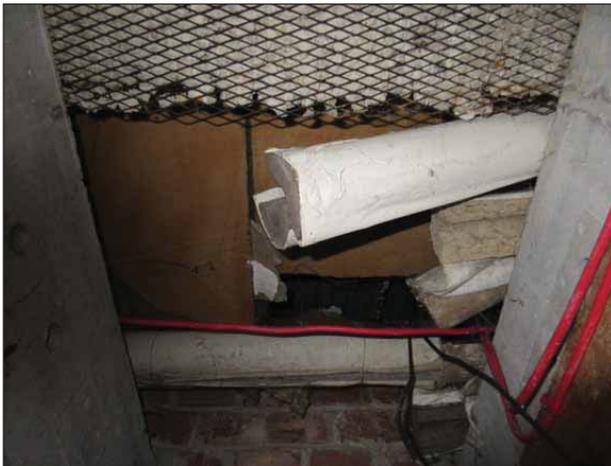
FINDING DETAILS					
Finding Code 06122014AGPA017		Item	Thermal Insulation to Pipework		
		Recommendations	Remove Prior to Demolition		
LOCATION					
Internal/External	Floor Level	Location Description		Extent	Identification
Internal Occupied	Ground Floor	Room 00705GC07, Ceiling Void, Horizontal Pipe		3m	Identified
MATERIAL ASSESSMENT					
Material	Asbestos Type	Condition	Accessibility	Encapsulation	Material Assessment
Thermal Insulation	Amosite & Chrysotile	Low Damage: a few scratches or surface marks	Accessible, but above head height	Enclosed	7
SURVEYORS COMMENTS					
REMEDIAL ACTION TAKEN					
Action			Date Works Completed

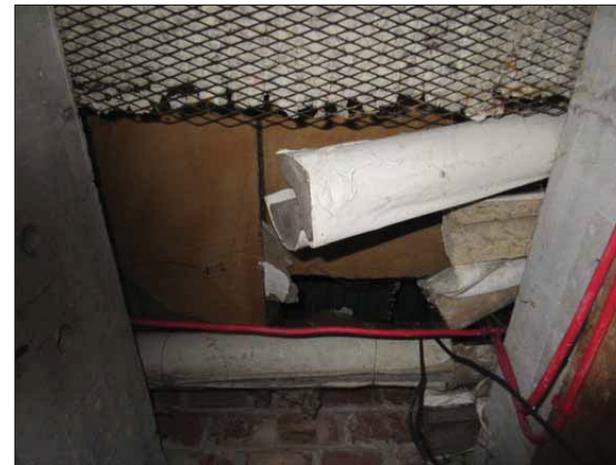
FINDING DETAILS					
Finding Code 06122014AGPA018		Item	Ceiling Panel		
		Recommendations	Remove Prior to Demolition		
LOCATION					
Internal/External	Floor Level	Location Description		Extent	Identification
Internal Occupied	Ground Floor	Room 00705GC07, Ceiling Void, above suspended ceiling		11sq.m	Identified
MATERIAL ASSESSMENT					
Material	Asbestos Type	Condition	Accessibility	Encapsulation	Material Assessment
Cement	Chrysotile (white)	Medium Damage: Significant breakage of materials	Accessible, but above head height	Enclosed	5
SURVEYORS COMMENTS					
REMEDIAL ACTION TAKEN					
Action			Date Works Completed

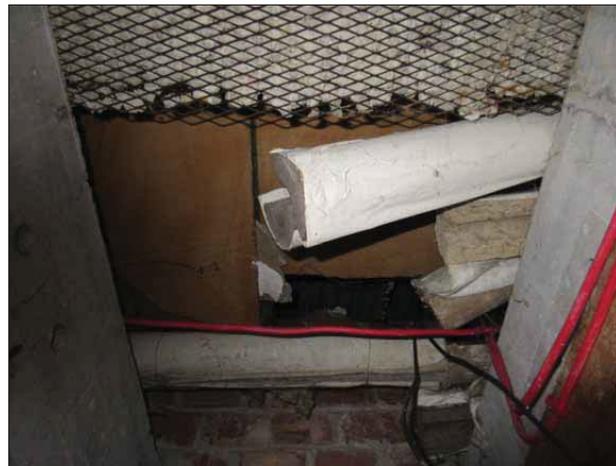
Representative Photo

FINDING DETAILS					
Finding Code 06122014AGPA019		Item	Thermal Insulation to Pipework		
		Recommendations	Remove Prior to Demolition		
LOCATION					
Internal/External	Floor Level	Location Description		Extent	Identification
Internal Occupied	Ground Floor	Room 00705G086, Ceiling Void, Horizontal Pipe		1m	Strongly Presumed
MATERIAL ASSESSMENT					
Material	Asbestos Type	Condition	Accessibility	Encapsulation	Material Assessment
Thermal Insulation	Amosite & Chrysotile	Low Damage: a few scratches or surface marks	Accessible, but above head height	Enclosed	7
SURVEYORS COMMENTS					
REMEDIAL ACTION TAKEN					
Action			Date Works Completed

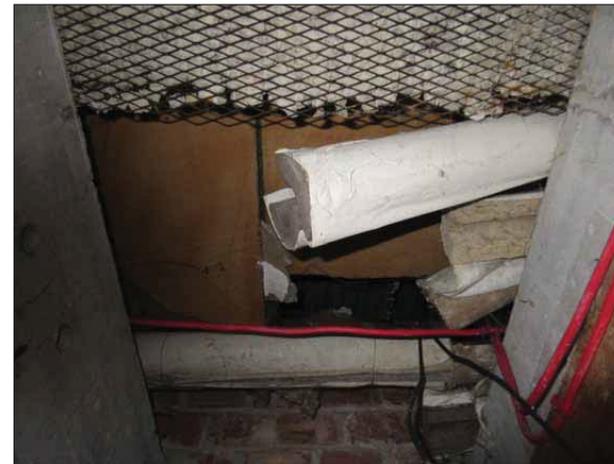
Representative Photo

FINDING DETAILS					
Finding Code 06122014AGPA020		Item	Ceiling Panel		
		Recommendations	Remove Prior to Demolition		
LOCATION					
Internal/External	Floor Level	Location Description		Extent	Identification
Internal Occupied	Ground Floor	Room 00705G086, Ceiling Void, above suspended ceiling		1sq.m	Strongly Presumed
MATERIAL ASSESSMENT					
Material	Asbestos Type	Condition	Accessibility	Encapsulation	Material Assessment
Cement	Chrysotile (white)	Medium Damage: Significant breakage of materials	Accessible, but above head height	Enclosed	5
SURVEYORS COMMENTS					
REMEDIAL ACTION TAKEN					
Action			Date Works Completed

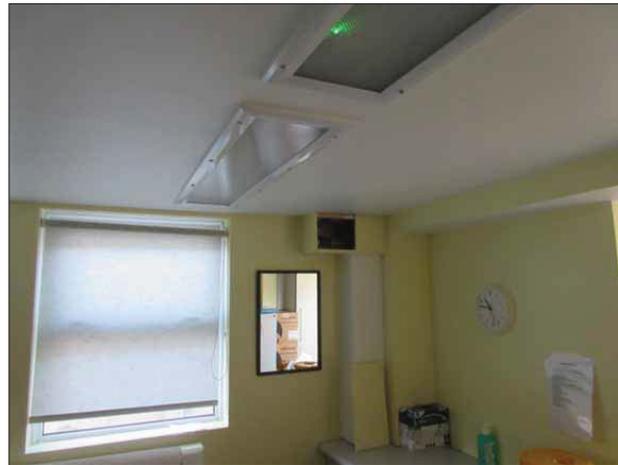
FINDING DETAILS					
Finding Code 06122014AGPA021		Item	Thermal Insulation to Pipework		
		Recommendations	Remove Prior to Demolition		
LOCATION					
Internal/External	Floor Level	Location Description		Extent	Identification
Internal Occupied	Ground Floor	Room 00705G074, Ceiling Void, Horizontal Pipe		4m	Identified
MATERIAL ASSESSMENT					
Material	Asbestos Type	Condition	Accessibility	Encapsulation	Material Assessment
Thermal Insulation	Amosite & Chrysotile	Low Damage: a few scratches or surface marks	Accessible, but above head height	Enclosed	7
SURVEYORS COMMENTS					
REMEDIAL ACTION TAKEN					
Action			Date Works Completed

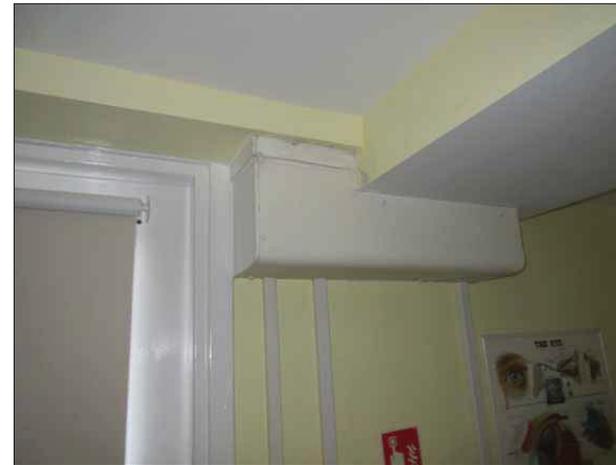
FINDING DETAILS					
Finding Code 06122014AGPA022		Item	Thermal Insulation to Pipework		
		Recommendations	Remove Prior to Demolition		
LOCATION					
Internal/External	Floor Level	Location Description		Extent	Identification
Internal Occupied	Ground Floor	Room 00705GC05, Ceiling Void, Horizontal Pipe		5m	Strongly Presumed
MATERIAL ASSESSMENT					
Material	Asbestos Type	Condition	Accessibility	Encapsulation	Material Assessment
Thermal Insulation	Amosite & Chrysotile	Low Damage: a few scratches or surface marks	Accessible, but above head height	Enclosed	7
SURVEYORS COMMENTS					
REMEDIAL ACTION TAKEN					
Action			Date Works Completed

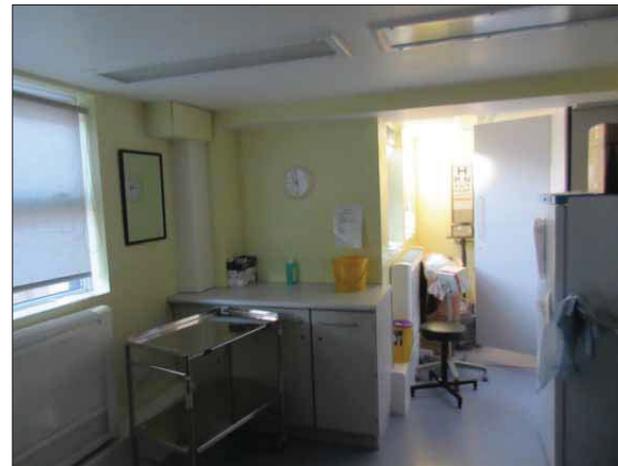
FINDING DETAILS					
Finding Code 06122014AGPA023		Item Ceiling Panel	Recommendations Remove Prior to Demolition		
LOCATION					
Internal/External Internal Occupied	Floor Level Ground Floor	Location Description Room 00705G074, Ceiling Void, above suspended ceiling	Extent 11.5sq. m	Identification Strongly Presumed	
MATERIAL ASSESSMENT					
Material Cement	Asbestos Type Chrysotile (white)	Condition Low Damage: a few scratches or surface marks	Accessibility Accessible, but above head height	Encapsulation Enclosed	Material Assessment 4
SURVEYORS COMMENTS					
REMEDIAL ACTION TAKEN					
Action			Date Works Completed

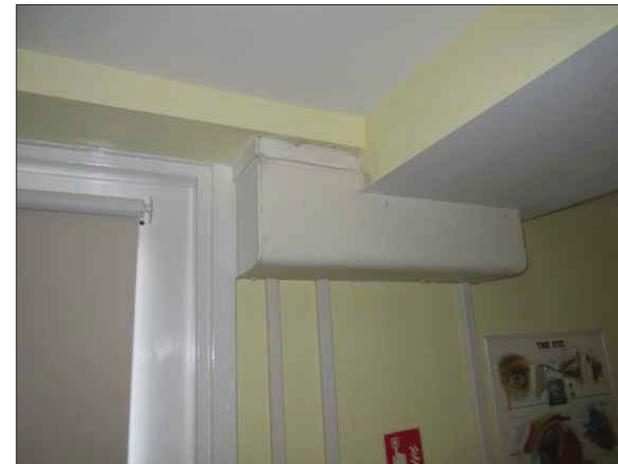
FINDING DETAILS					
Finding Code 06122014AGPA024		Item Ceiling Panel	Recommendations Remove Prior to Demolition		
LOCATION					
Internal/External Internal Occupied	Floor Level Ground Floor	Location Description Room 00705GC05, Ceiling Void, above suspended ceiling	Extent 14sq.m	Identification Strongly Presumed	
MATERIAL ASSESSMENT					
Material Cement	Asbestos Type Chrysotile (white)	Condition Low Damage: a few scratches or surface marks	Accessibility Accessible, but above head height	Encapsulation Enclosed	Material Assessment 4
SURVEYORS COMMENTS					
REMEDIAL ACTION TAKEN					
Action			Date Works Completed

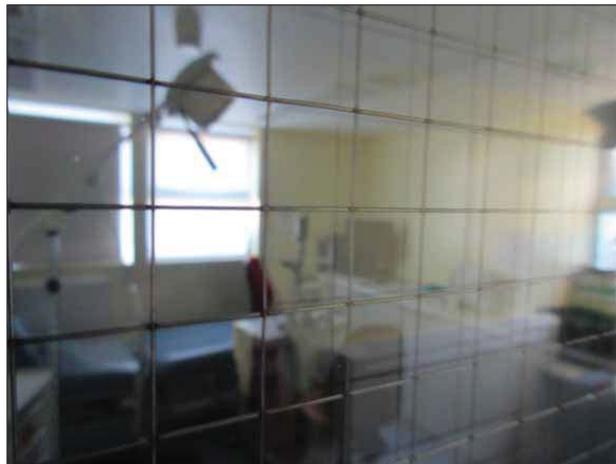
FINDING DETAILS					
Finding Code 06122014AGPA025		Item Thermal Insulation to Pipework	Recommendations Remove Prior to Demolition		
LOCATION					
Internal/External Internal Occupied	Floor Level Ground Floor	Location Description Room 00705G072/073, Ceiling Void, Horizontal Pipe	Extent 5m	Identification Strongly Presumed	
MATERIAL ASSESSMENT					
Material Thermal Insulation	Asbestos Type Amosite & Chrysotile	Condition Low Damage: a few scratches or surface marks	Accessibility Accessible, but above head height	Encapsulation Enclosed	Material Assessment 7
SURVEYORS COMMENTS					
REMEDIAL ACTION TAKEN					
Action			Date Works Completed

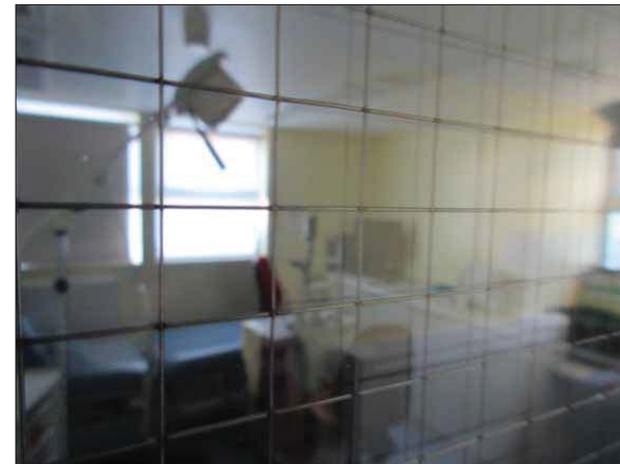
FINDING DETAILS					
Finding Code 06122014AGPA026		Item Ceiling Panel	Recommendations Remove Prior to Demolition		
LOCATION					
Internal/External Internal Occupied	Floor Level Ground Floor	Location Description Room 00705G072/073, Ceiling Void, above suspended ceiling	Extent 11sq.m	Identification Strongly Presumed	
MATERIAL ASSESSMENT					
Material Cement	Asbestos Type Chrysotile (white)	Condition Low Damage: a few scratches or surface marks	Accessibility Accessible, but above head height	Encapsulation Enclosed	Material Assessment 4
SURVEYORS COMMENTS					
REMEDIAL ACTION TAKEN					
Action			Date Works Completed

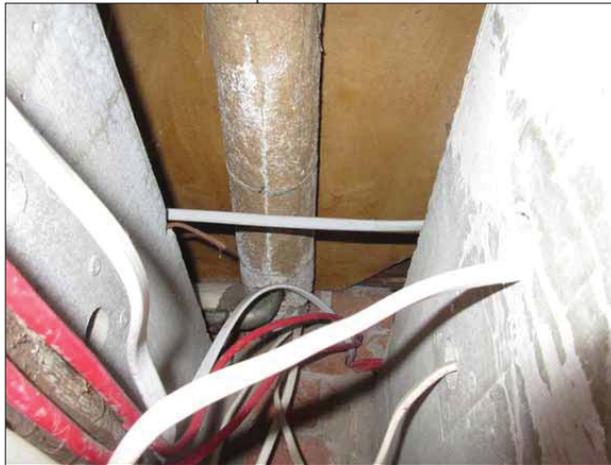
Representative Photo

FINDING DETAILS					
Finding Code 06122014AGPA027		Item Thermal Insulation to Pipework	Recommendations Remove Prior to Demolition		
LOCATION					
Internal/External	Floor Level	Location Description	Extent	Identification	
Internal Occupied	Ground Floor	Room 00705GC09, Ceiling Void, Horizontal Pipe	3m	Identified	
MATERIAL ASSESSMENT					
Material	Asbestos Type	Condition	Accessibility	Encapsulation	Material Assessment
Thermal Insulation	Amosite & Chrysotile	Low Damage: a few scratches or surface marks	Accessible, but above head height	Enclosed	7
SURVEYORS COMMENTS					
REMEDIAL ACTION TAKEN					
Action			Date Works Completed

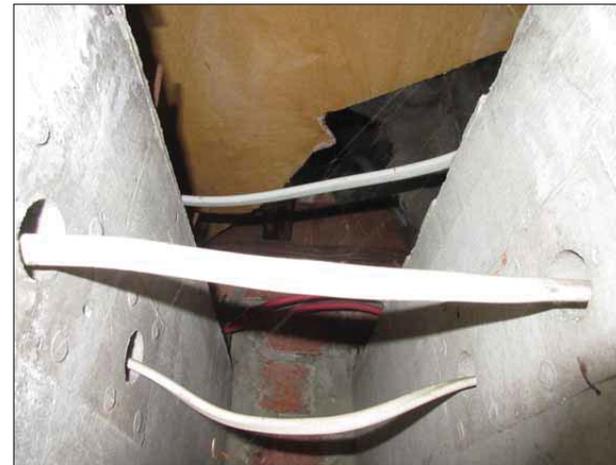
FINDING DETAILS					
Finding Code 06122014AGPA028		Item Ceiling Panel	Recommendations Remove Prior to Demolition		
LOCATION					
Internal/External	Floor Level	Location Description	Extent	Identification	
Internal Occupied	Ground Floor	Room 00705GC09, Ceiling Void, above suspended ceiling	6sq.m	Identified	
MATERIAL ASSESSMENT					
Material	Asbestos Type	Condition	Accessibility	Encapsulation	Material Assessment
Cement	Chrysotile (white)	Low Damage: a few scratches or surface marks	Accessible, but above head height	Enclosed	4
SURVEYORS COMMENTS					
REMEDIAL ACTION TAKEN					
Action			Date Works Completed

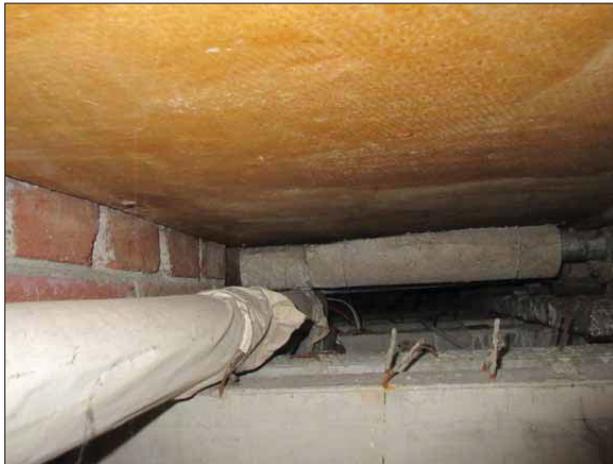
Representative Photo

FINDING DETAILS					
Finding Code 06122014AGPA029		Item Thermal Insulation to Pipework	Recommendations Remove Prior to Demolition		
LOCATION					
Internal/External	Floor Level	Location Description	Extent	Identification	
Internal Occupied	Ground Floor	Room 00705G097a, Ceiling Void, Horizontal Pipe	1m	Strongly Presumed	
MATERIAL ASSESSMENT					
Material	Asbestos Type	Condition	Accessibility	Encapsulation	Material Assessment
Thermal Insulation	Amosite & Chrysotile	Low Damage: a few scratches or surface marks	Accessible, but above head height	Enclosed	7
SURVEYORS COMMENTS					
REMEDIAL ACTION TAKEN					
Action			Date Works Completed

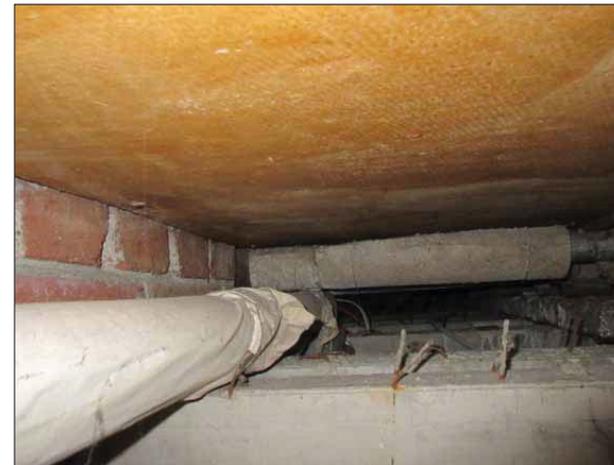
Representative Photo

FINDING DETAILS					
Finding Code 06122014AGPA030		Item Ceiling Panel	Recommendations Remove Prior to Demolition		
LOCATION					
Internal/External	Floor Level	Location Description	Extent	Identification	
Internal Occupied	Ground Floor	Room 00705G097a, Ceiling Void, above suspended ceiling	1sq.m	Strongly Presumed	
MATERIAL ASSESSMENT					
Material	Asbestos Type	Condition	Accessibility	Encapsulation	Material Assessment
Cement	Chrysotile (white)	Low Damage: a few scratches or surface marks	Accessible, but above head height	Enclosed	4
SURVEYORS COMMENTS					
REMEDIAL ACTION TAKEN					
Action			Date Works Completed

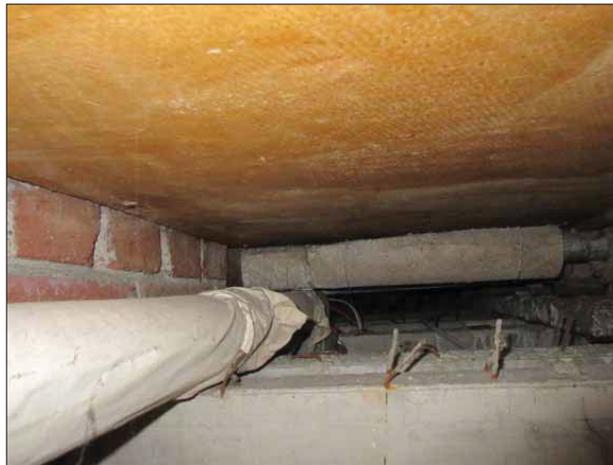
Representative Photo

FINDING DETAILS					
Finding Code 06122014AGPA031		Item	Thermal Insulation to Pipework		
		Recommendations	Remove Prior to Demolition		
LOCATION					
Internal/External	Floor Level	Location Description		Extent	Identification
Internal Occupied	Ground Floor	Room 00705G097, Ceiling Void, Horizontal Pipe		1m	Strongly Presumed
MATERIAL ASSESSMENT					
Material	Asbestos Type	Condition	Accessibility	Encapsulation	Material Assessment
Thermal Insulation	Amosite & Chrysotile	Low Damage: a few scratches or surface marks	Accessible, but above head height	Enclosed	7
SURVEYORS COMMENTS					
REMEDIAL ACTION TAKEN					
Action			Date Works Completed

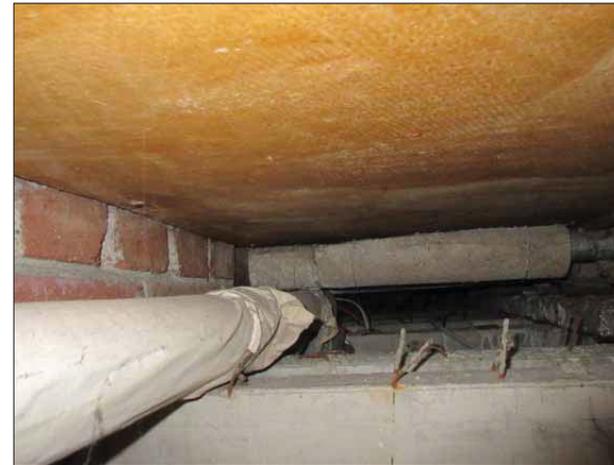
Representative Photo

FINDING DETAILS					
Finding Code 06122014AGPA032		Item	Ceiling Panel		
		Recommendations	Remove Prior to Demolition		
LOCATION					
Internal/External	Floor Level	Location Description		Extent	Identification
Internal Occupied	Ground Floor	Room 00705G097, Ceiling Void, above suspended ceiling		5sq.m	Strongly Presumed
MATERIAL ASSESSMENT					
Material	Asbestos Type	Condition	Accessibility	Encapsulation	Material Assessment
Cement	Chrysotile (white)	Low Damage: a few scratches or surface marks	Accessible, but above head height	Enclosed	4
SURVEYORS COMMENTS					
REMEDIAL ACTION TAKEN					
Action			Date Works Completed

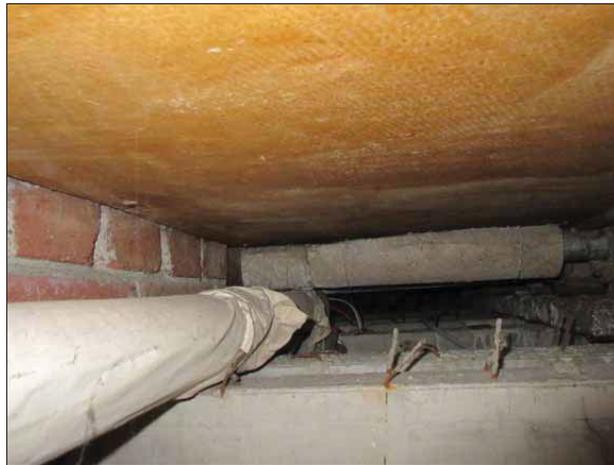
FINDING DETAILS					
Finding Code 06122014AGPA033		Item	Thermal Insulation to Pipework		
		Recommendations	Remove Prior to Demolition		
LOCATION					
Internal/External	Floor Level	Location Description		Extent	Identification
Internal Occupied	Ground Floor	Room 00705G098, Ceiling Void, Horizontal Pipe		2m	Identified
MATERIAL ASSESSMENT					
Material	Asbestos Type	Condition	Accessibility	Encapsulation	Material Assessment
Thermal Insulation	Amosite & Chrysotile	Low Damage: a few scratches or surface marks	Accessible, but above head height	Enclosed	7
SURVEYORS COMMENTS					
REMEDIAL ACTION TAKEN					
Action			Date Works Completed
