## Appendix

<b>Name</b>	<b>Appendix No.</b>
Ready to Dig Searches and Responses	A
Arboricultural	B
Topographical Survey	C
Decontamination Survey	D
Habitat & Bat Survey	E
Asbestos	F

REFERENCE: 34638/PS  
ROUTE: Cotswold Road, Sutton  
OSGR: 525954,162355  
POSTCODE: SM2 5NF

**Ready to Dig – Utility Search Service**

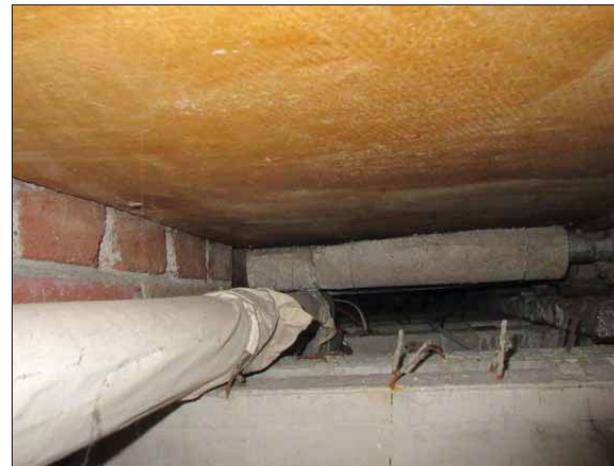
FINDING DETAILS				
Finding Code 06122014AGPA034		Item	Ceiling Panel	
		Recommendations	Remove Prior to Demolition	
LOCATION				
Internal/External	Floor Level	Location Description		Extent
Internal Occupied	Ground Floor	Room 00705G098, Ceiling Void, above suspended ceiling		5sq.m
MATERIAL ASSESSMENT				
Material	Asbestos Type	Condition	Accessibility	Material Assessment
Cement	Chrysotile (white)	Low Damage: a few scratches or surface marks	Accessible, but above head height	4
SURVEYORS COMMENTS				
REMEDIAL ACTION TAKEN				
Action			Date Works Completed

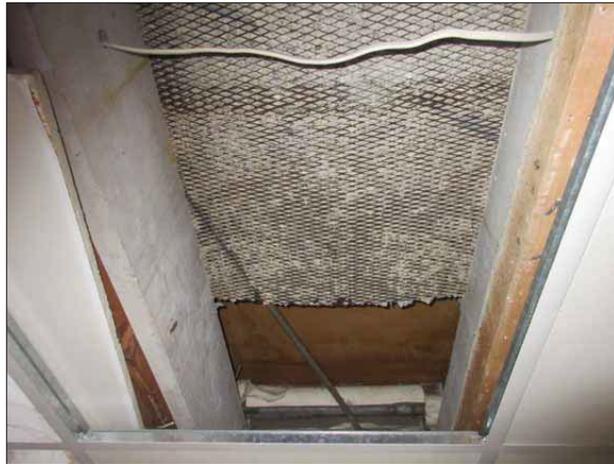
FINDING DETAILS					
Finding Code 06122014AGPA035		Item Thermal Insulation to Pipework	Recommendations Remove Prior to Demolition		
LOCATION					
Internal/External Internal Occupied	Floor Level Ground Floor	Location Description Room 00705G099, Ceiling Void, Horizontal Pipe	Extent 1m	Identification Identified	
MATERIAL ASSESSMENT					
Material Thermal Insulation	Asbestos Type Amosite & Chrysotile	Condition Low Damage: a few scratches or surface marks	Accessibility Accessible, but above head height	Encapsulation Enclosed	Material Assessment 7
SURVEYORS COMMENTS					
REMEDIAL ACTION TAKEN					
Action			Date Works Completed

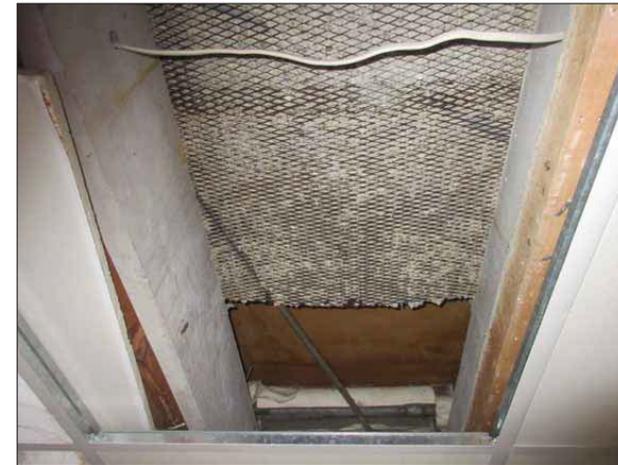
FINDING DETAILS					
Finding Code 06122014AGPA036		Item Ceiling Panel	Recommendations Remove Prior to Demolition		
LOCATION					
Internal/External Internal Occupied	Floor Level Ground Floor	Location Description Room 00705G099, Ceiling Void, above suspended ceiling	Extent 1sq.m	Identification Identified	
MATERIAL ASSESSMENT					
Material Cement	Asbestos Type Chrysotile (white)	Condition Low Damage: a few scratches or surface marks	Accessibility Accessible, but above head height	Encapsulation Enclosed	Material Assessment 4
SURVEYORS COMMENTS					
REMEDIAL ACTION TAKEN					
Action			Date Works Completed

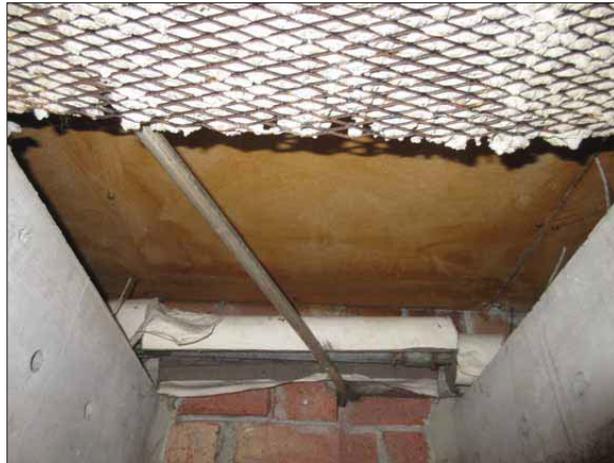
FINDING DETAILS					
Finding Code 06122014AGPA037		Item Thermal Insulation to Pipework			
		Recommendations Remove Prior to Demolition			
LOCATION					
Internal/External	Floor Level	Location Description	Extent	Identification	
Internal Occupied	Ground Floor	Room 00705G100, Ceiling Void, Horizontal Pipe	2m	Identified	
MATERIAL ASSESSMENT					
Material	Asbestos Type	Condition	Accessibility	Encapsulation	Material Assessment
Thermal Insulation	Amosite & Chrysotile	Low Damage: a few scratches or surface marks	Accessible, but above head height	Enclosed	7
SURVEYORS COMMENTS					
REMEDIAL ACTION TAKEN					
Action			Date Works Completed

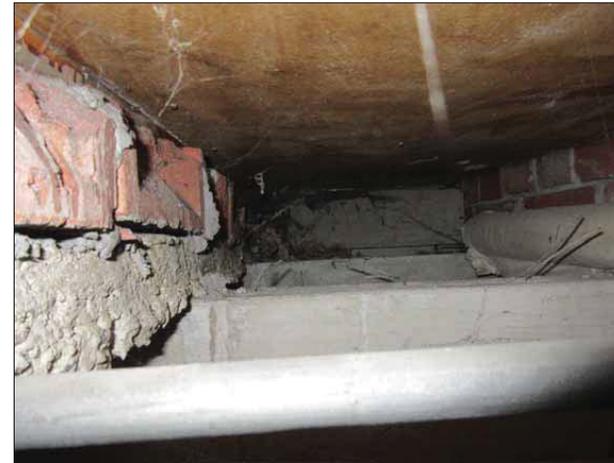
FINDING DETAILS				
Finding Code 06122014AGPA038		Item Ceiling Panel		
		Recommendations Remove Prior to Demolition		
LOCATION				
Internal/External	Floor Level	Location Description	Extent	Identification
Internal Occupied	Ground Floor	Room 00705G100, Ceiling Void, above suspended ceiling	2.5sq. m	Identified
MATERIAL ASSESSMENT				
Material	Asbestos Type	Condition	Accessibility	Material Assessment
Cement	Chrysotile (white)	Low Damage: a few scratches or surface marks	Accessible, but above head height	4
SURVEYORS COMMENTS				
REMEDIAL ACTION TAKEN				
Action			Date Works Completed

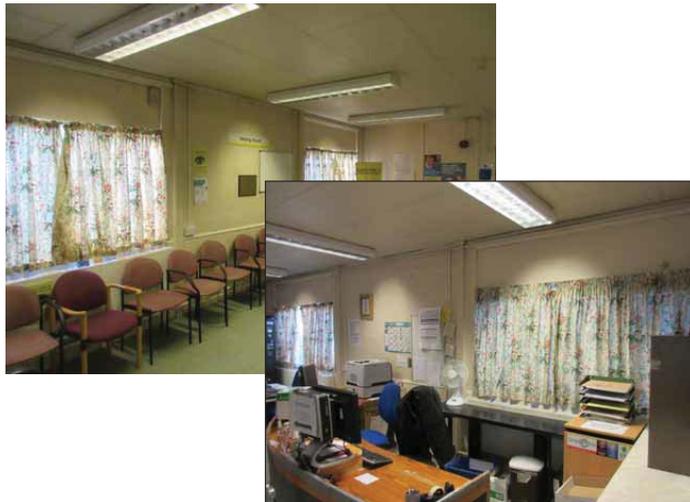
FINDING DETAILS					
Finding Code 06122014AGPA039		Item Lining Panels	Recommendations Remove Prior to Demolition		
LOCATION					
Internal/External Internal Occupied	Floor Level Ground Floor	Location Description Room 00705G116, Wall	Extent 60sq.m	Identification Identified	
MATERIAL ASSESSMENT					
Material Insulating Board	Asbestos Type Amosite & Chrysotile	Condition Low Damage: a few scratches or surface marks	Accessibility Accessible, below head height	Encapsulation Enclosed	Material Assessment 6
SURVEYORS COMMENTS					
REMEDIAL ACTION TAKEN					
Action			Date Works Completed

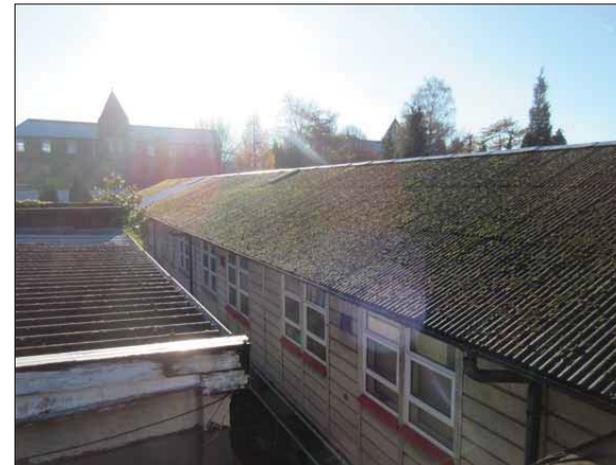
FINDING DETAILS					
Finding Code 06122014AGPA040		Item Profiled Sheets and Ridge Tiles	Recommendations Remove Prior to Demolition		
LOCATION					
Internal/External External	Floor Level Ground Floor	Location Description Left Hand Side Building, Roof	Extent 450sq.m	Identification Identified	
MATERIAL ASSESSMENT					
Material Cement	Asbestos Type Chrysotile (white)	Condition Low Damage: a few scratches or surface marks	Accessibility Accessible, but in restricted access areas	Encapsulation Enclosed	Material Assessment 4
SURVEYORS COMMENTS					
REMEDIAL ACTION TAKEN					
Action			Date Works Completed

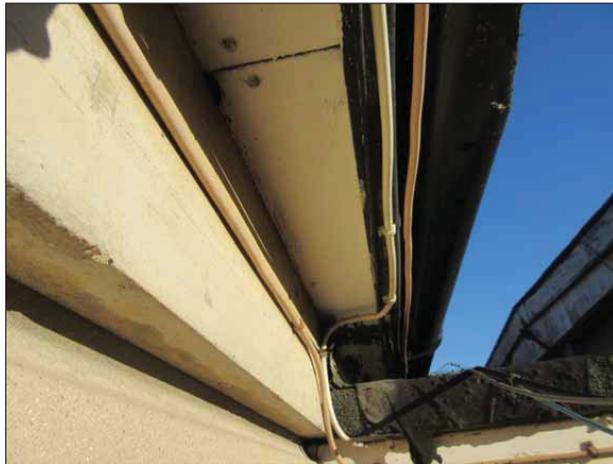
FINDING DETAILS					
Finding Code 06122014AGPA041		Item Soffit Board	Recommendations Remove Prior to Demolition		
LOCATION					
Internal/External	Floor Level	Location Description	Extent	Identification	
External	Ground Floor	Left Hand Side Building, Roof	70m	Identified	
MATERIAL ASSESSMENT					
Material	Asbestos Type	Condition	Accessibility	Encapsulation	Material Assessment
Cement	Amosite (brown)	Low Damage: a few scratches or surface marks	Accessible, but above head height	Enclosed	5
SURVEYORS COMMENTS					
REMEDIAL ACTION TAKEN					
Action			Date Works Completed

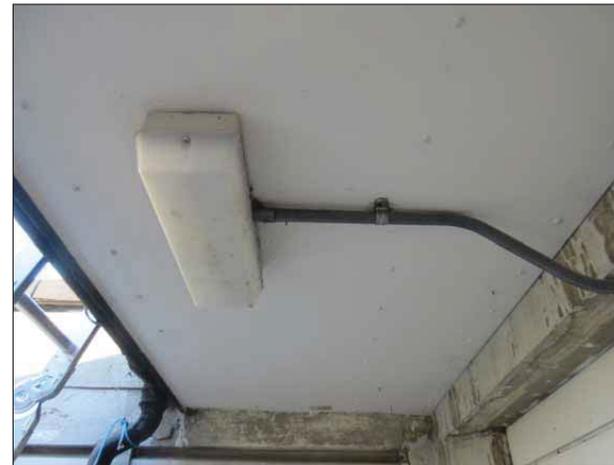
FINDING DETAILS					
Finding Code 06122014AGPA042		Item Door Canopy Lining Panels	Recommendations Remove Prior to Demolition		
LOCATION					
Internal/External	Floor Level	Location Description	Extent	Identification	
External	Ground Floor	LHS Building, Door to Room 00705GC05	5sq.m	Identified	
MATERIAL ASSESSMENT					
Material	Asbestos Type	Condition	Accessibility	Encapsulation	Material Assessment
Cement	Chrysotile (white)	Low Damage: a few scratches or surface marks	Accessible, but above head height	Enclosed	4
SURVEYORS COMMENTS					
REMEDIAL ACTION TAKEN					
Action			Date Works Completed

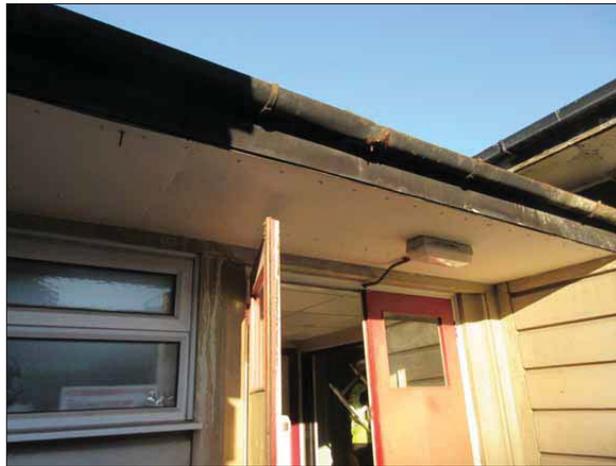
FINDING DETAILS					
Finding Code 06122014AGPA043		Item Door Canopy Lining Panels	Recommendations Remove Prior to Demolition		
LOCATION					
Internal/External	Floor Level	Location Description	Extent	Identification	
External	Ground Floor	LHS Building, Door to Room 00705GC06	5sq.m	Identified	
MATERIAL ASSESSMENT					
Material	Asbestos Type	Condition	Accessibility	Encapsulation	Material Assessment
Cement	Chrysotile (white)	Low Damage: a few scratches or surface marks	Accessible, but above head height	Enclosed	4
SURVEYORS COMMENTS					
REMEDIAL ACTION TAKEN					
Action			Date Works Completed

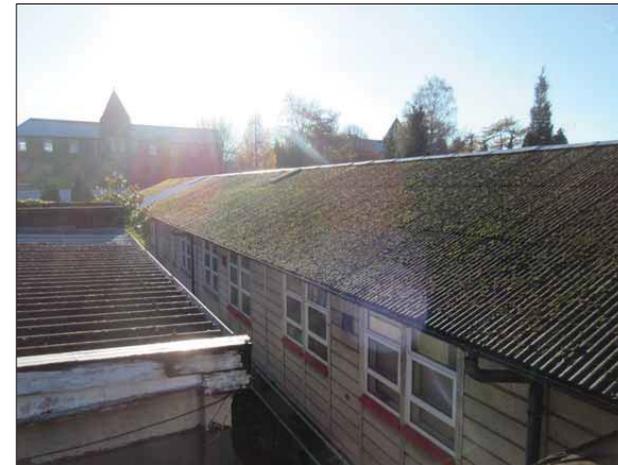
FINDING DETAILS					
Finding Code 06122014AGPA044		Item Profiled Sheets and Ridge Tiles	Recommendations Remove Prior to Demolition		
LOCATION					
Internal/External	Floor Level	Location Description	Extent	Identification	
External	Ground Floor	Right Hand Side Building, Roof	450sq.m	Identified	
MATERIAL ASSESSMENT					
Material	Asbestos Type	Condition	Accessibility	Encapsulation	Material Assessment
Cement	Chrysotile (white)	Low Damage: a few scratches or surface marks	Accessible, but in restricted access areas	Enclosed	4
SURVEYORS COMMENTS					
REMEDIAL ACTION TAKEN					
Action			Date Works Completed

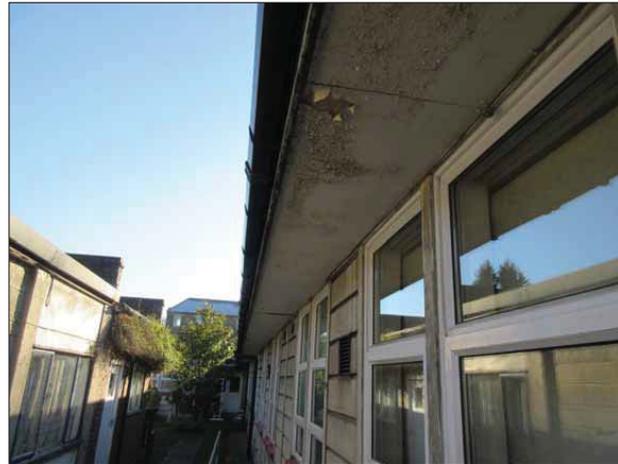
FINDING DETAILS					
Finding Code 06122014AGPA045		Item Soffit Board			
		Recommendations Remove Prior to Demolition			
LOCATION					
Internal/External	Floor Level	Location Description		Extent	Identification
External	Ground Floor	Right Hand Side Building, Roof		70m	Identified
MATERIAL ASSESSMENT					
Material	Asbestos Type	Condition	Accessibility	Encapsulation	Material Assessment
Cement	Amosite (brown)	Low Damage: a few scratches or surface marks	Accessible, but above head height	Enclosed	5
SURVEYORS COMMENTS					
REMEDIAL ACTION TAKEN					
Action			Date Works Completed

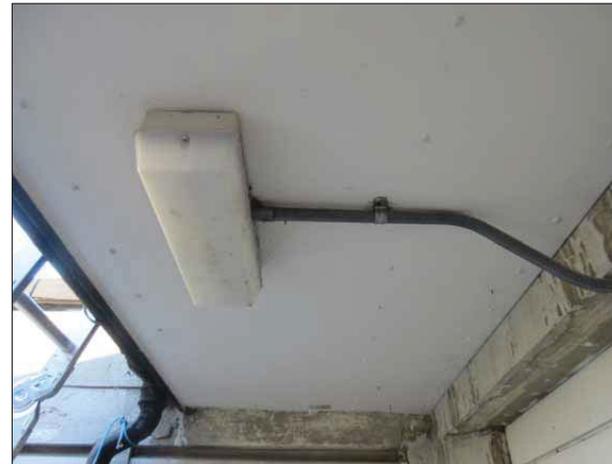
FINDING DETAILS					
Finding Code 06122014AGPA046		Item Door Canopy Lining Panels			
		Recommendations Remove Prior to Demolition			
LOCATION					
Internal/External	Floor Level	Location Description		Extent	Identification
External	Ground Floor	RHS Building, Door to Room 00705GC07		5sq.m	Identified
MATERIAL ASSESSMENT					
Material	Asbestos Type	Condition	Accessibility	Encapsulation	Material Assessment
Cement	Chrysotile (white)	Low Damage: a few scratches or surface marks	Accessible, but above head height	Enclosed	4
SURVEYORS COMMENTS					
REMEDIAL ACTION TAKEN					
Action			Date Works Completed

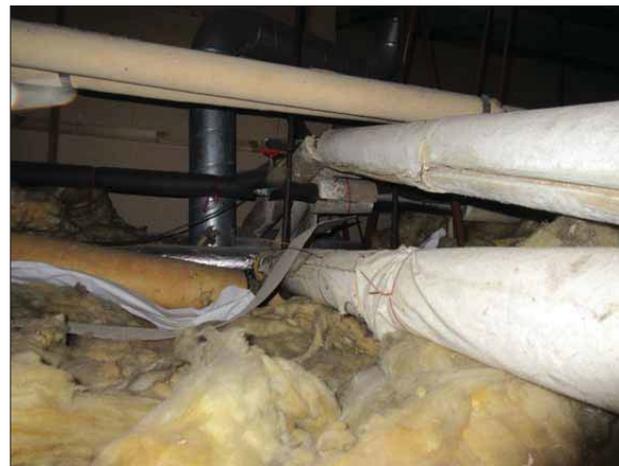
FINDING DETAILS					
Finding Code 06122014AGPA047		Item Thermal Insulation to Pipework	Recommendations Remove Prior to Demolition		
LOCATION					
Internal/External Internal Occupied	Floor Level Ground Floor	Location Description Left Hand Side Building, Loft, Pipework x2	Extent 0m	Identification Identified	
MATERIAL ASSESSMENT					
Material Thermal Insulation	Asbestos Type Crocidolite, Amosite & Chrysotile	Condition Medium Damage: Significant breakage of materials	Accessibility Accessible, but above head height	Encapsulation Enclosed	Material Assessment 9
SURVEYORS COMMENTS					
REMEDIAL ACTION TAKEN					
Action			Date Works Completed

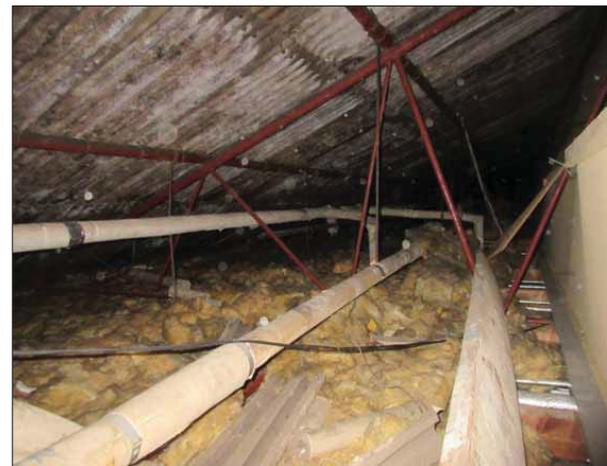
FINDING DETAILS					
Finding Code 06122014AGPA048		Item Thermal Insulation to Pipework	Recommendations Remove Prior to Demolition		
LOCATION					
Internal/External Internal Occupied	Floor Level Ground Floor	Location Description Right Hand Side Building, Loft, Pipework x4	Extent 0m	Identification Identified	
MATERIAL ASSESSMENT					
Material Thermal Insulation	Asbestos Type Crocidolite, Amosite & Chrysotile	Condition Medium Damage: Significant breakage of materials	Accessibility Accessible, but above head height	Encapsulation Enclosed	Material Assessment 9
SURVEYORS COMMENTS					
REMEDIAL ACTION TAKEN					
Action			Date Works Completed

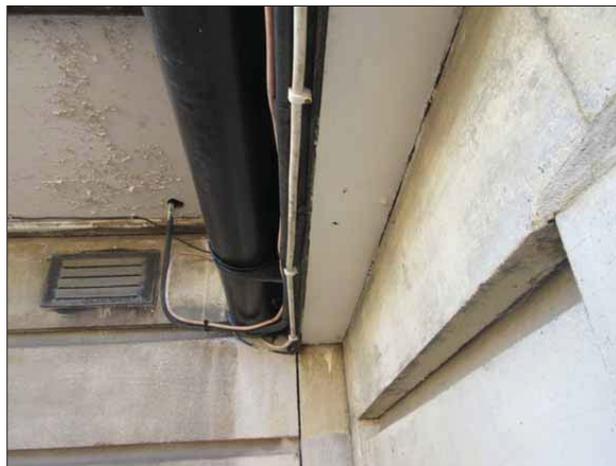
FINDING DETAILS					
Finding Code 06122014AGPA049		Item Soffit Board	Recommendations Remove Prior to Demolition		
LOCATION					
Internal/External	Floor Level	Location Description	Extent	Identification	
External	Ground Floor	Covered Walkway to front of Department, Corridor 00705G011, Flat Roof	25sq.m	Identified	
MATERIAL ASSESSMENT					
Material	Asbestos Type	Condition	Accessibility	Encapsulation	Material Assessment
Cement	Chrysotile (white)	Low Damage: a few scratches or surface marks	Accessible, but above head height	Enclosed	4
SURVEYORS COMMENTS					
REMEDIAL ACTION TAKEN					
Action			Date Works Completed

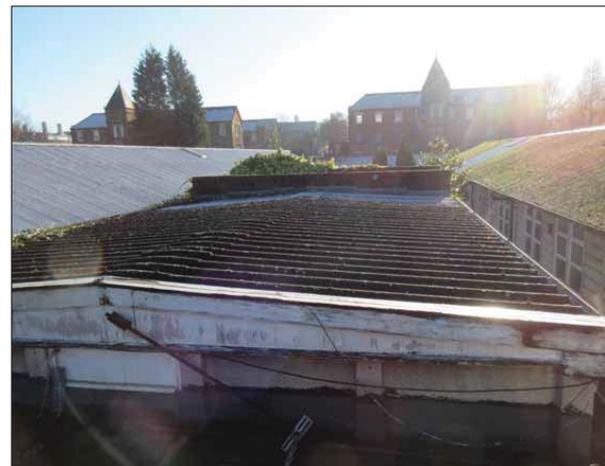
FINDING DETAILS					
Finding Code 06122014AGPA050		Item Profiled Sheets	Recommendations Remove Prior to Demolition		
LOCATION					
Internal/External	Floor Level	Location Description	Extent	Identification	
External	Ground Floor	Room 00705G116, Roof	45sq.m	Identified	
MATERIAL ASSESSMENT					
Material	Asbestos Type	Condition	Accessibility	Encapsulation	Material Assessment
Cement	Chrysotile (white)	Low Damage: a few scratches or surface marks	Accessible, but in restricted access areas	Enclosed	4
SURVEYORS COMMENTS					
REMEDIAL ACTION TAKEN					
Action			Date Works Completed

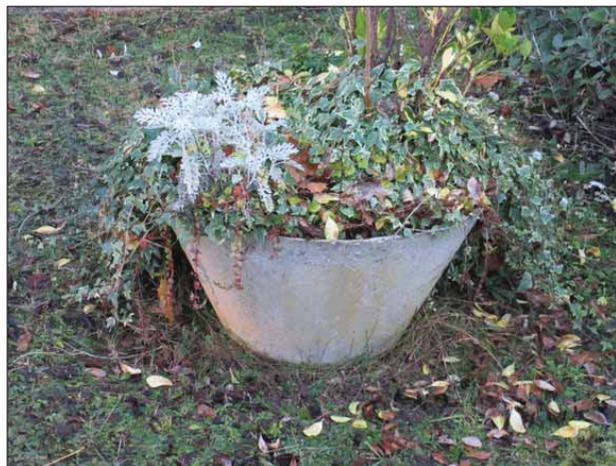
FINDING DETAILS					
Finding Code 06122014AGPA051		Item Flower Pots	Recommendations Remove Prior to Demolition		
LOCATION					
Internal/External	Floor Level	Location Description	Extent	Identification	
External	Ground Floor	Rear Court Yard	4no.	Identified	
MATERIAL ASSESSMENT					
Material	Asbestos Type	Condition	Accessibility	Encapsulation	Material Assessment
Cement	Chrysotile (white)	Low Damage: a few scratches or surface marks	Accessible, below head height	Unsealed	5
SURVEYORS COMMENTS					
REMEDIAL ACTION TAKEN					
Action			Date Works Completed

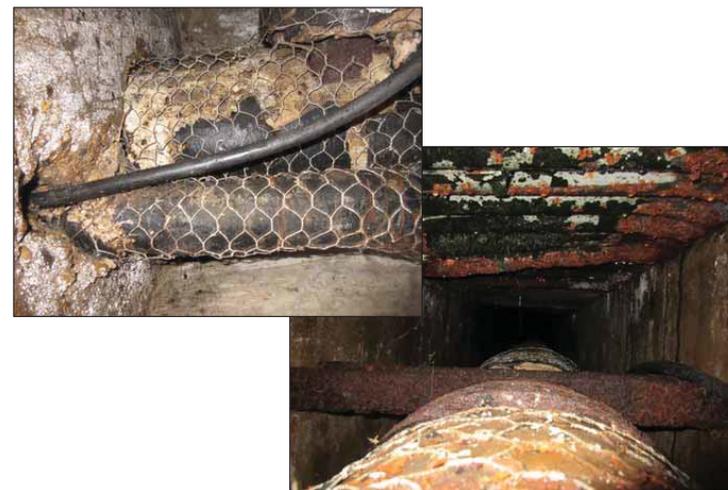
FINDING DETAILS					
Finding Code 06122014AGPA052		Item Thermal Insulation to Pipework	Recommendations Remove Prior to Demolition		
LOCATION					
Internal/External	Floor Level	Location Description	Extent	Identification	
External	Ground Floor	Grounds Outside Department Between Ophthalmology & Lithotripsy, Service Duct Running to Old Boiler Room, Pipes x2	100m	Identified	
MATERIAL ASSESSMENT					
Material	Asbestos Type	Condition	Accessibility	Encapsulation	Material Assessment
Thermal Insulation	Chrysotile (white)	Medium Damage: Significant breakage of materials	Inaccessible	Enclosed	7
SURVEYORS COMMENTS					
REMEDIAL ACTION TAKEN					
Action			Date Works Completed

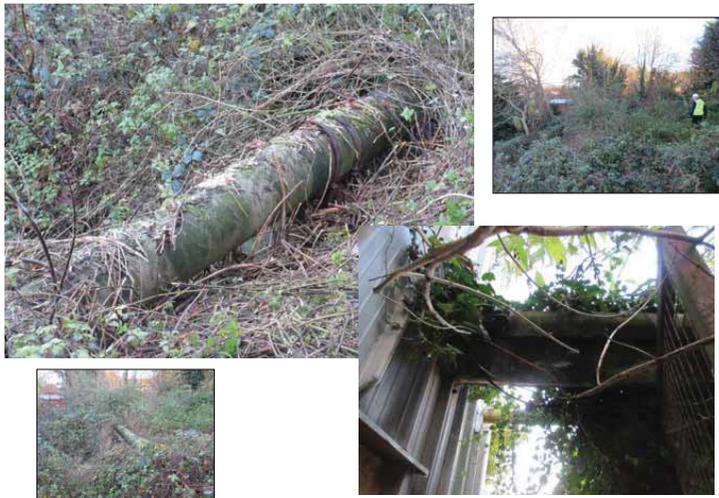
FINDING DETAILS					
Finding Code 06122014AGPA053		Item Thermal Insulation to Pipework	Recommendations Remove Prior to Demolition		
LOCATION					
Internal/External	Floor Level	Location Description	Extent	Identification	
External	Ground Floor	Grounds Outside Department Between Ophthalmology & Lithotripsy, Service Duct Running to Old Boiler Room, Pipes x2	150m	Identified	
MATERIAL ASSESSMENT					
Material	Asbestos Type	Condition	Accessibility	Encapsulation	Material Assessment
Thermal Insulation	Chrysotile (white)	Medium Damage: Significant breakage of materials	Accessible, but in restricted access areas	Enclosed	7
SURVEYORS COMMENTS					
REMEDIAL ACTION TAKEN					
Action			Date Works Completed

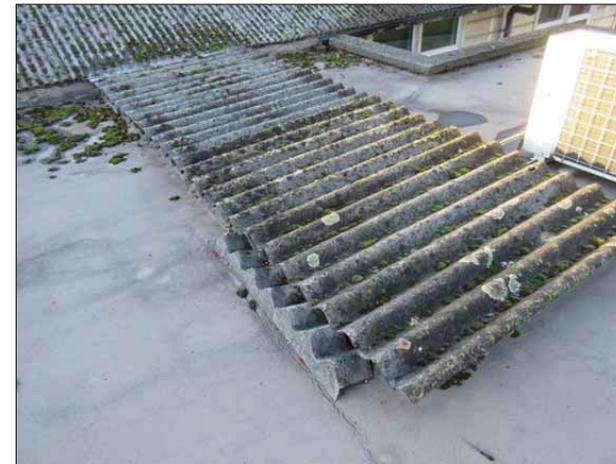
FINDING DETAILS					
Finding Code 06122014AGPA054		Item Profiled Sheets	Recommendations Remove Prior to Demolition		
LOCATION					
Internal/External	Floor Level	Location Description	Extent	Identification	
External	Ground Floor	Corridor 00705GC05, Roof	5sq.m	Identified	
MATERIAL ASSESSMENT					
Material	Asbestos Type	Condition	Accessibility	Encapsulation	Material Assessment
Cement	Chrysotile (white)	Low Damage: a few scratches or surface marks	Accessible, but in restricted access areas	Unsealed	5
SURVEYORS COMMENTS					
REMEDIAL ACTION TAKEN					
Action			Date Works Completed

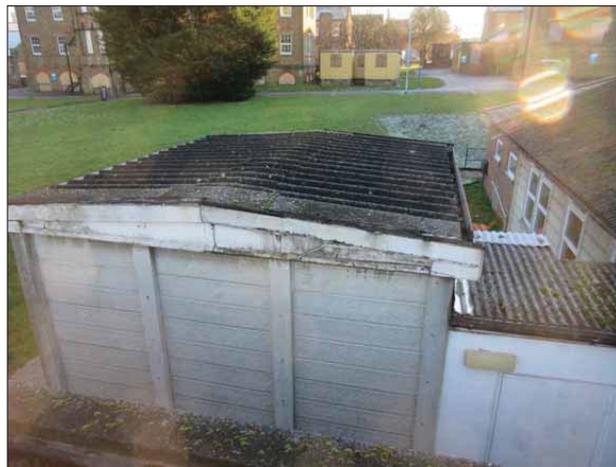
FINDING DETAILS					
Finding Code 06122014AGPA055		Item Profiled Sheets			
		Recommendations Remove Prior to Demolition			
LOCATION					
Internal/External	Floor Level	Location Description	Extent	Identification	
External	Ground Floor	Room 00705G075, Roof	20sq.m	Identified	
MATERIAL ASSESSMENT					
Material	Asbestos Type	Condition	Accessibility	Encapsulation	Material Assessment
Cement	Chrysotile (white)	Low Damage: a few scratches or surface marks	Accessible, but in restricted access areas	Enclosed	4
SURVEYORS COMMENTS					
REMEDIAL ACTION TAKEN					
Action			Date Works Completed

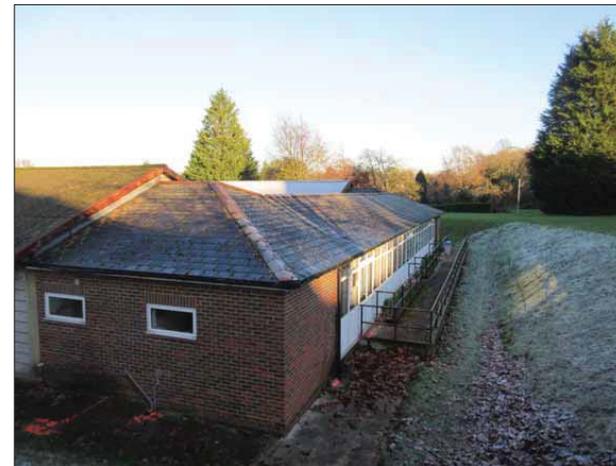
FINDING DETAILS					
Finding Code 06122014AGPA056		Item Artificial Slate Tiles			
		Recommendations No Action Required			
LOCATION					
Internal/External	Floor Level	Location Description	Extent	Identification	
External	Ground Floor	Rooms 00705G080 to 00705G085; Roof	160sq.m	Identified	
MATERIAL ASSESSMENT					
Material	Asbestos Type	Condition	Accessibility	Encapsulation	Material Assessment
Cement	No Asbestos Detected	Low Damage: a few scratches or surface marks	Accessible, but in restricted access areas	Enclosed	0
SURVEYORS COMMENTS					
REMEDIAL ACTION TAKEN					
Action			Date Works Completed

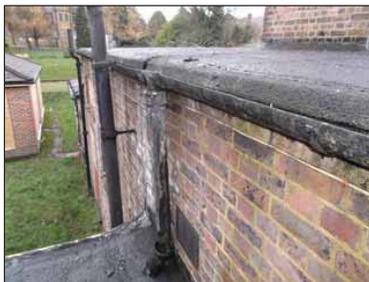
3.1.2 The rainwater guttering and downpipes to the property are all asbestos cement. There is also a redundant asbestos cement flue which is only located externally at high level, it does not appear within the property.

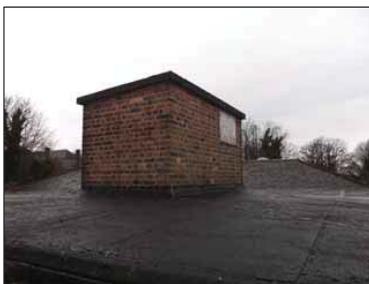
3.1.4 The bitumen covering the flat roof is visually the same as the material identified on the Main Building. This coating proved not to contain asbestos fibre.

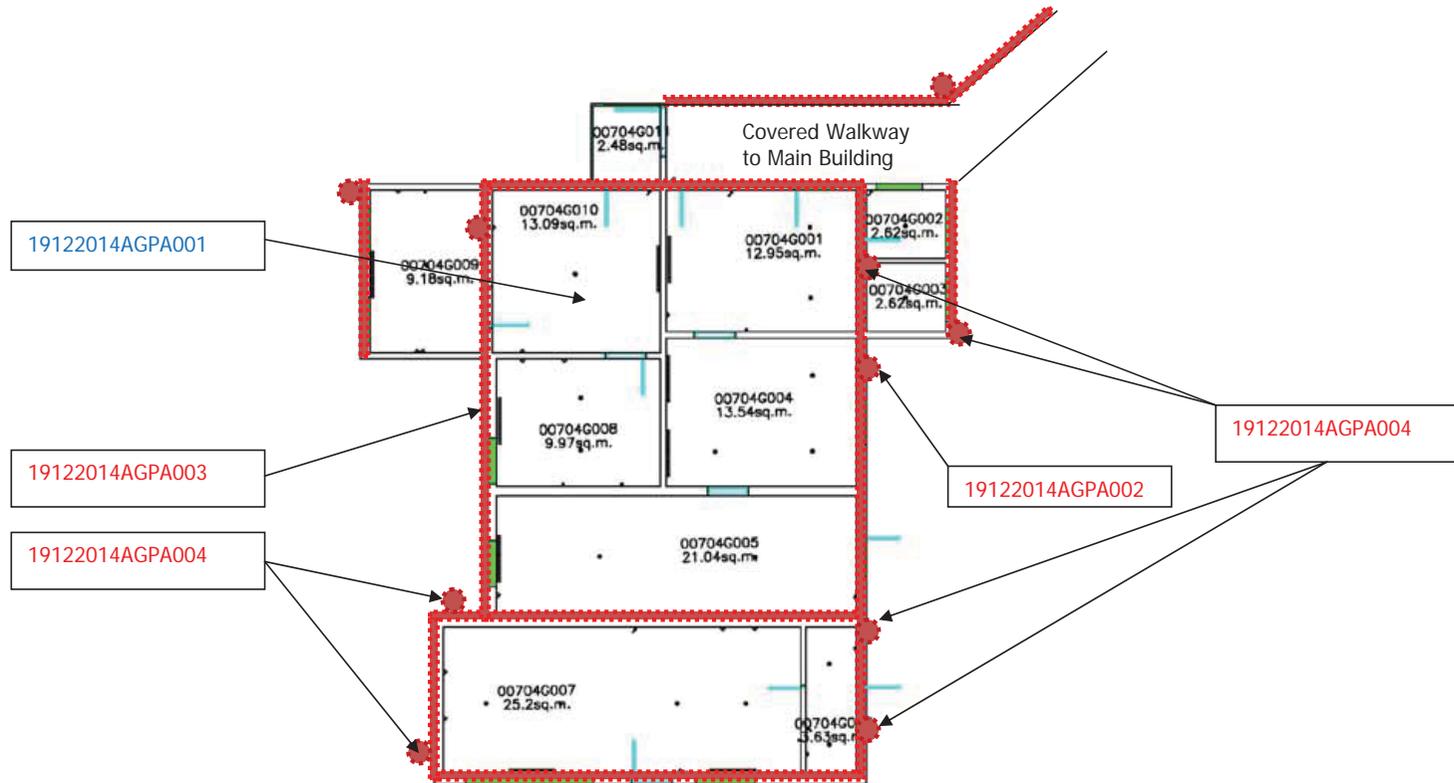
## Back Care, Sutton Hospital – Ground Floor

Key:	
Asbestos Item:	
Cement Guttering	-----
Cement Downpipe/Flue	●
Non Asbestos Item (Sampled)

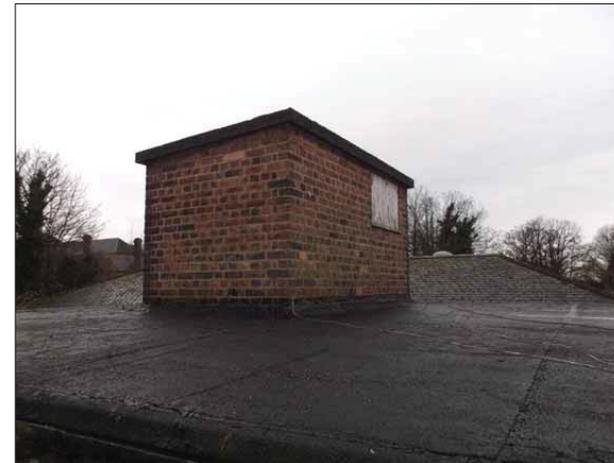
FINDING DETAILS					
Finding Code 12122014AGPA001		Item	Bitumen Cover to Roof		
		Recommendations	No action required		
LOCATION					
Internal/External	Floor Level	Location Description		Extent	Identification
External	Ground Floor	Roof Covering to Back Care		130sq.m	Identified
MATERIAL ASSESSMENT					
Material	Asbestos Type	Condition	Accessibility	Encapsulation	Material Assessment
Bitumen	No Asbestos Detected	Low Damage: a few scratches or surface marks	Accessible, but in restricted access areas	Enclosed	0
SURVEYORS COMMENTS					
REMEDIAL ACTION TAKEN					
Action			Date Works Completed

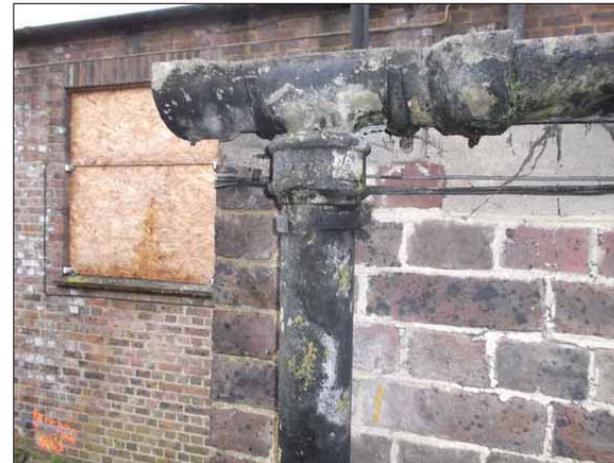
FINDING DETAILS					
Finding Code 12122014AGPA003		Item Guttering	Recommendations Remove Prior to Demolition		
LOCATION					
Internal/External	Floor Level	Location Description		Extent	Identification
External	Ground Floor	Roof Level, Rain Water Guttering		70m	Identified
MATERIAL ASSESSMENT					
Material	Asbestos Type	Condition	Accessibility	Encapsulation	Material Assessment
Cement	Chrysotile (white)	Low Damage: a few scratches or surface marks	Accessible, but above head height	Unsealed	5
SURVEYORS COMMENTS					
REMEDIAL ACTION TAKEN					
Action			Date Works Completed

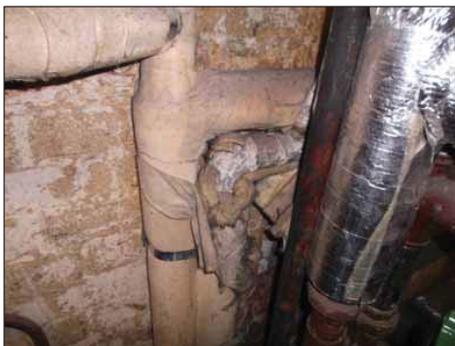
3.1.2 The boiler room is accessed externally has a number of old pipes lagged in machine-made mineral fibre (MMMf) and a canvas wrap. Asbestos thermal insulation residue was identified below on the metal pipes.

3.1.3 The tank room located above the boiler room has asbestos thermal insulation residue on the walls.

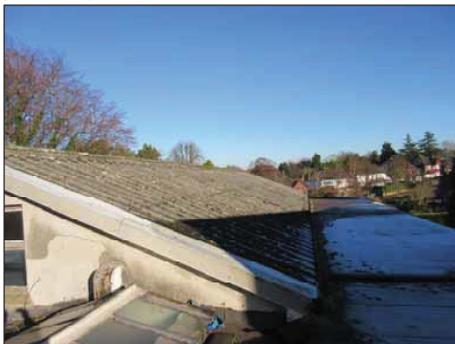
3.1.5 Asbestos cement roof sheets and ridge tiles have been used throughout this department, on the apex roof areas. Asbestos cement guttering is located on the flat roof areas.

3.1.6 A small section of asbestos cement debris is located behind a boarded-up window between the glass and adjacent plasterboard wall.

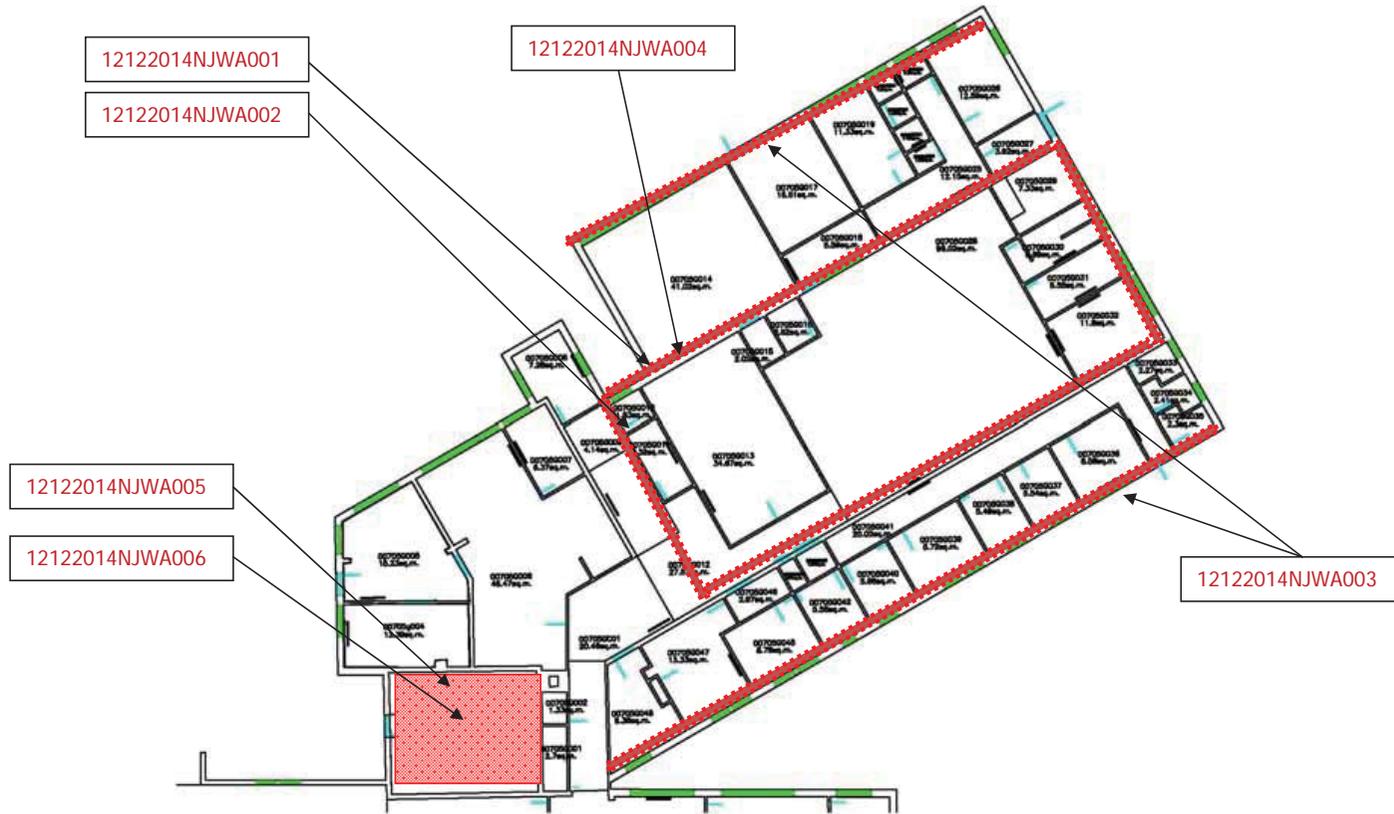
## Pharmacy/Bloods, Sutton Hospital – Ground Floor

<b>Key:</b>	
Asbestos Item:	
Thermal Insulation Debris	
Cement	
Non Asbestos Item (Sampled)

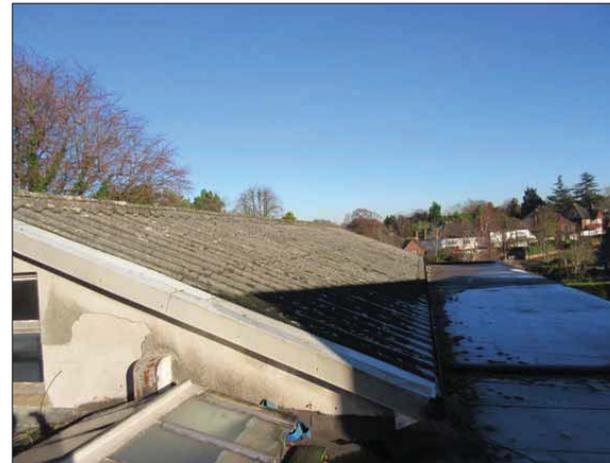
FINDING DETAILS					
Finding Code 12122014NJWA001		Item	Profile Sheets and Ridge Tiles		
		Recommendations	Remove Prior to Demolition		
LOCATION					
Internal/External	Floor Level	Location Description		Extent	Identification
External	Ground Floor	Apex Roof		265sq. m	Identified
MATERIAL ASSESSMENT					
Material	Asbestos Type	Condition	Accessibility	Encapsulation	Material Assessment
Cement	Chrysotile (white)	Low Damage: a few scratches or surface marks	Accessible, but above head height	Enclosed	4
SURVEYORS COMMENTS					
REMEDIAL ACTION TAKEN					
Action			Date Works Completed

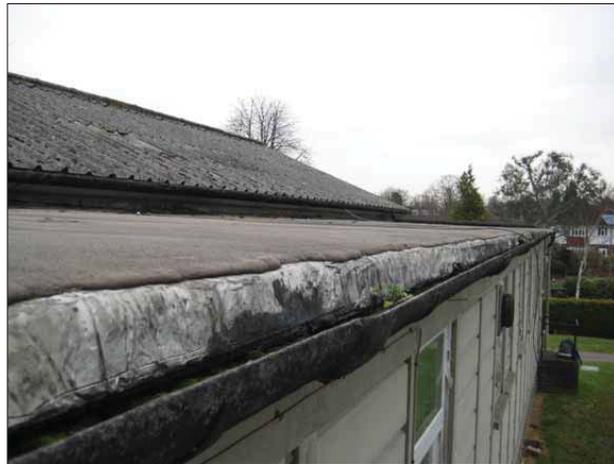
FINDING DETAILS					
Finding Code 12122014NJWA002		Item Soffit Board	Recommendations Remove Prior to Demolition		
LOCATION					
Internal/External	Floor Level	Location Description	Extent	Identification	
External	Ground Floor	Apex and Flat Roof	35s	Identified	
MATERIAL ASSESSMENT					
Material	Asbestos Type	Condition	Accessibility	Encapsulation	Material Assessment
Cement	Amosite & Chrysotile	Low Damage: a few scratches or surface marks	Accessible, but above head height	Unsealed	6
SURVEYORS COMMENTS					
REMEDIAL ACTION TAKEN					
Action			Date Works Completed

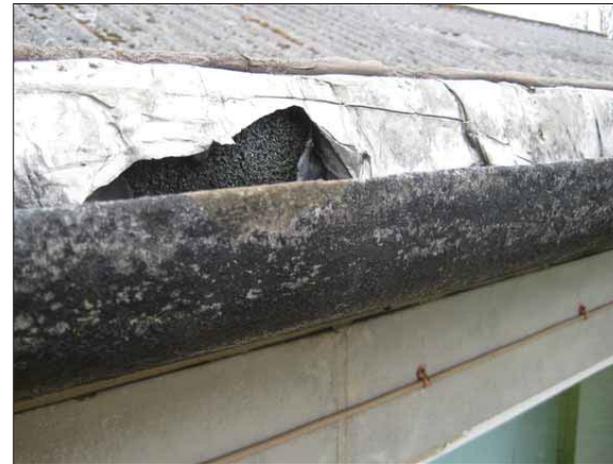
FINDING DETAILS					
Finding Code 12122014NJWA003		Item Rainwater Guttering (Not Down Pipes)	Recommendations Remove Prior to Demolition		
LOCATION					
Internal/External	Floor Level	Location Description	Extent	Identification	
External	Ground Floor	Flat Roof	25m	Identified	
MATERIAL ASSESSMENT					
Material	Asbestos Type	Condition	Accessibility	Encapsulation	Material Assessment
Cement	Chrysotile (white)	Low Damage: a few scratches or surface marks	Accessible, but above head height	Unsealed	5
SURVEYORS COMMENTS					
REMEDIAL ACTION TAKEN					
Action			Date Works Completed

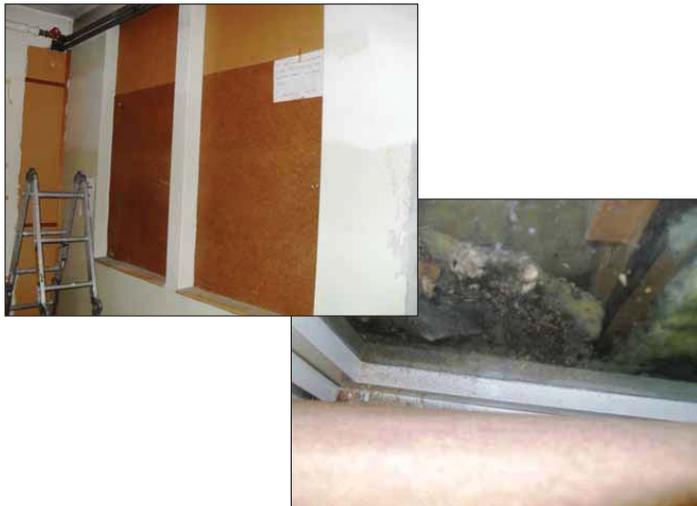
FINDING DETAILS					
Finding Code 12122014NJWA004		Item Debris	Recommendations Remove Prior to Demolition		
LOCATION					
Internal/External	Floor Level	Location Description	Extent	Identification	
Internal Occupied	Ground Floor	Window between existing and former filing room	<1sq. m	Identified	
MATERIAL ASSESSMENT					
Material	Asbestos Type	Condition	Accessibility	Encapsulation	Material Assessment
Cement	Chrysotile (white)	Medium Damage: Significant breakage of materials	Accessible, but in restricted access areas	Unsealed	6
SURVEYORS COMMENTS					
REMEDIAL ACTION TAKEN					
Action			Date Works Completed

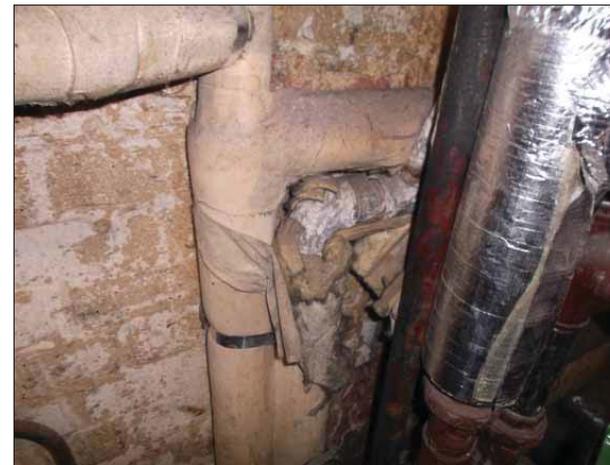
FINDING DETAILS					
Finding Code 12122014NJWA005		Item Thermal Insulation Residue	Recommendations Remove Prior to Demolition		
LOCATION					
Internal/External	Floor Level	Location Description	Extent	Identification	
Internal Occupied	Ground Floor	Boiler Room 00705G003, Pipework	30m	Identified	
MATERIAL ASSESSMENT					
Material	Asbestos Type	Condition	Accessibility	Encapsulation	Material Assessment
Thermal Insulation	Amosite & Chrysotile	High Damage: Or delamination of material	Accessible, but in restricted access areas	Unsealed lagging & sprays	11
SURVEYORS COMMENTS					
REMEDIAL ACTION TAKEN					
Action			Date Works Completed

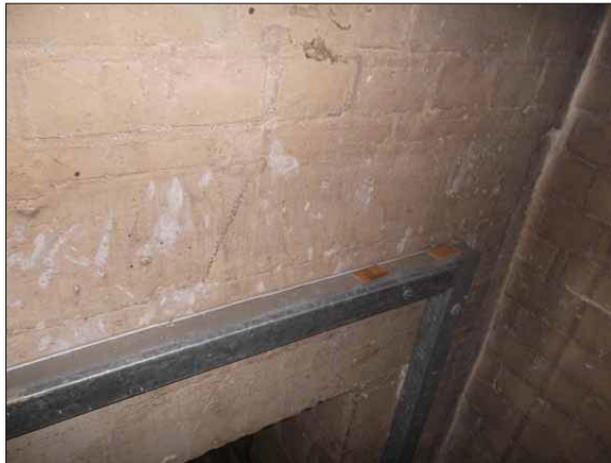
FINDING DETAILS					
Finding Code 12122014NJWA006		Item	Thermal Insulation Residue		
		Recommendations	Remove Prior to Demolition		
LOCATION					
Internal/External	Floor Level	Location Description		Extent	Identification
Internal Occupied	Ground Floor	Boiler Room 00705G003, Tanks Room Above, Walls		25sq.m	Identified
MATERIAL ASSESSMENT					
Material	Asbestos Type	Condition	Accessibility	Encapsulation	Material Assessment
Thermal Insulation	Amosite & Chrysotile	High Damage: Or delamination of material	Accessible, but in restricted access areas	Unsealed lagging & sprays	11
SURVEYORS COMMENTS					
REMEDIAL ACTION TAKEN					
Action			Date Works Completed
